# WISSAHICKON CREEK STREAM ASSESSMENT STUDY LOWER WISSAHICKON WATERSHED

Philadelphia Water Department Office of Watersheds 2010

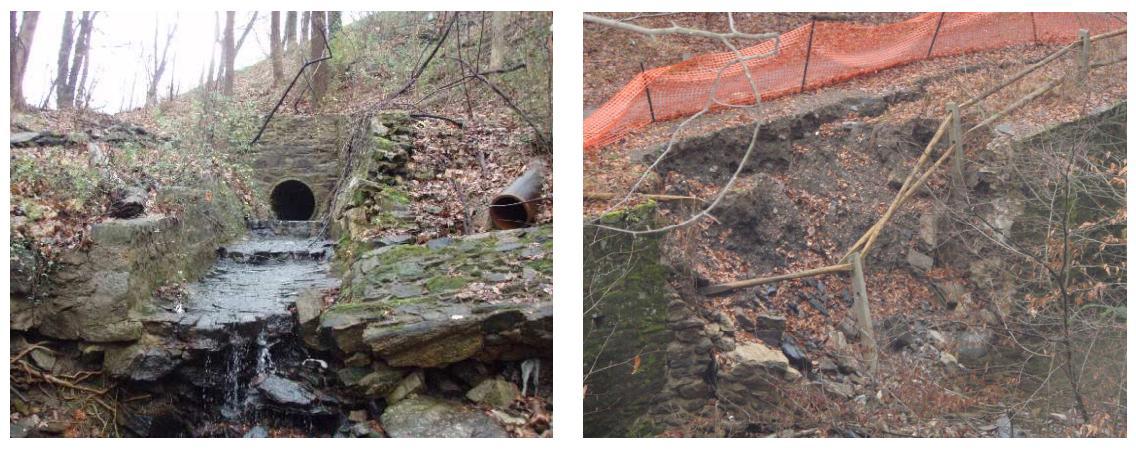
Figure 3-34: Degraded section of WScha280 (left). Degraded section of WScha142 (right).

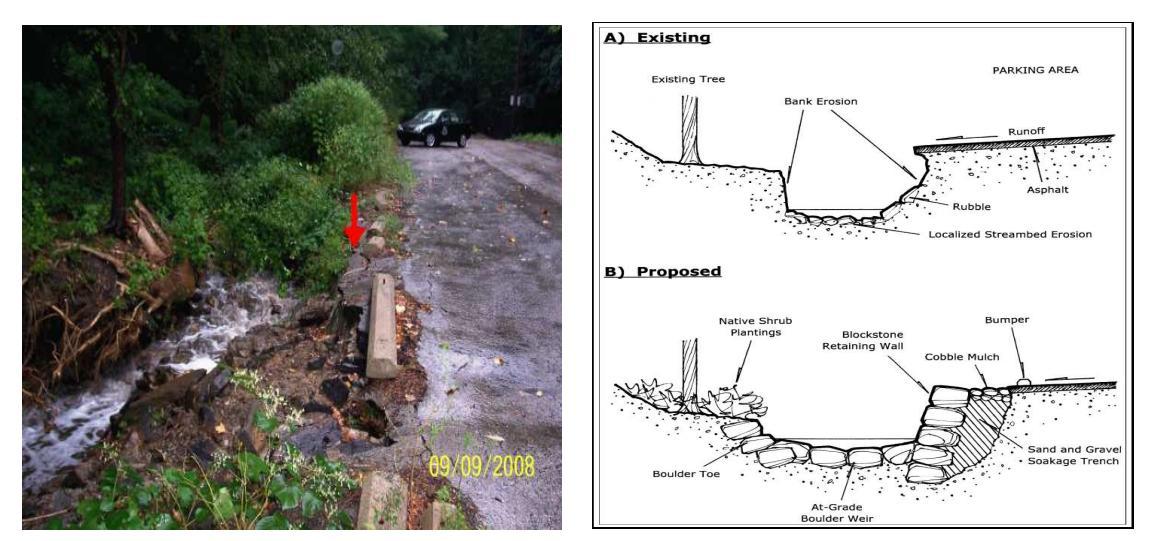
Figure 3-100: Bank erosion caused by parking lot runoff (left); schematic of restored condition (right).

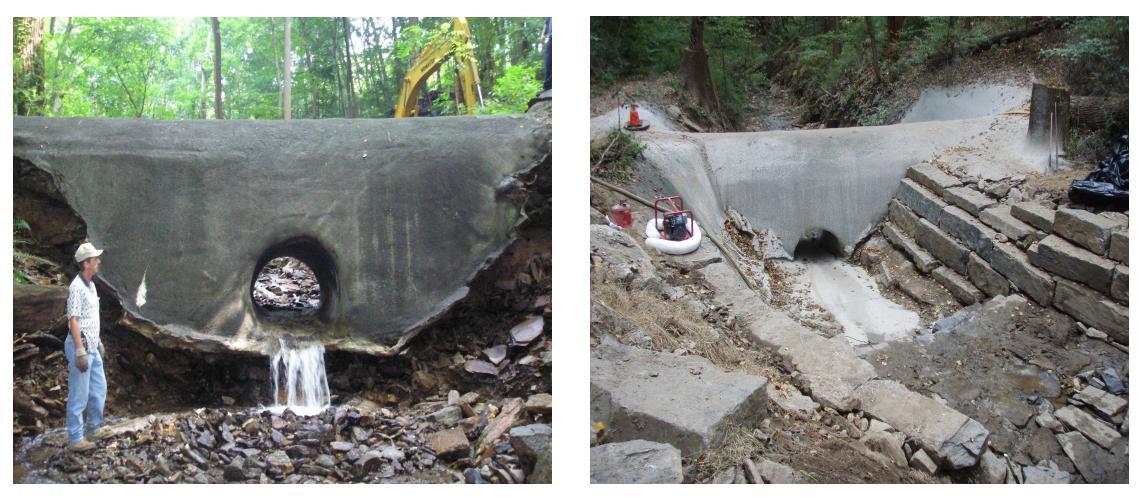
Figure 3-101: Upstream view of WScul116 pre-construction (left); Downstream view of WScul116 post-construction (right).

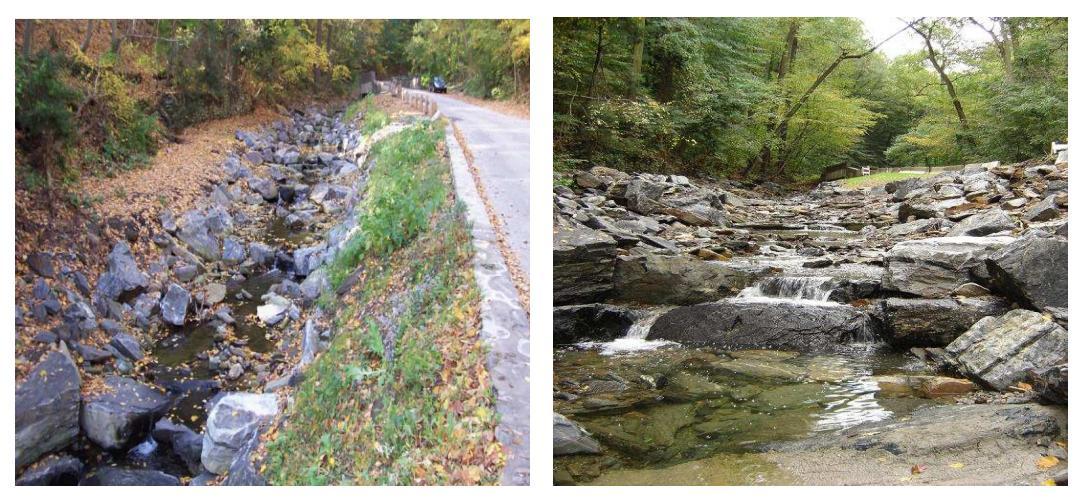
Figure 3-102: View of boulder step-pool system looking upstream (left): scour pool at the base of the step-pool system (right).

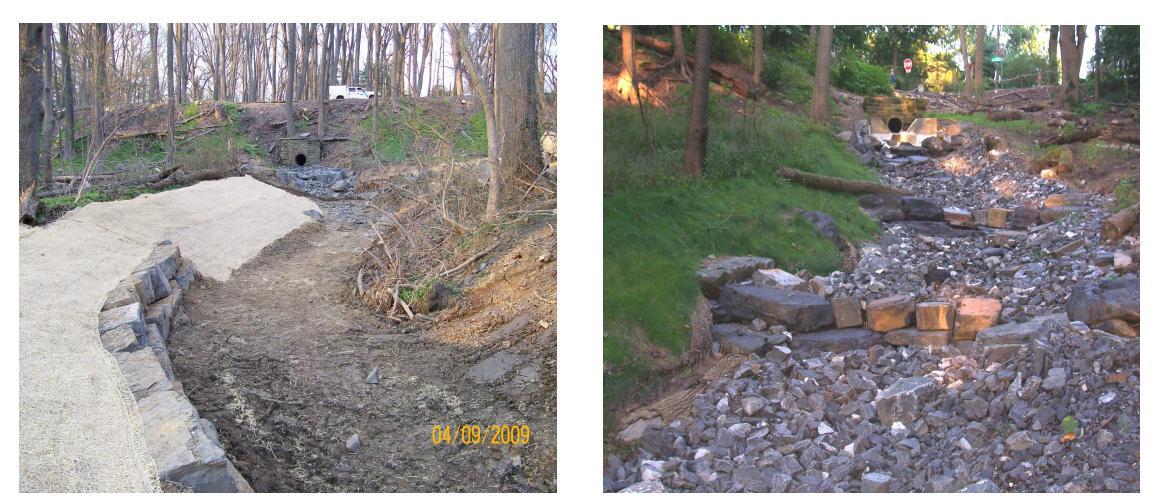
Figure 3-103: WSout513 conveyance channel during (left) and after (right) construction

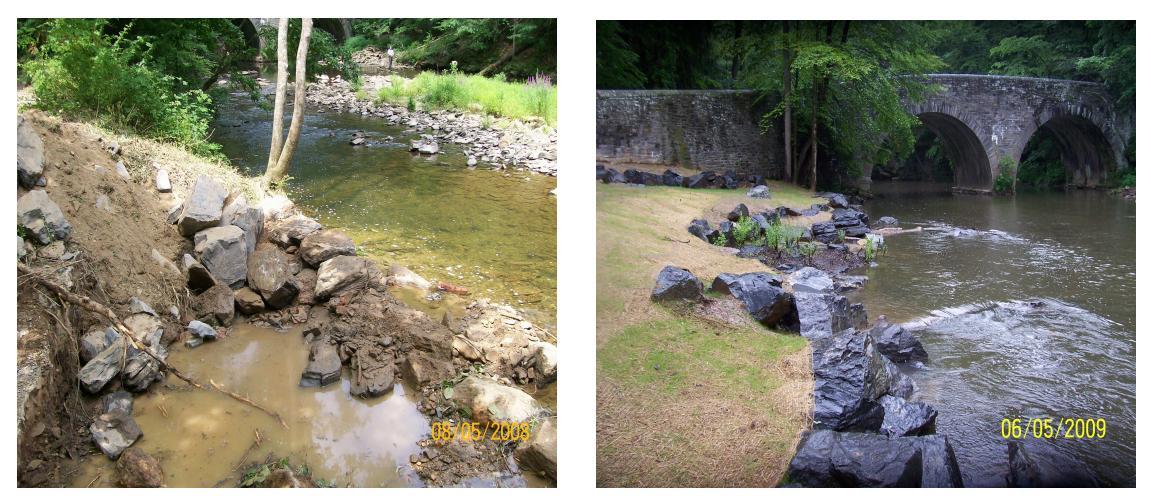
Figure 3-105: DSR bank in reach WSMS110 following emergency repairs (left); DSR bank following bank stabilization and instream flow structure installation (right).
