# TOOKANY CREEK WATERSHED MANAGEMENT PLAN (TCWMP)

# Visual Streambank Assessment

## TOOKANY CREEK WATERSHED MANAGEMENT PLAN

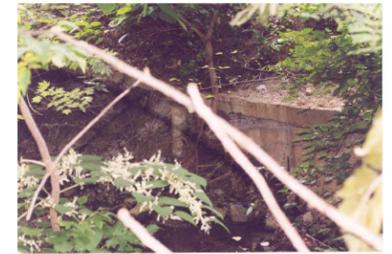
5. Broken concrete bulkhead  
**Action/BMP:** Have the township engineer assess the problem and develop solution.

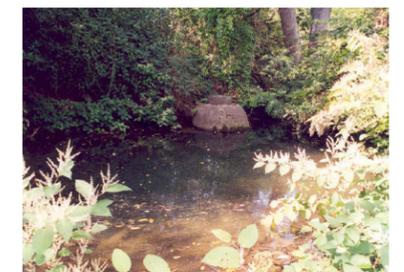
10. Discolored water in deep pool behind Kaname Gardens adjacent to Waverly Road  
**Action/BMP:** Follow up with the nursery owner

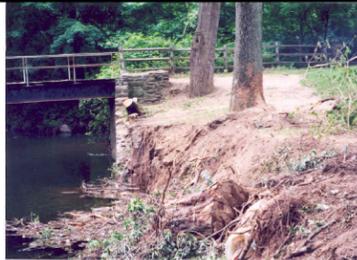
1. Pedestrian bridge at Jenkintown Creek shortly after Tropical Storm Allison (5/01). The surrounding area under the trees is routinely mowed to the bank.  
**Action/BMP** : This area is currently undergoing biotechnical streambank restoration.

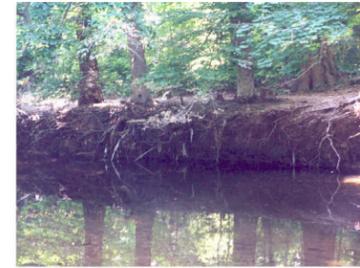
4. The steep wooded slopes of the west bank of the Tookany Creek along the Parkway are becoming undercut as a result of the upstream volumes of stormwater. The mature trees can hold the bank with their roots, but if the volume of water continues, the roots will be undermined and the trees will fall.  
**Action/BMP** : Conduct a complete study of the hydrology of the Tookany Creek using the Rosgen model to develop a long-term plan for the restoration. Use biotechnical streambank restoration to fortify the roots and stabilize the banks.

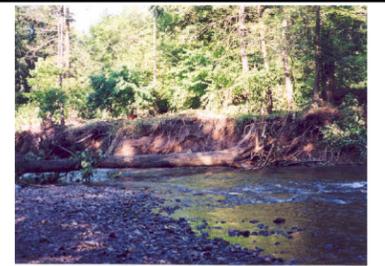
5. Newly eroded banks as a result of Tropical Storm Allison.  
**Action/BMP** : This area is undergoing biotechnical streambank restoration. Continue to monitor for knotweed re-infestation.

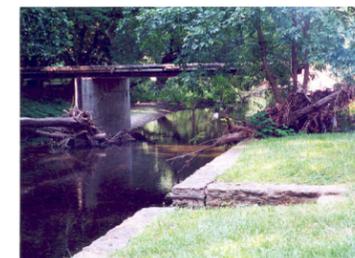
10. The area adjacent to the Tookany Parkway and the creek is mowed to the banks, preventing any filtering of the NPS pollution.  
**Action/BMP** : The golf course and the township should revise the mowing practices to less area and frequency. Plant the understory with native shrubs and herbaceous layer to fortify the riparian buffer.

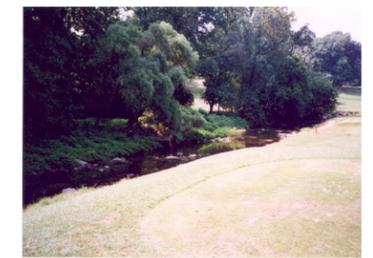
11. Melrose Golf Course maintains the grass to the creek bed, preventing any riparian filtration of NPS pollution.  
**Action/BMP** : Encourage participation in the Audubon certification program for golf courses. Possibly reduce the greens directly next to the Tookany Creek and replant with native vegetation to filter NPS pollution and stabilize the banks.

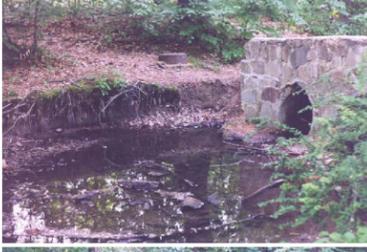
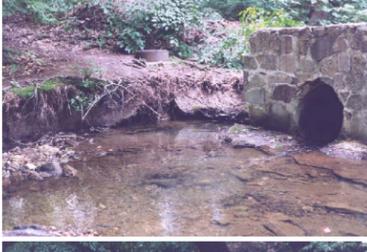
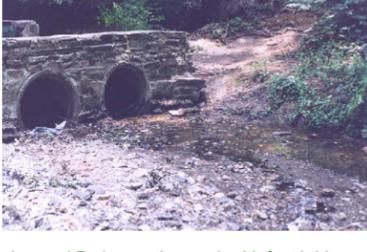
4. Baederwood Park near the creek with foot bridge. Stream widens to 15ft. Small wetland area as indicated by obligate plant species of skunk cabbage. Water clear. Slope 20% on one side, other side wetlands then gradual slope. Under cutting around foot bridge.

Action/BMP: Employ biotechnical streambank techniques to restore bank. After bridge, stream widens considerably in a spot. Bank really cut on side of playground. Action/BMP: Employ biotechnical streambank techniques to restore and stabilize bank.

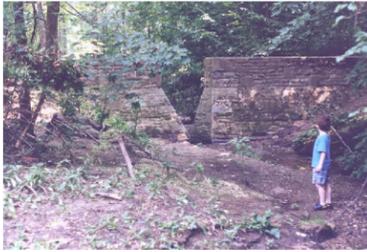
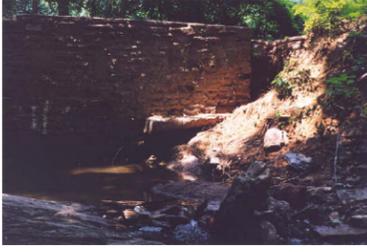
5. Attractive stone wall across the creek, 20 ft high 3ft. gap cut into it - possibly used to slow down water flow. Several mature beech trees, maples, tulip, and oak. A great deal of in-channel erosion.

Action/BMP: Employ Biotechnical streambank techniques to restore bank to repair channel erosion and bring the banks to more natural 3:1 slope and replant with native vegetation

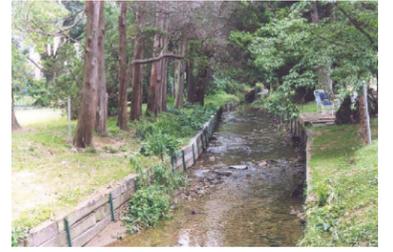
11. After flowing under Baeder Road, the stream is walled in on both sides. Walls vary in height from 6 to 12 feet in spots. The vertical wall is 6x6 lumber most of the way. Along part of the creek, the wall is cement.

Action/BMP: Consider removing the walls and employ biotechnical streambank techniques to restore riparian buffer and its essential functions, and allow the bank to become a more natural 3:1 slope and replant with native vegetation.

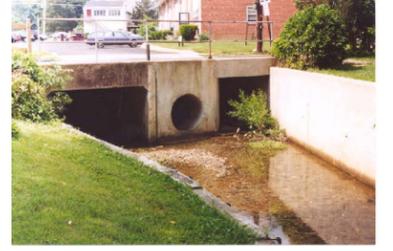
12. The stream travels under the Madison Apartments parking lot and then under Jenkintown Rd.

Action/BMP: Stop mowing to the creek banks; Employ Biotechnical streambank techniques to restore bank to a more natural 3:1 slope and replant with native vegetation.

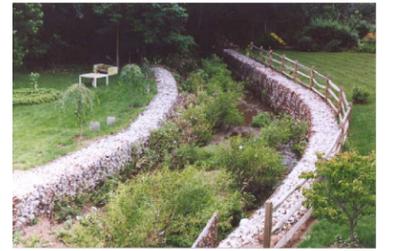
13. On the other side of Jenkintown Road, the creek reappears in a residential neighborhood. Gabion baskets make up the vertical walls on both sides. Native veg, such as willows and viburnum growing in stream bed.

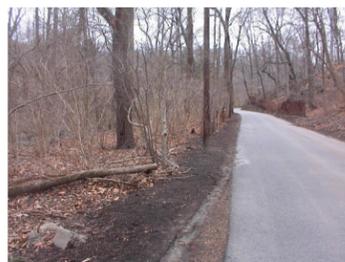
8. For the next half mile from Washington Lane to the Rock Lane bridge, the stream flows through a wooded valley with the lightly traveled Rock Lane close on its southern bank.  
**Action/BMP** : No action necessary; continue to maintain the land uses surrounding this area.

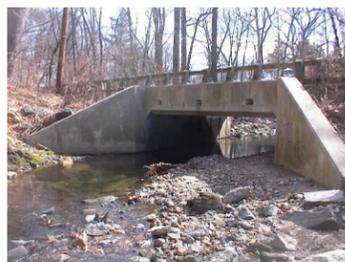
9. Small fish (up to 6") frequent the pool under the Rock Lane Bridge. The channel is more stable and naturalized due to the vegetated stream banks.  
**Action/BMP** : No action necessary; continue to maintain the land uses surrounding this area.
