POQUESSING CREEK STREAM ASSESSMENT STUDY

Philadelphia Water Department Office of Watersheds 2013

Poquessing Creek Watershed Assessment Report

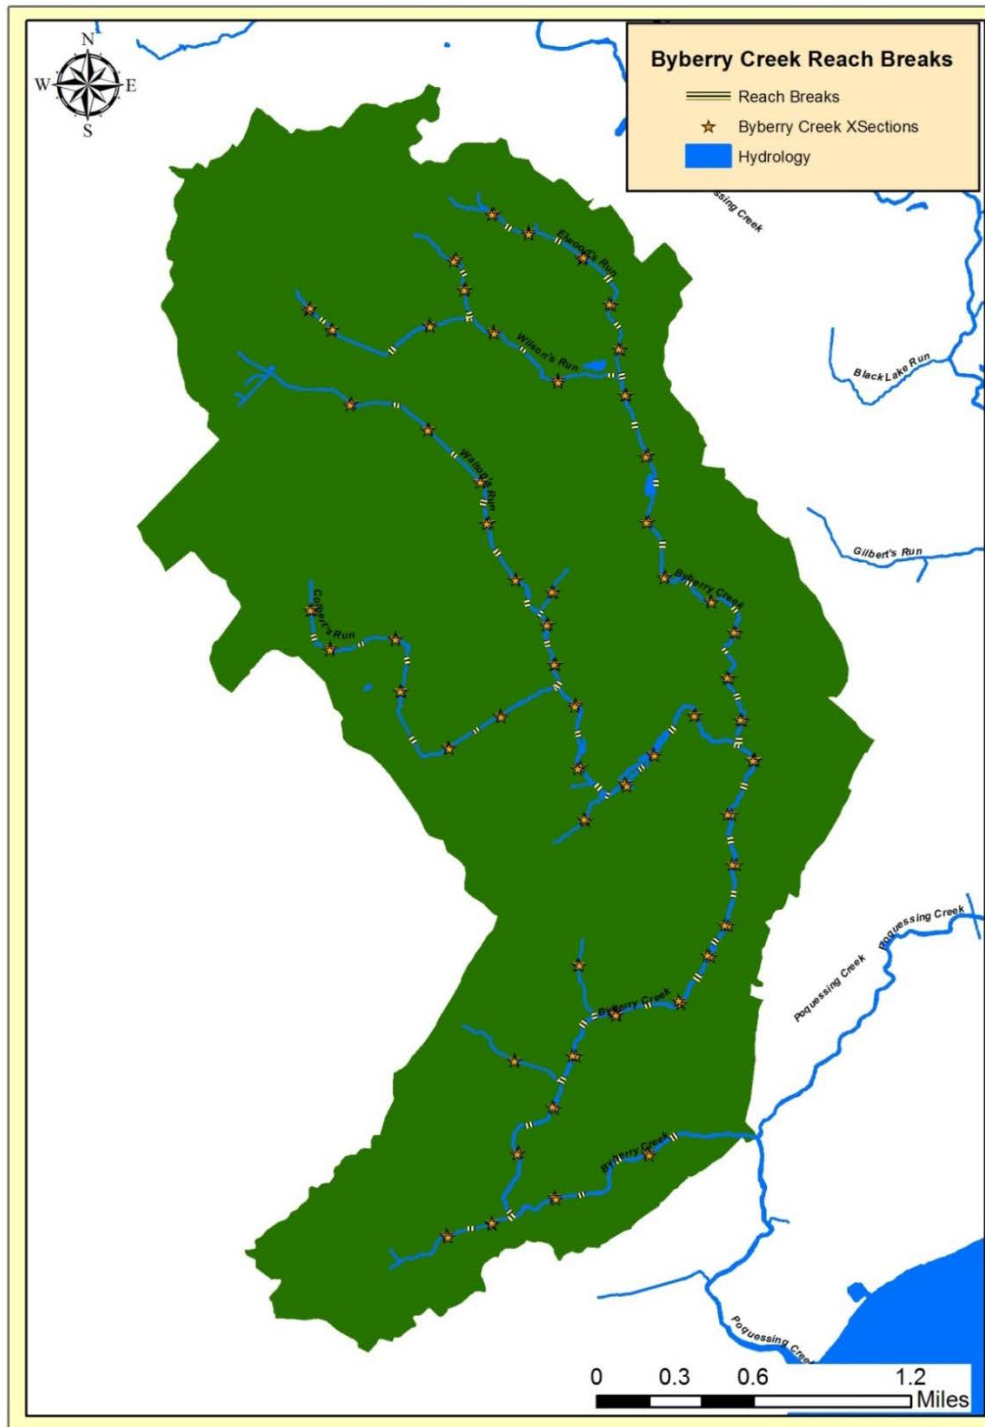
Figure 2-4: Byberry Creek Reach Breaks.

The measured reach stream survey also consisted of surveying channel cross sections at each location previously chosen during the field reconnaissance. [Appendix A](#) contains a summary of the results of the surveyed cross sections and local longitudinal profiles. Digital photographs were taken at every cross section location as a means of verification for field identified parameters. The photos consisted of an upstream view, a downstream view, views of the left and right banks, and views of the left and right floodplains ([Appendix A](#)). Cross section locations are shown in Figure 2-3. An example of the reach break locations (for the Byberry Creek Watershed) is shown on Figure 2-4.

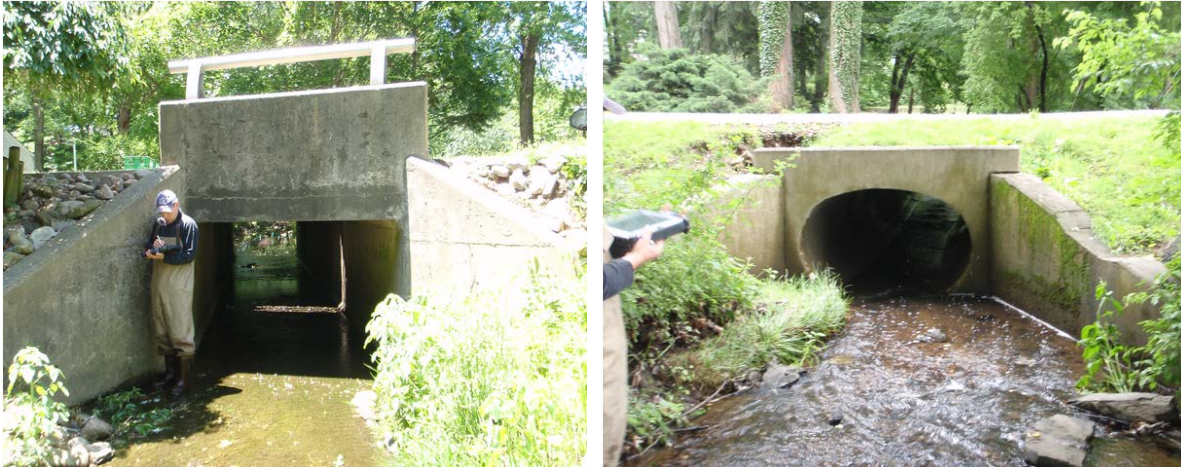
Figure 2-10: Examples of culverts assessed in infrastructure trackdown.

A culvert was defined as a conduit which carried the stream under a roadway, sidewalk, building, or miscellaneous structure (Figure 2-12). Culverts were mapped by taking GPS coordinates at the start and end of the culvert with photos taken at each point. The data collected for each culvert included the approximate dimensions, construction material (e.g. stone, concrete, brick, etc.), and structural condition

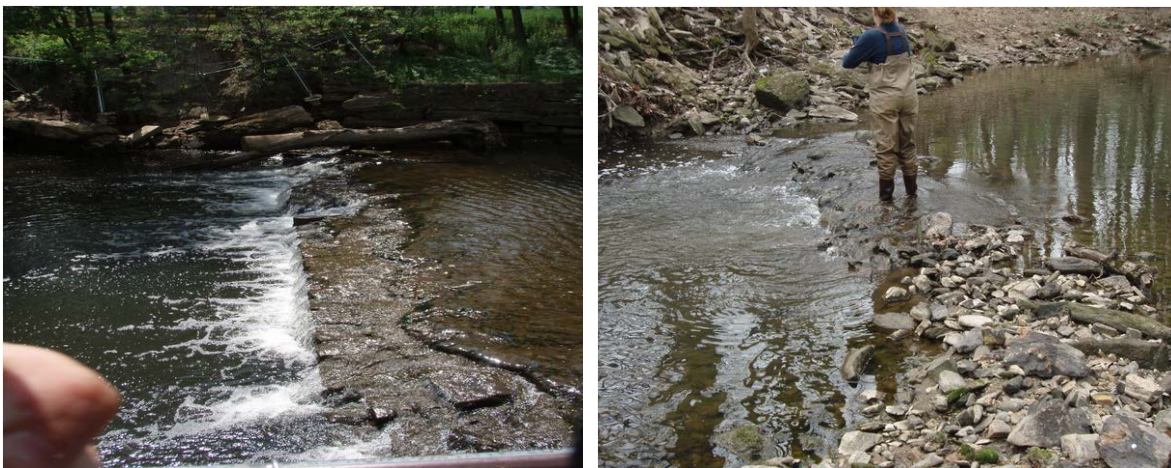
Figure 2-11: Examples of dams assessed in infrastructure trackdown.

A dam was defined as an obstruction that impounded stream flow (Figure 2-13). Data was only collected for manmade dams and did not include natural debris jams caused by coarse woody debris (CWD). The data collected for each dam included the approximate dimension, structural condition (good, fair, or poor), and height exposed above the stream bed.

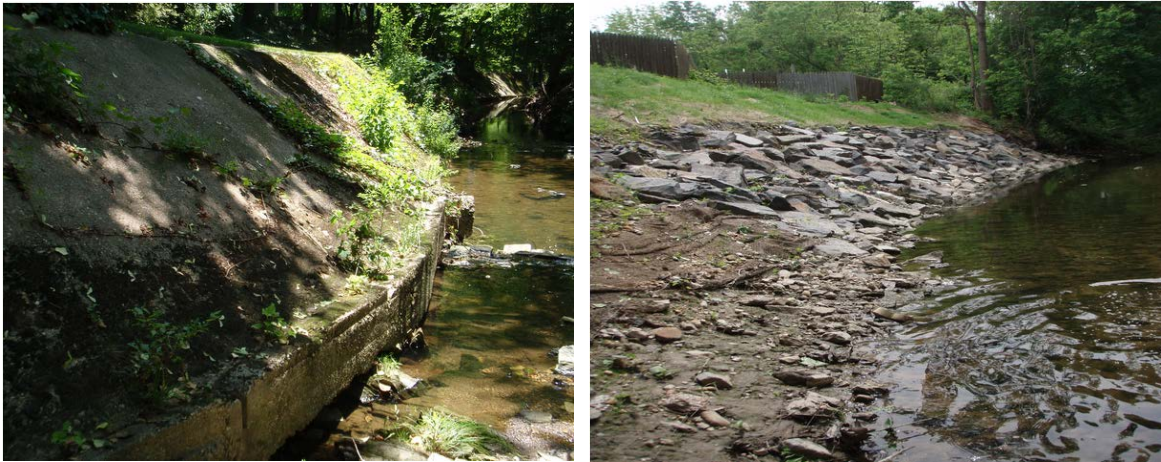
Figure 2-12: Examples of channels assessed in infrastructure trackdown.

A channel was defined as a straightening and reinforcement of stream bed and/or banks with manmade materials such as concrete (Figure 2-14). Channels were located on one or both banks, as well as on the

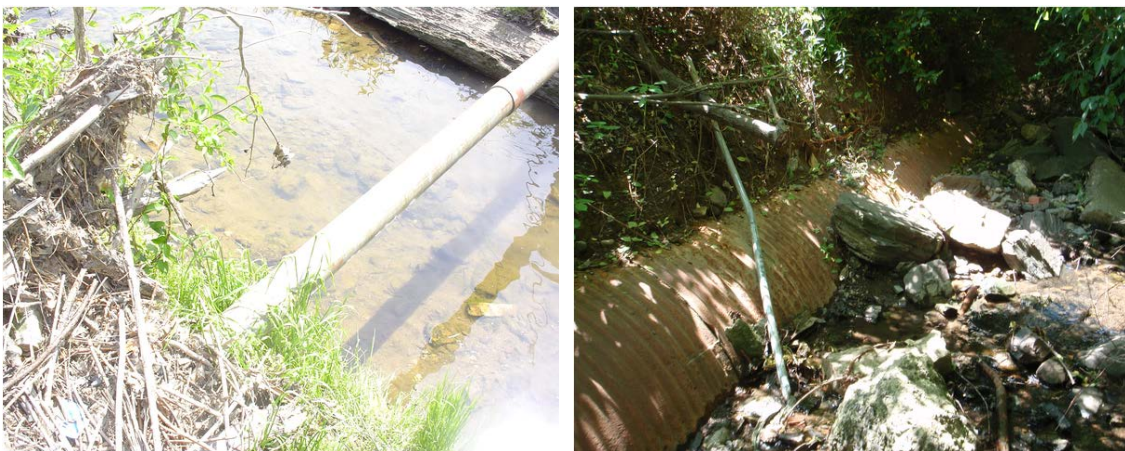
Figure 2-13: Example of a pipe assessed in infrastructure trackdown.

A pipe was defined as a conduit for carrying a utility across the stream (Figure 2-16). The data collected for each pipe included the approximate diameter, construction material (i.e. concrete, metal, terra cotta, etc.), the length and height above the water or ground surface of the exposed portion, structural condition (i.e. good, fair, or poor), and bank location (i.e. left, right or across the creek).

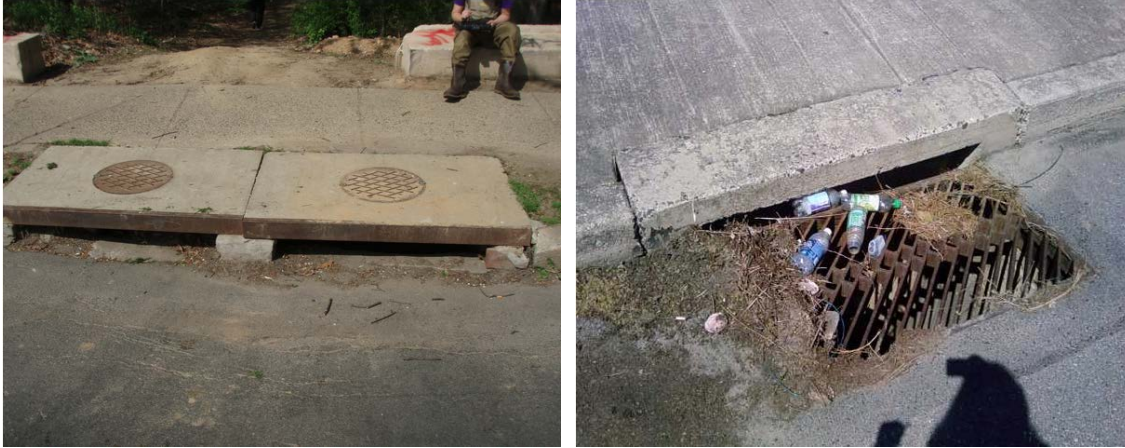
Figure 2-14: Example of a miscellaneous item (i.e. an inlet or sewer grate)

Miscellaneous infrastructure consists of structures not falling within the previously listed categories (Figure 2-17). For example, storm sewer inlets and grates make up the majority of this category. Descriptions of the miscellaneous infrastructure were collected.

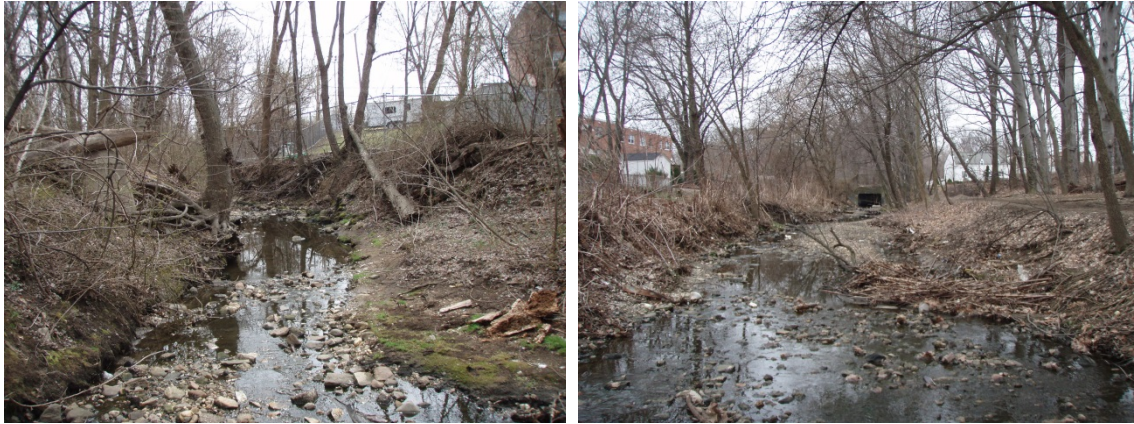
Figure 3- 119: Left- downstream view of PQGR02, Right- downstream view of PQGR06

The entire 0.9 miles of Gilbert's Run and 0.1 miles of the Unnamed Tributary to Gilbert Run are classified as high priority reaches. These reaches are located in the Poquessing Valley Park (Fairmount Park Commission) in Philadelphia County. This priority location consists of reaches PQGR02, PQGR04, PQGR06, and PQGRA02 (See [Appendix E](#) for Priority Restoration Reach Maps). This location had the highest priority reaches in the entire Poquessing Creek Watershed. These reaches are extremely entrenched and over-widened. Streambanks are actively eroding and streambank vegetation is impacted. Over-widening, sedimentation, and minimal baseflow has severely impacted instream habitat. Invasive vegetation exists throughout the priority location.

The presence of Fairmount Park Commission land on both sides of much of the stream channel will improve the potential for successful restoration partnerships. A walking trail adjacent to Gilbert's Run could provide construction access for restoration activities.

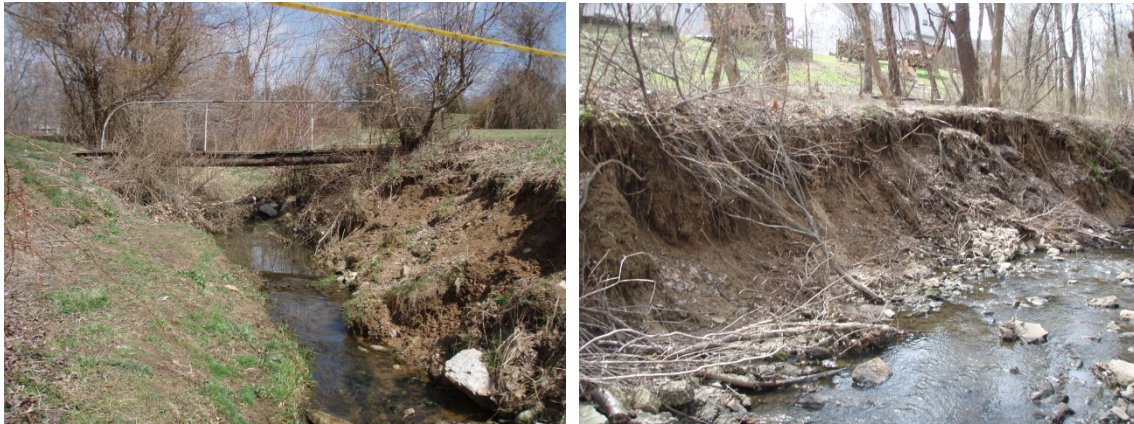
Figure 3- 120: Left- upstream view of PQMSI02; Right- downstream left bank of PQMSJ06

The entire 0.4 miles of Poquessing Creek Unnamed Tributary I is classified as a high priority reach. The upper 0.7 miles of Poquessing Creek Unnamed Tributary J are classified as high priority. These reaches are located on the Bensalem Township Country Club Golf Course property in Bucks County. This priority location consists of reaches PQMSI02, PQMSJ02, PQMSJ04, and PQMSJ06 (See [Appendix E](#) for Priority Restoration Reach Maps). These reaches have extremely eroded banks and little riparian vegetation throughout the golf course. Although good access to the channel exists throughout these reaches, there may be difficulties coordinating construction activities on an active golf course. Also, a highly eroded bank adjacent to a golf course pond exists on Poquessing Creek (Reaches PQMS 60 & PQMS 62) near Unnamed Tributary I. This bank should be stabilized to prevent the connection of Poquessing Creek with this pond. This would result in a significant sediment discharge to Poquessing Creek.

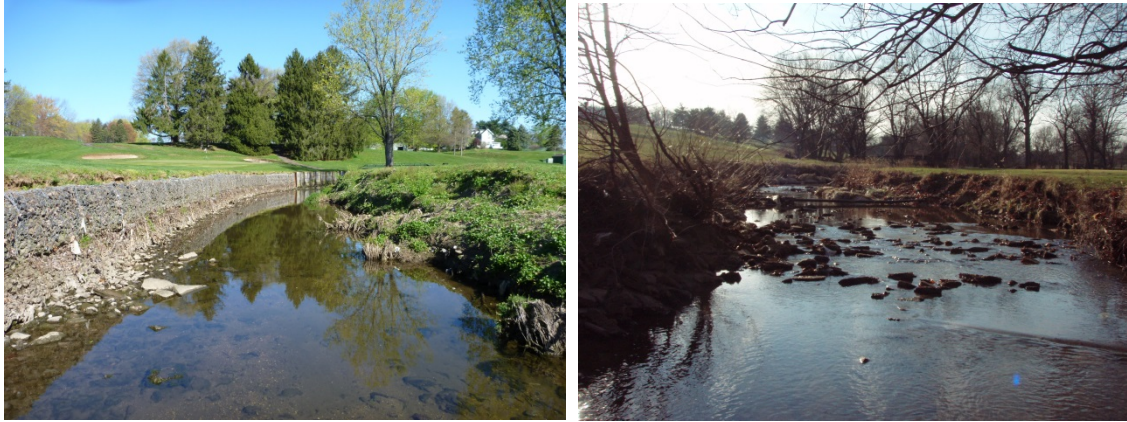
Figure 3- 121: Left- upstream view of PQBY36; Right- upstream View of PQBY38

A total of 0.7 miles of Byberry Creek and 0.2 miles on Byberry Creek, unnamed tributary C are classified as high priority reaches. These reaches lie entirely within Philadelphia County. These reaches pass through the privately owned Torresdale-Frankford Country Club at the upstream and downstream ends. The middle of this priority section passes through the publicly owned (Fairmount Park) John F. Byrne Golf Club. This priority location consists of reaches PQBY36, PQBY38, and PQBYC04 (See [Appendix E](#) for Priority Restoration Reach Maps). These reaches have extremely eroded banks and little riparian vegetation throughout the golf courses. Also, the stream channels are over-widened and little useable habitat exists. Also, the Creek is channelized in gabion walls through the Torresdale-Frankford Country Club and significant coordination and approvals would be required with the private landowner to complete a more naturalized restoration. Also, the expansion of a riparian buffer throughout the reach would be very beneficial to the Creek in this location. However, this may not be compatible with the current golf course layouts. Although good access to the channel exists throughout these reaches, there may be difficulties coordinating construction activities on active golf courses.

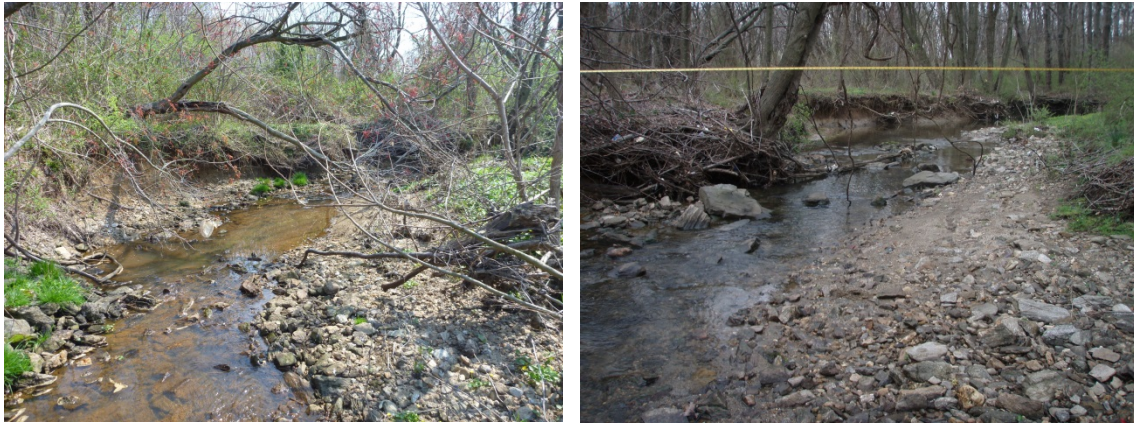
Figure 3- 122: Left: Upstream view of PQWA14; Downstream view of PQWA18

The most downstream 1.9 miles of Walton's Run is classified as high or moderately high priority reaches. These reaches lie entirely within Philadelphia County. The upper portion of these prioritized reaches flow adjacent to Northeast Philadelphia Airport property. The lower portion of these reaches run through the Walton's Run Fairmount Park Parcel. This priority location consists of reaches PQWA14, PQWA16, PQWA18, PQWA20, PQWA22, PQWA24, PQWA26, and PQWA28 (See [Appendix E](#) for Priority Restoration Reach Maps). This location had the longest length of high priority reaches in the entire Poquessing Creek Watershed. These reaches are generally entrenched and over-widened. Streambanks are actively eroding and streambank vegetation is impacted. Over-widening, sedimentation, and minimal baseflow has severely impacted instream habitat. Invasive vegetation exists throughout the priority location. However, significant forested buffers and floodplain wetlands exist throughout these reaches.

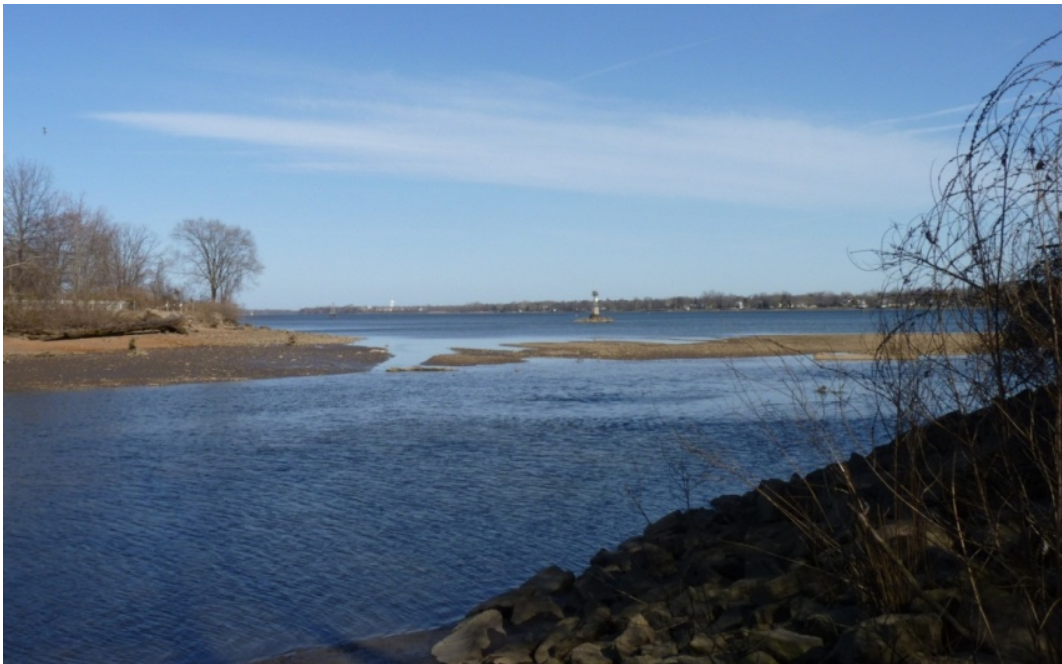
Figure 3-125: The confluence of the Poquessing Creek and the Delaware River (viewed from the base of the stream bank; presently inaccessible to the public due to safety concerns)

In the proposed Phase 1 of this project, for which they are currently requesting funds, invasive vegetation along the southern bank of the Poquessing Creek will be removed and native trees, shrubs and herbaceous species of the Atlantic coastal plain will be planted. The new landscape will reduce erosion of the steep slopes of this tidal waterway, provide habitat for birds, insect pollinators, and other wildlife, reduce
