## **APPENDIX A - CROSS SECTION PICTURES**

Tacony-Frankford Watershed Stream Study  
Philadelphia Water Department  
Office of Watersheds

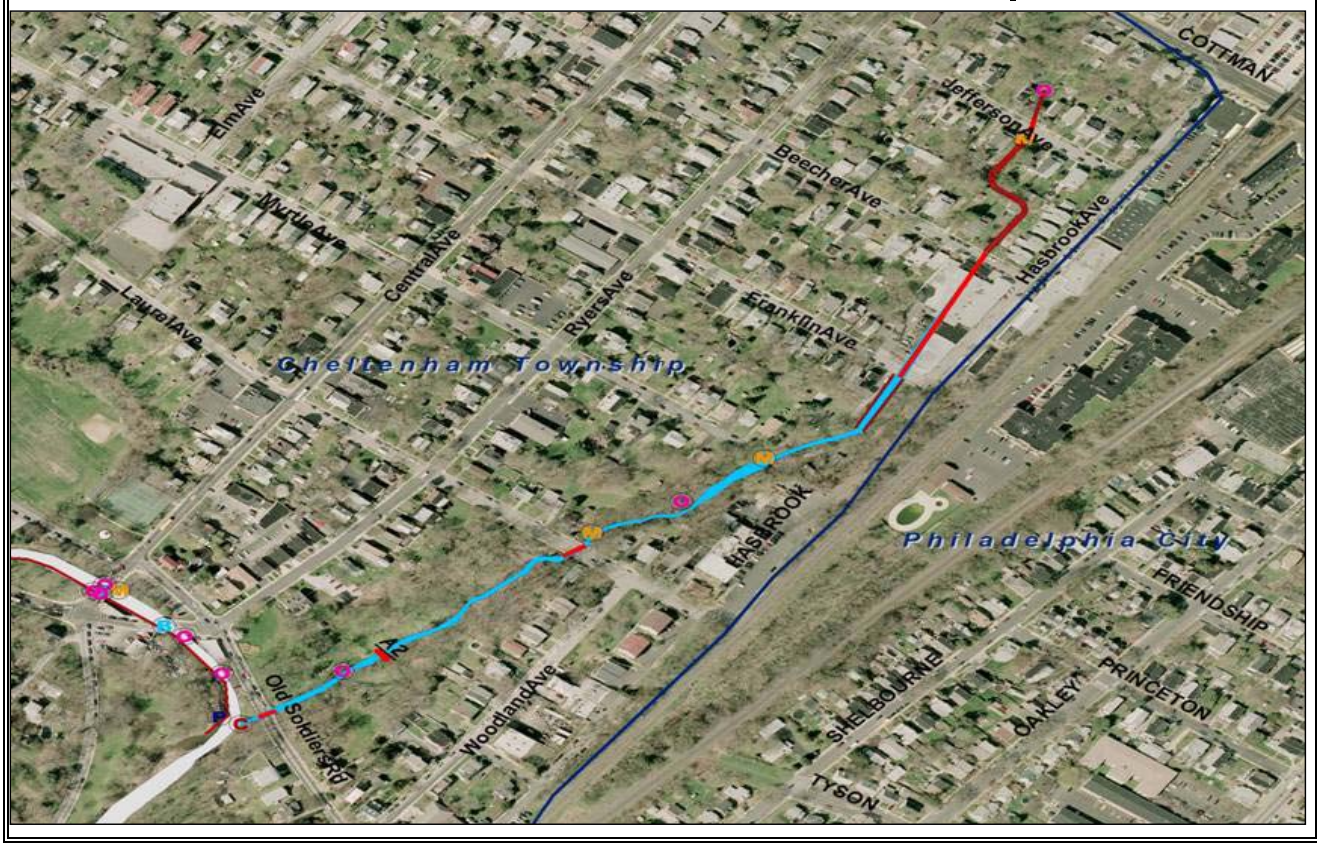
P	Riparian Width - DSR	1 / 5	
H	A	Riparian Width - DSL	3 / 5
A	R	Riparian Composition - DSR	3 / 5
B	A	Riparian Composition - DSL	3 / 5
I	M	Canopy Cover - DSR	5 / 5
T	E	Canopy Cover - DSL	4 / 5
A	T	Bed Materials	0 / 5
T	E	Sediment Supply	3 / 5
R		Sinuosity	5 / 5
S		Woody Debris	1 / 5
		Attachment Sites	3 / 5

R		
A	Total Score	69 / 155
N	Stability Score	34 / 100
K	Habitat Score	35 / 55
I	Priority In Shed	44 / 102
N	Priority In Tributary	3 / 5
G

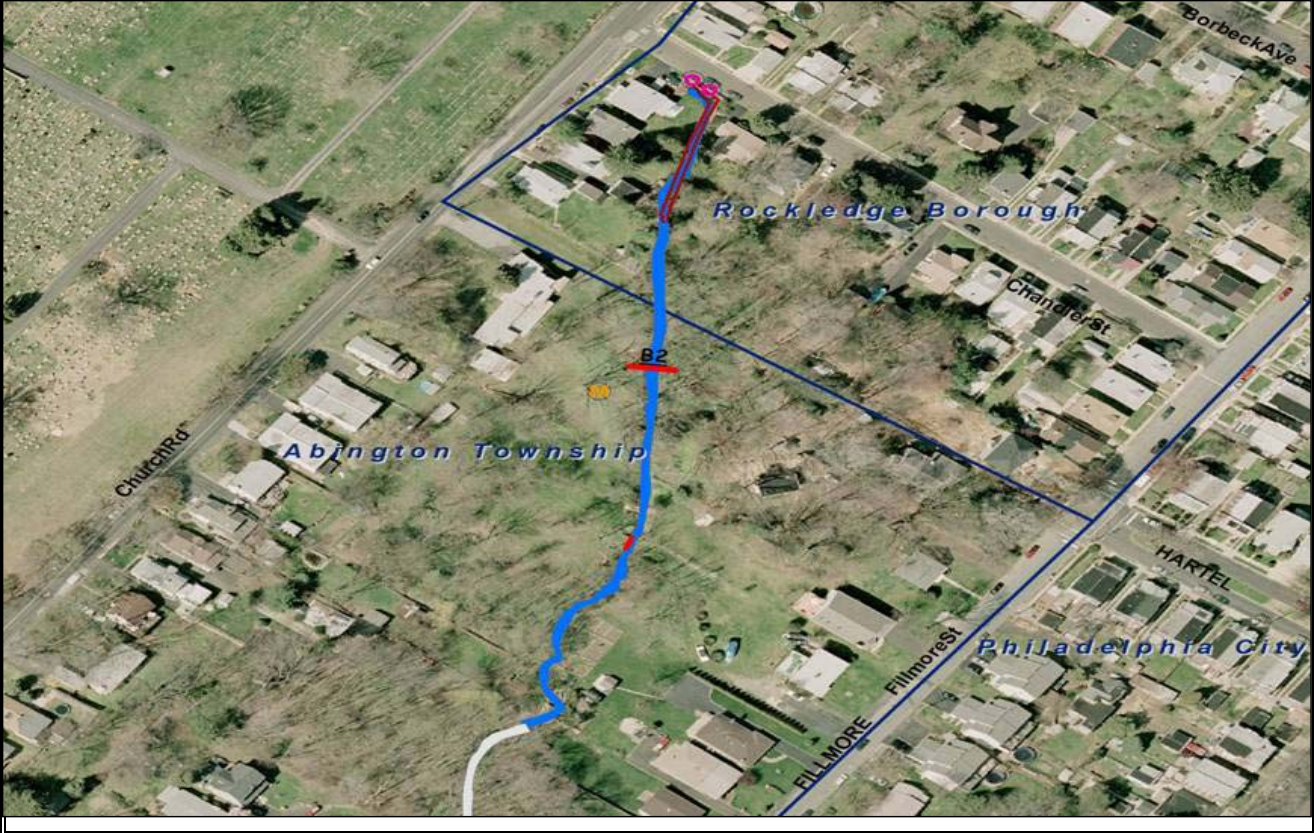
I	<b>B2</b>
N	<u>Burholme Creek</u>
F	<u>350 ft SSE of Church Rd &amp; Chandler St</u>
O	<u>Rockledge Township</u>

P	Riparian Width - DSR	1 / 5	
H	A	Riparian Width - DSL	3 / 5
A	R	Riparian Composition - DSR	4 / 5
B	A	Riparian Composition - DSL	3 / 5
I	M	Canopy Cover - DSR	5 / 5
T	E	Canopy Cover - DSL	5 / 5
A	T	Bed Materials	0 / 5
T	E	Sediment Supply	5 / 5
R		Sinuosity	5 / 5
S		Woody Debris	1 / 5
		Attachment Sites	3 / 5

R		
A	Total Score	70 / 155
N	Stability Score	33 / 100
K	Habitat Score	37 / 55
I	Priority In Shed	39 / 102
N	Priority In Tributary	2 / 5
G

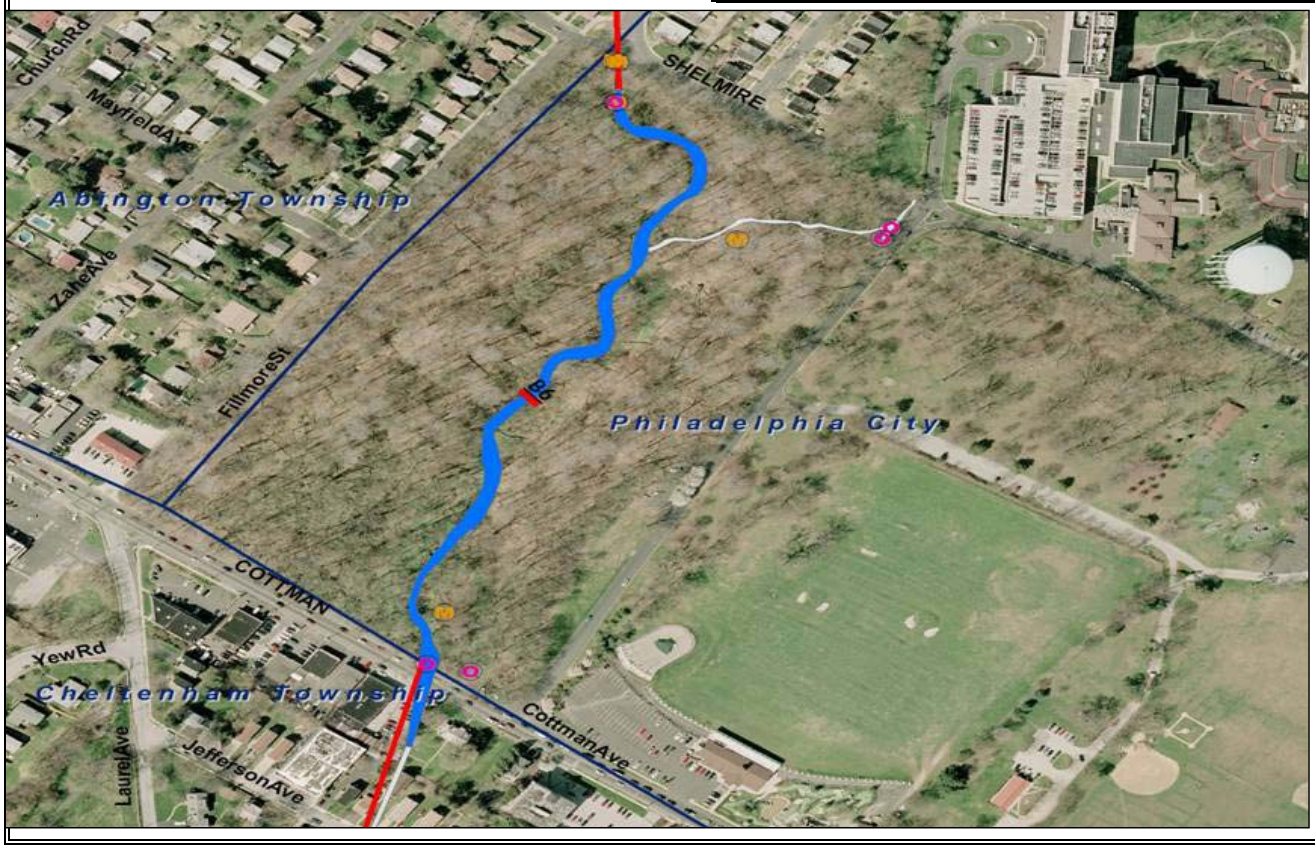
P	Riparian Width - DSR	0 / 5	
H	A	Riparian Width - DSL	0 / 5
A	R	Riparian Composition - DSR	1 / 5
B	A	Riparian Composition - DSL	1 / 5
I	M	Canopy Cover - DSR	1 / 5
T	E	Canopy Cover - DSL	1 / 5
A	T	Bed Materials	0 / 5
T	E	Sediment Supply	3 / 5
R		Sinuosity	5 / 5
S		Woody Debris	3 / 5
		Attachment Sites	3 / 5

R		
A	Total Score	79 / 155
N	Stability Score	38 / 100
K	Habitat Score	41 / 55
I	Priority In Shed	22 / 102
N	Priority In Tributary	1 / 5
G

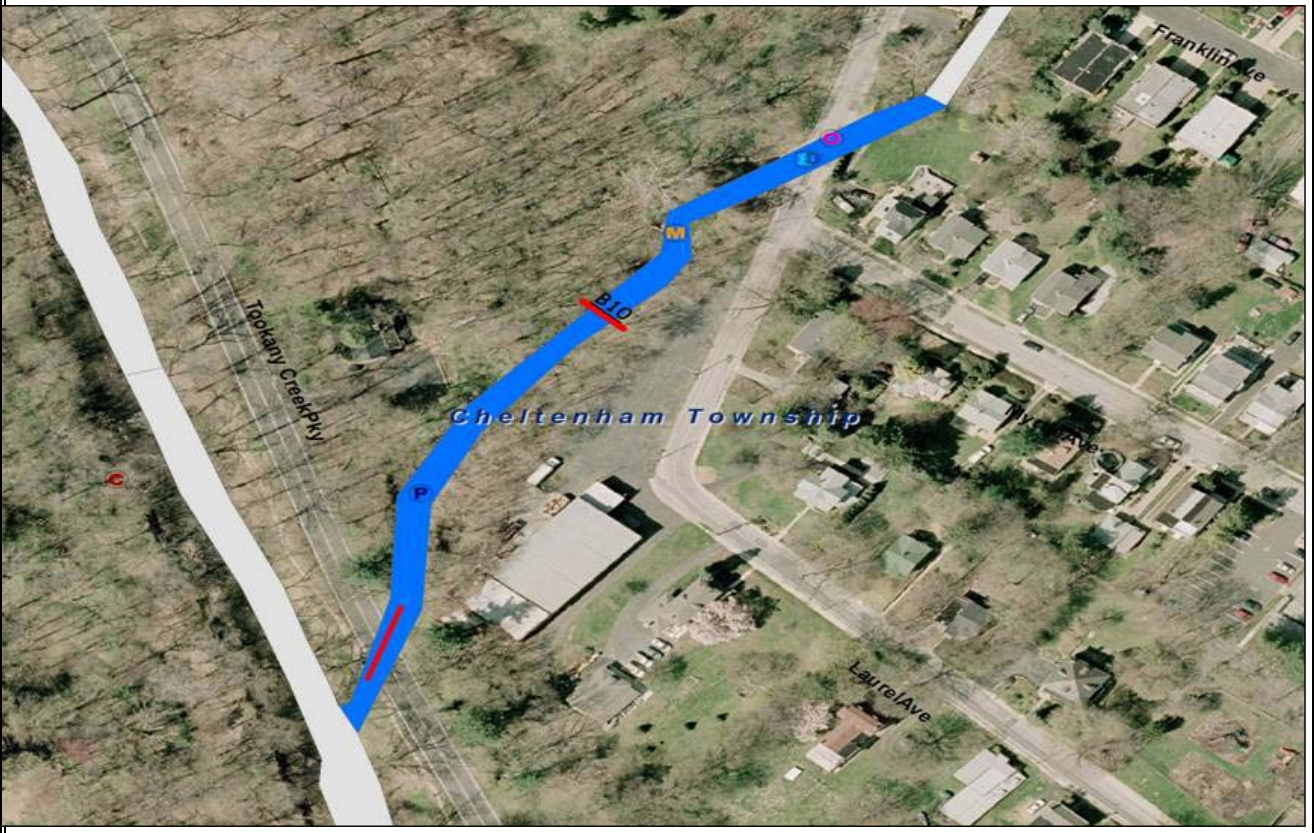
P	Riparian Width - DSR	1 / 5	
H	A	Riparian Width - DSL	3 / 5
A	R	Riparian Composition - DSR	1 / 5
B	A	Riparian Composition - DSL	1 / 5
I	M	Canopy Cover - DSR	3 / 5
T	E	Canopy Cover - DSL	3 / 5
A	T	Bed Materials	2 / 5
T	E	Sediment Supply	5 / 5
R		Sinuosity	5 / 5
S		Woody Debris	1 / 5
		Attachment Sites	0 / 5

R		
A	Total Score	70 / 155
N	Stability Score	32 / 100
K	Habitat Score	38 / 55
I	Priority In Shed	39 / 102
N	Priority In Tributary	1 / 1
G

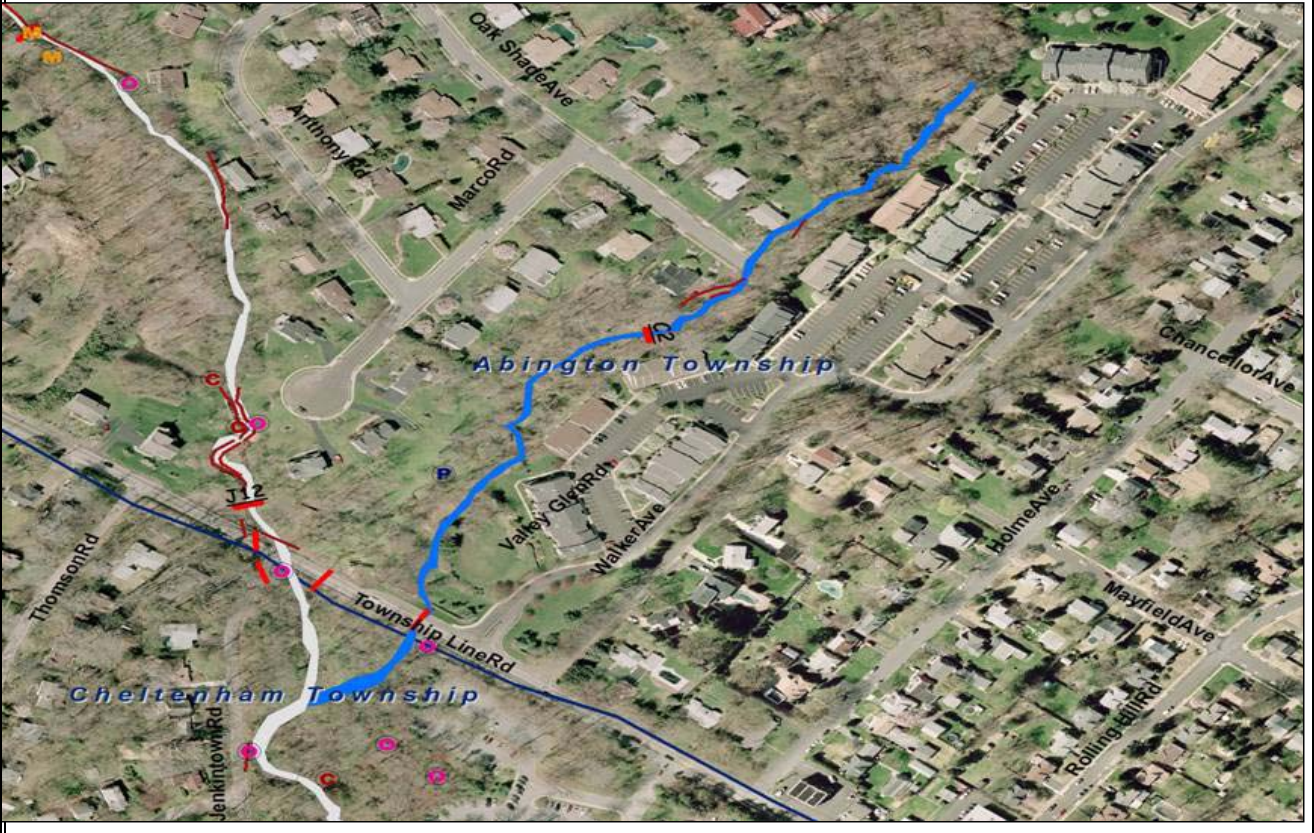
P	Riparian Width - DSR	1 / 5	
H	A	Riparian Width - DSL	3 / 5
A	R	Riparian Composition - DSR	1 / 5
B	A	Riparian Composition - DSL	1 / 5
I	M	Canopy Cover - DSR	5 / 5
T	E	Canopy Cover - DSL	5 / 5
A	T	Bed Materials	4 / 5
T	E	Sediment Supply	5 / 5
R		Sinuosity	5 / 5
S		Woody Debris	5 / 5
		Attachment Sites	3 / 5

R		
A	Total Score	60 / 155
N	Stability Score	32 / 100
K	Habitat Score	28 / 55
I	Priority In Shed	67 / 102
N	Priority In Tributary	1 / 2
G

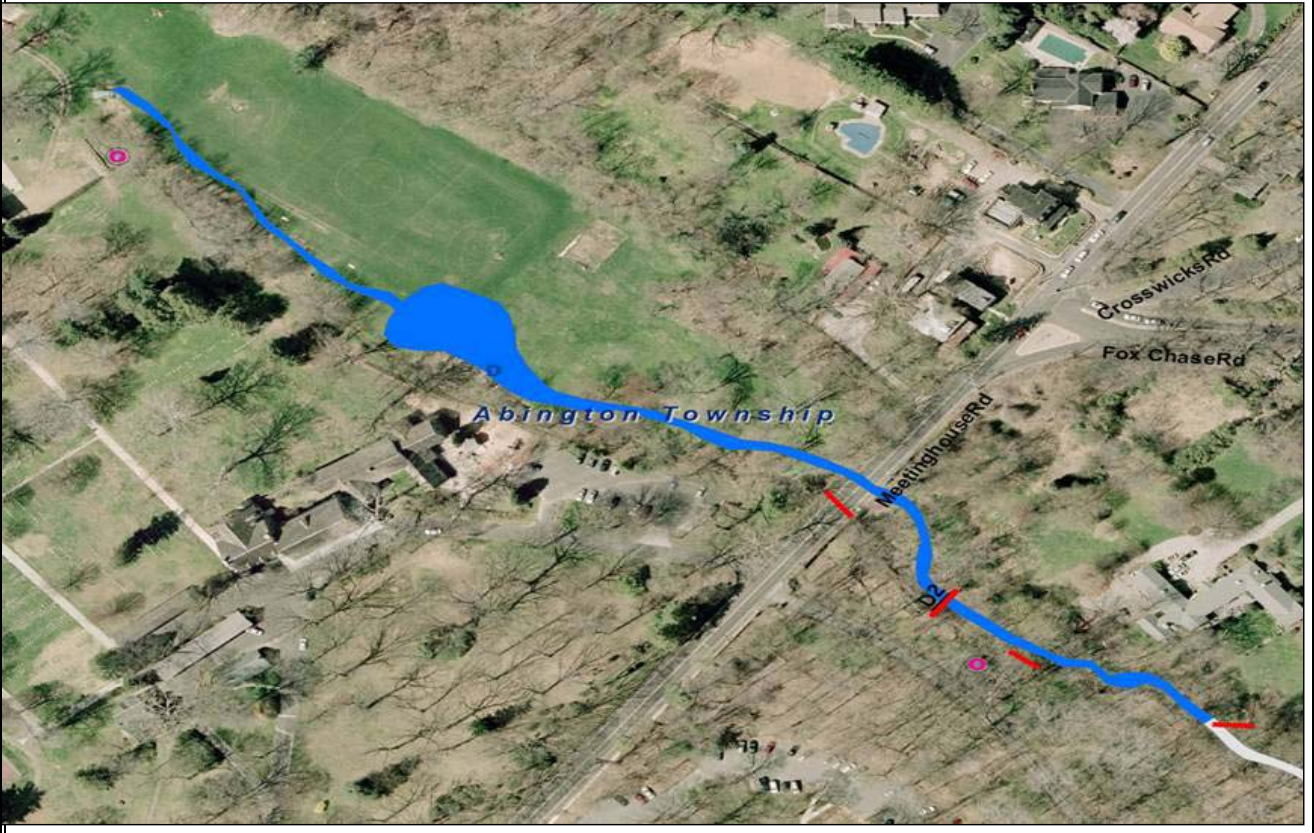
P	Riparian Width - DSR	3 / 5	
H	A	Riparian Width - DSL	3 / 5
A	R	Riparian Composition - DSR	1 / 5
B	A	Riparian Composition - DSL	1 / 5
I	M	Canopy Cover - DSR	1 / 5
T	E	Canopy Cover - DSL	1 / 5
A	T	Bed Materials	2 / 5
T	E	Sediment Supply	5 / 5
R		Sinuosity	5 / 5
S		Woody Debris	3 / 5
		Attachment Sites	3 / 5

R		
A	Total Score	51 / 155
N	Stability Score	35 / 100
K	Habitat Score	16 / 55
I	Priority In Shed	86 / 102
N	Priority In Tributary	2 / 2
G

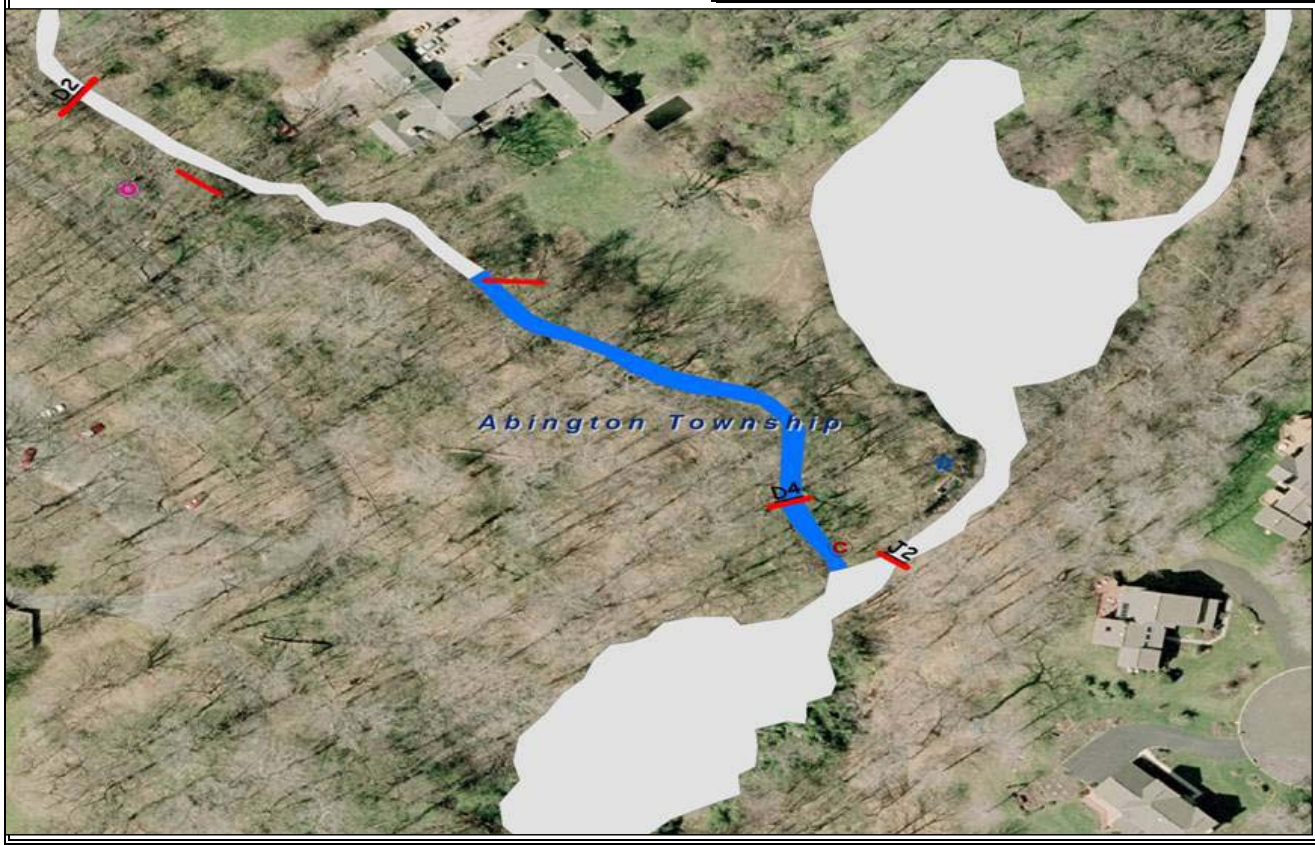
P	Riparian Width - DSR	0 / 5	
H	A	Riparian Width - DSL	1 / 5
A	R	Riparian Composition - DSR	1 / 5
B	A	Riparian Composition - DSL	1 / 5
I	M	Canopy Cover - DSR	0 / 5
T	E	Canopy Cover - DSL	0 / 5
A	T	Bed Materials	2 / 5
T	E	Sediment Supply	3 / 5
R		Sinuosity	5 / 5
S		Woody Debris	3 / 5
		Attachment Sites	0 / 5

R		
A	Total Score	53 / 155
N	Stability Score	31 / 100
K	Habitat Score	22 / 55
I	Priority In Shed	81 / 102
N	Priority In Tributary	1 / 2
G

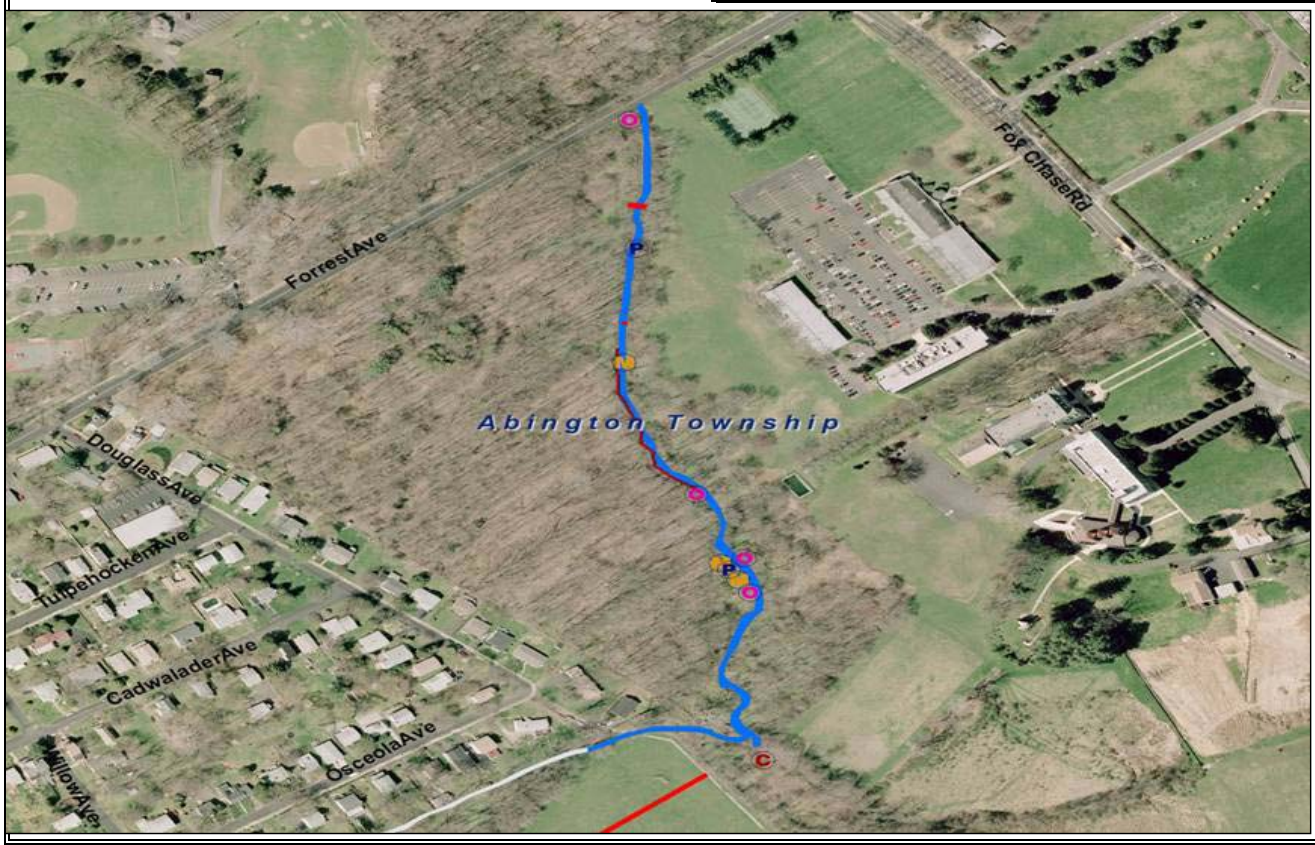
P	Riparian Width - DSR	0 / 5	
H	A	Riparian Width - DSL	5 / 5
A	R	Riparian Composition - DSR	1 / 5
B	A	Riparian Composition - DSL	1 / 5
I	M	Canopy Cover - DSR	0 / 5
T	E	Canopy Cover - DSL	0 / 5
A	T	Bed Materials	2 / 5
T	E	Sediment Supply	5 / 5
R		Sinuosity	5 / 5
S		Woody Debris	3 / 5
		Attachment Sites	0 / 5

R		
A	Total Score	51 / 155
N	Stability Score	36 / 100
K	Habitat Score	15 / 55
I	Priority In Shed	86 / 102
N	Priority In Tributary	2 / 2
G

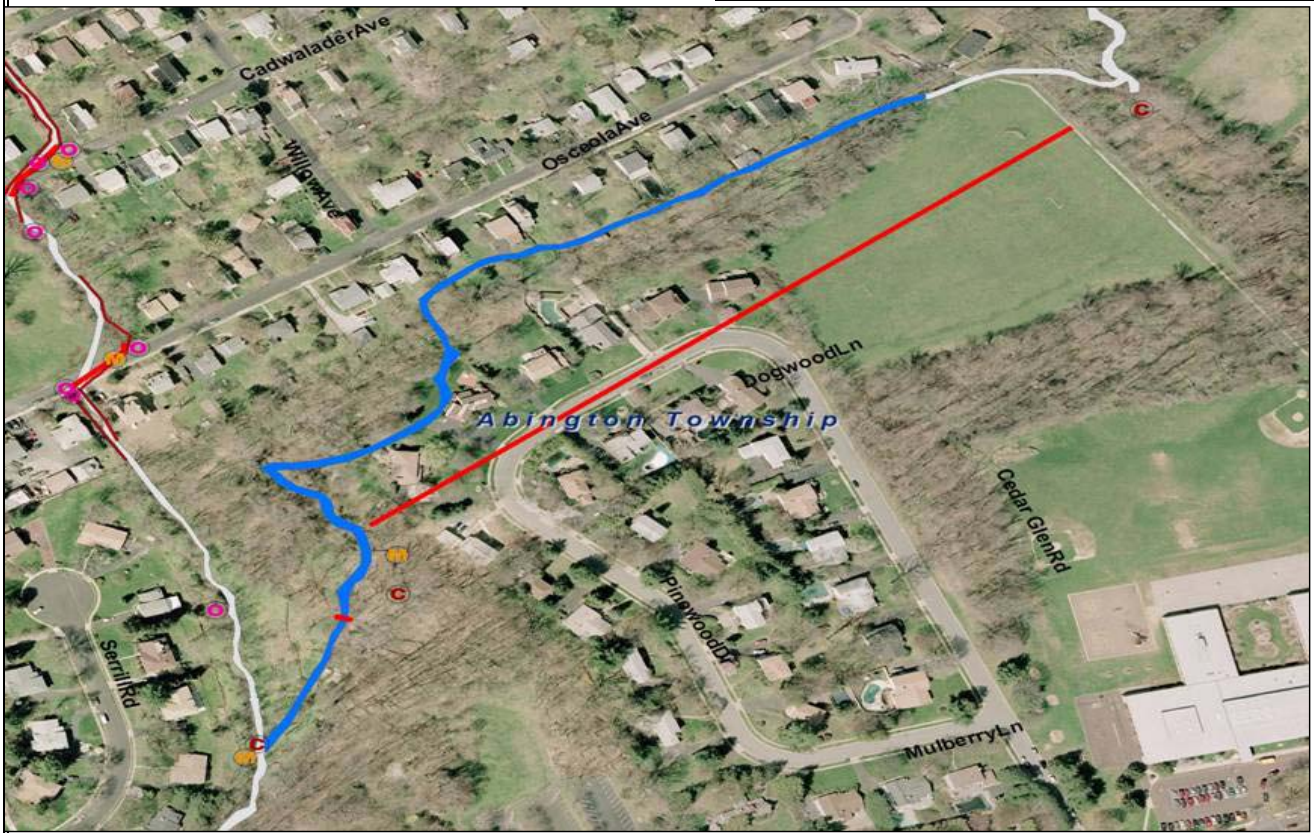
P	Riparian Width - DSR	0 / 5	
H	A	Riparian Width - DSL	0 / 5
A	R	Riparian Composition - DSR	1 / 5
B	A	Riparian Composition - DSL	1 / 5
I	M	Canopy Cover - DSR	0 / 5
T	E	Canopy Cover - DSL	0 / 5
A	T	Bed Materials	2 / 5
T	E	Sediment Supply	3 / 5
R		Sinuosity	5 / 5
S		Woody Debris	3 / 5
		Attachment Sites	0 / 5

R		
A	Total Score	68 / 155
N	Stability Score	27 / 100
K	Habitat Score	41 / 55
I	Priority In Shed	47 / 102
N	Priority In Tributary	4 / 5
G

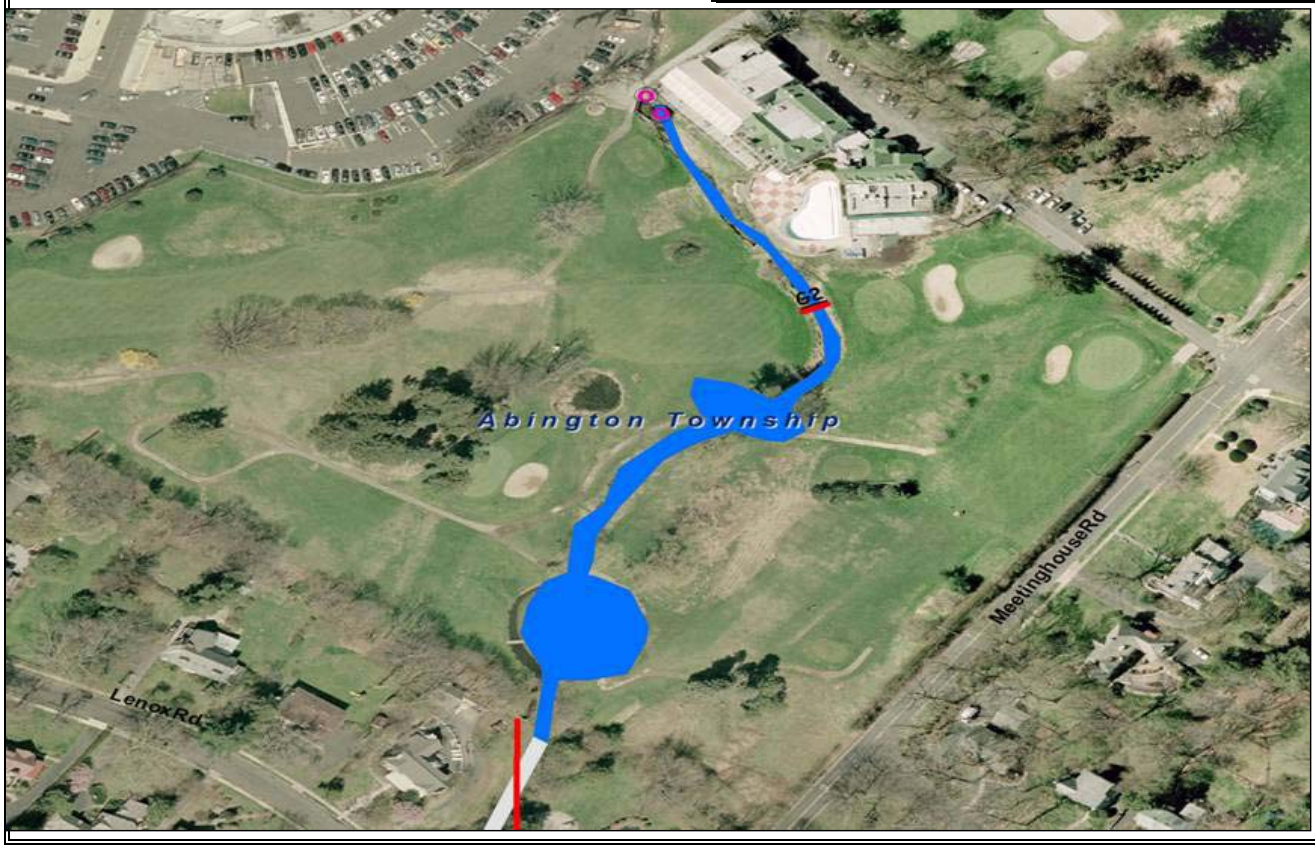
P	Riparian Width - DSR	5 / 5	
H	A	Riparian Width - DSL	5 / 5
A	R	Riparian Composition - DSR	4 / 5
B	A	Riparian Composition - DSL	4 / 5
I	M	Canopy Cover - DSR	5 / 5
T	E	Canopy Cover - DSL	5 / 5
A	T	Bed Materials	2 / 5
T	E	Sediment Supply	1 / 5
R		Sinuosity	5 / 5
S		Woody Debris	5 / 5
		Attachment Sites	0 / 5

R		
A	Total Score	97 / 155
N	Stability Score	60 / 100
K	Habitat Score	37 / 55
I	Priority In Shed	1 / 102
N	Priority In Tributary	1 / 5
G

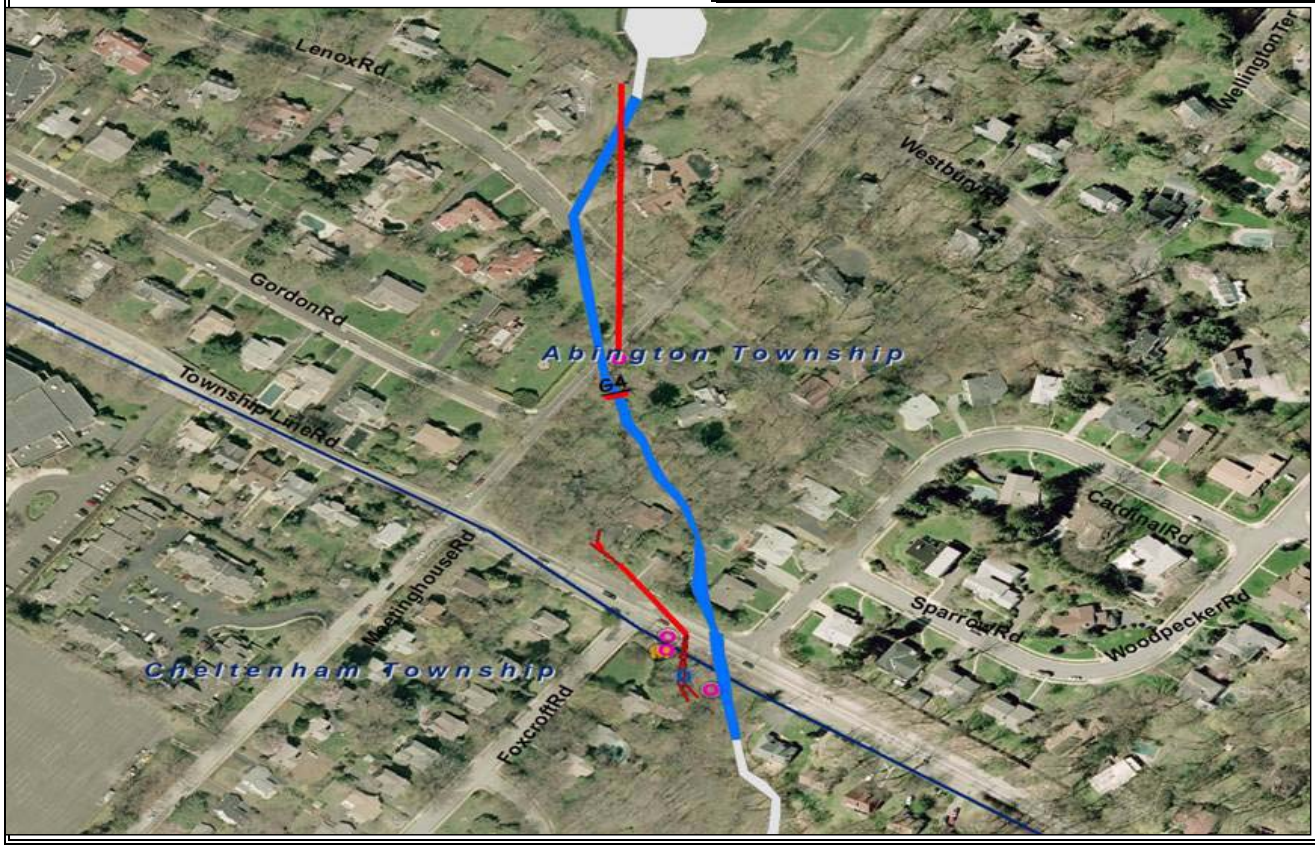
P	Riparian Width - DSR	1 / 5	
H	A	Riparian Width - DSL	5 / 5
A	R	Riparian Composition - DSR	3 / 5
B	A	Riparian Composition - DSL	3 / 5
I	M	Canopy Cover - DSR	4 / 5
T	E	Canopy Cover - DSL	5 / 5
A	T	Bed Materials	0 / 5
T	E	Sediment Supply	5 / 5
R		Sinuosity	5 / 5
S		Woody Debris	3 / 5
		Attachment Sites	3 / 5

R		
A	Total Score	56 / 155
N	Stability Score	28 / 100
K	Habitat Score	28 / 55
I	Priority In Shed	74 / 102
N	Priority In Tributary	5 / 5
G

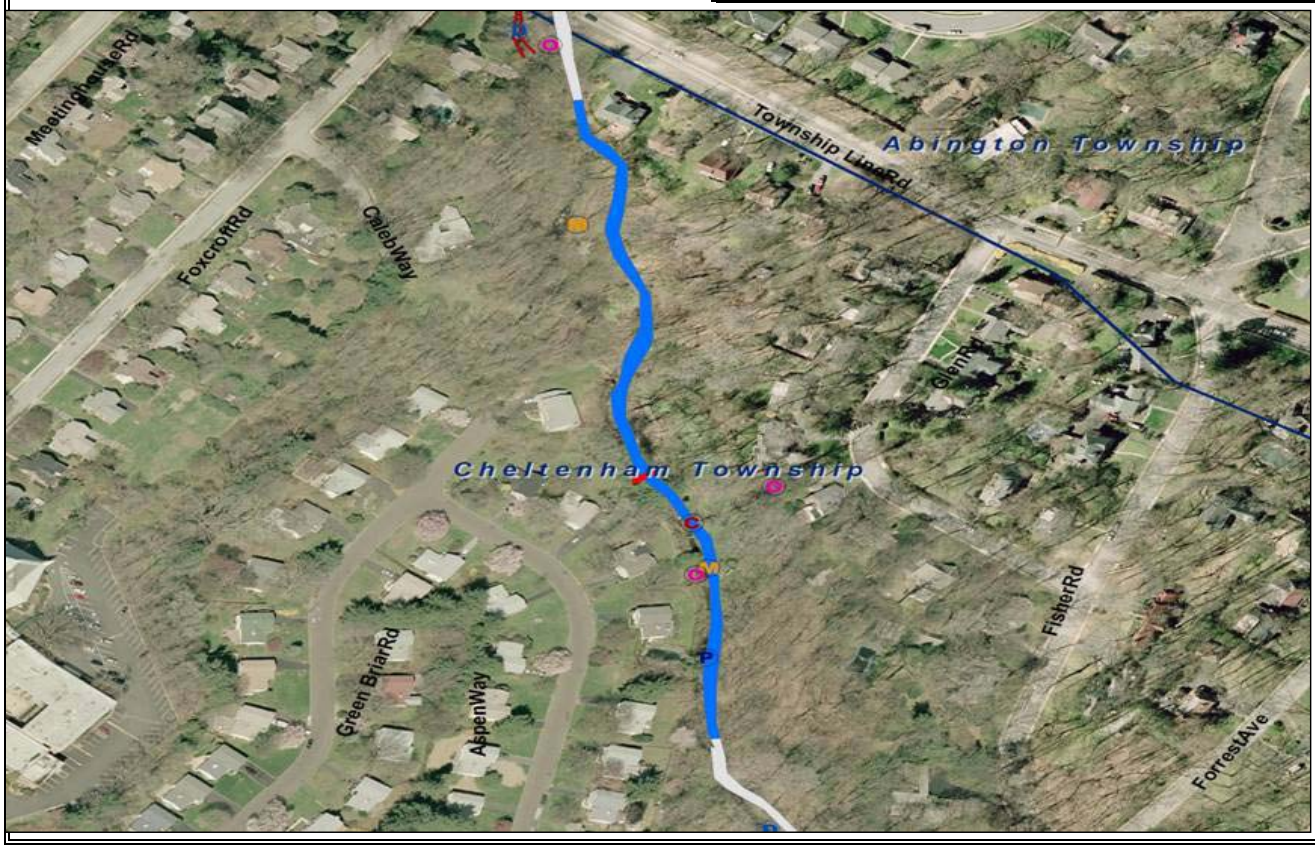
P	Riparian Width - DSR	3 / 5	
H	A	Riparian Width - DSL	1 / 5
A	R	Riparian Composition - DSR	3 / 5
B	A	Riparian Composition - DSL	1 / 5
I	M	Canopy Cover - DSR	1 / 5
T	E	Canopy Cover - DSL	3 / 5
A	T	Bed Materials	0 / 5
T	E	Sediment Supply	3 / 5
R		Sinuosity	5 / 5
S		Woody Debris	5 / 5
		Attachment Sites	3 / 5

R		
A	Total Score	77 / 155
N	Stability Score	44 / 100
K	Habitat Score	33 / 55
I	Priority In Shed	24 / 102
N	Priority In Tributary	3 / 5
G

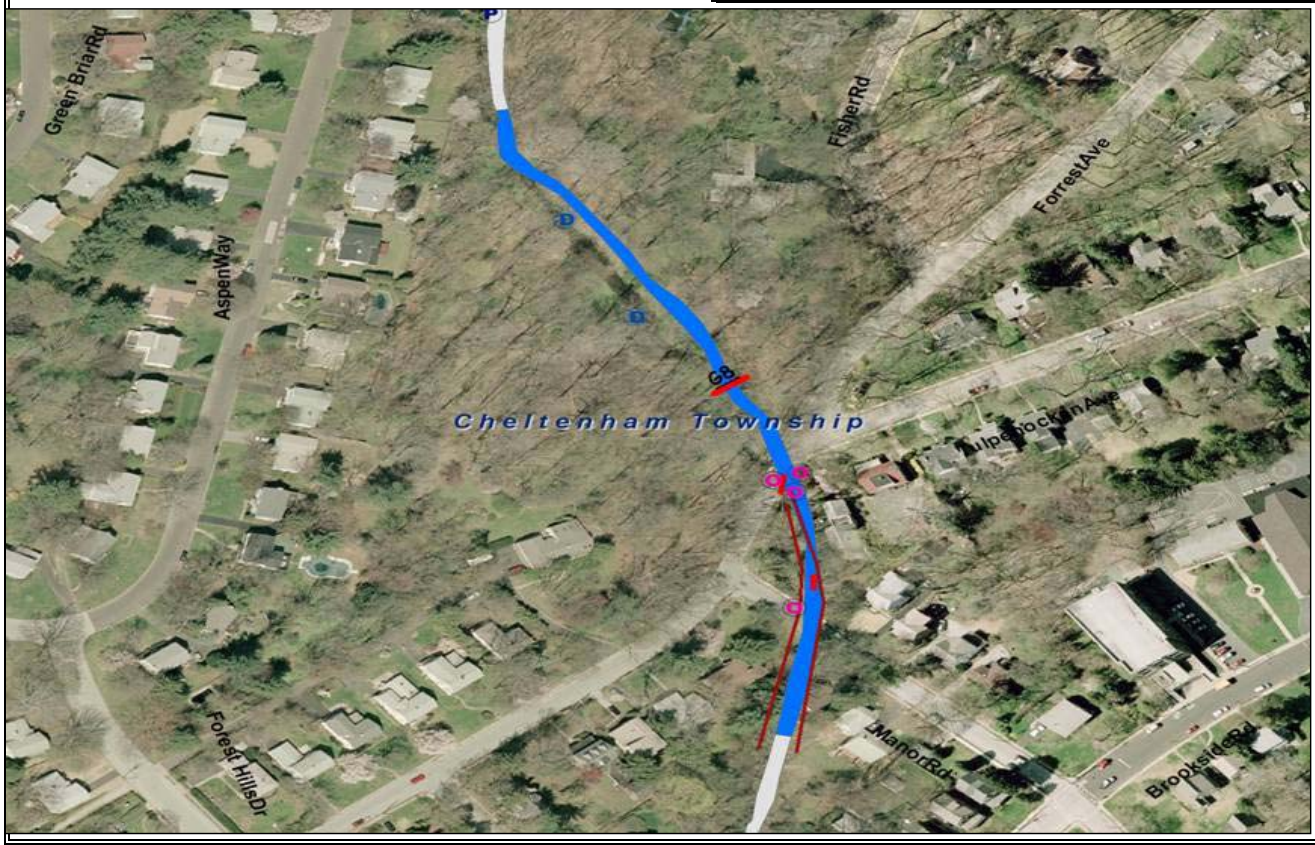
P	Riparian Width - DSR	0 / 5	
H	A	Riparian Width - DSL	0 / 5
A	R	Riparian Composition - DSR	3 / 5
B	A	Riparian Composition - DSL	3 / 5
I	M	Canopy Cover - DSR	4 / 5
T	E	Canopy Cover - DSL	3 / 5
A	T	Bed Materials	2 / 5
T	E	Sediment Supply	5 / 5
R		Sinuosity	5 / 5
S		Woody Debris	5 / 5
		Attachment Sites	3 / 5

R		
A	Total Score	91 / 155
N	Stability Score	53 / 100
K	Habitat Score	38 / 55
I	Priority In Shed	6 / 102
N	Priority In Tributary	2 / 5
G
