PHILADELPHIA'S WET WEATHER MANAGEMENT PROGRAMS

COMBINED SEWER MANAGEMENT PROGRAM ANNUAL REPORT

STORMWATER MANAGEMENT PROGRAM ANNUAL REPORT

Reporting Period July 1st 2009 to June 30th 2010

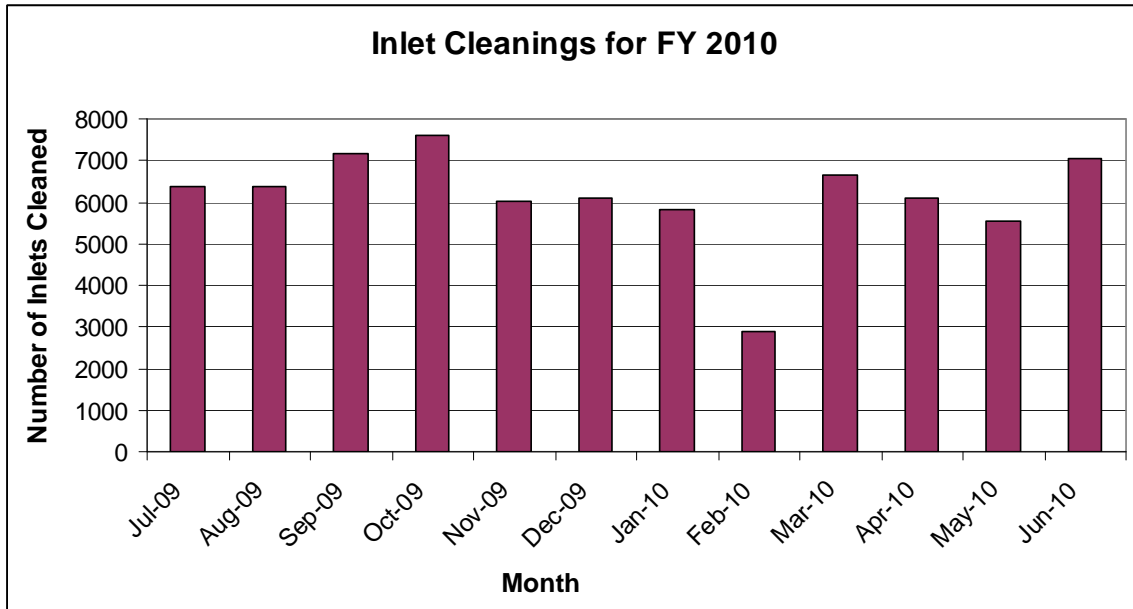
Figure II.F- 1 Monthly Inlet Cleaning Statistics

Total Inlets Inspected	88,604
Total Inlets Cleaned	73,764
Total Grates Cleared	5,827
Total Covers Replaced	1,662
Tons of Debris Removed	10,010
Avg. Lbs./ Inlet	271.4

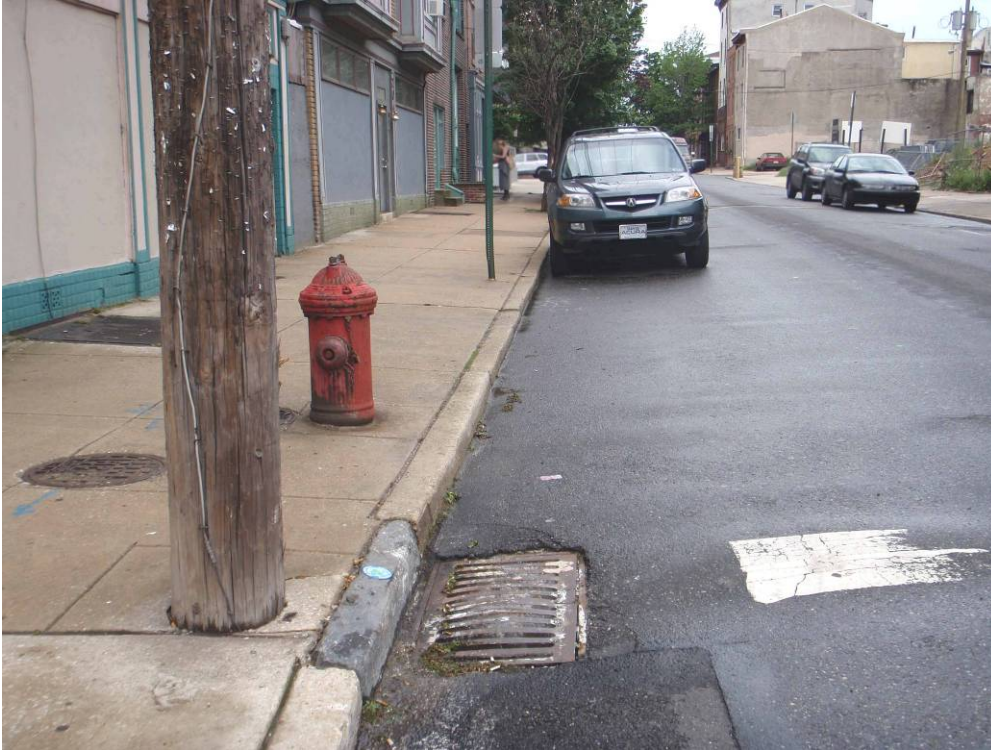
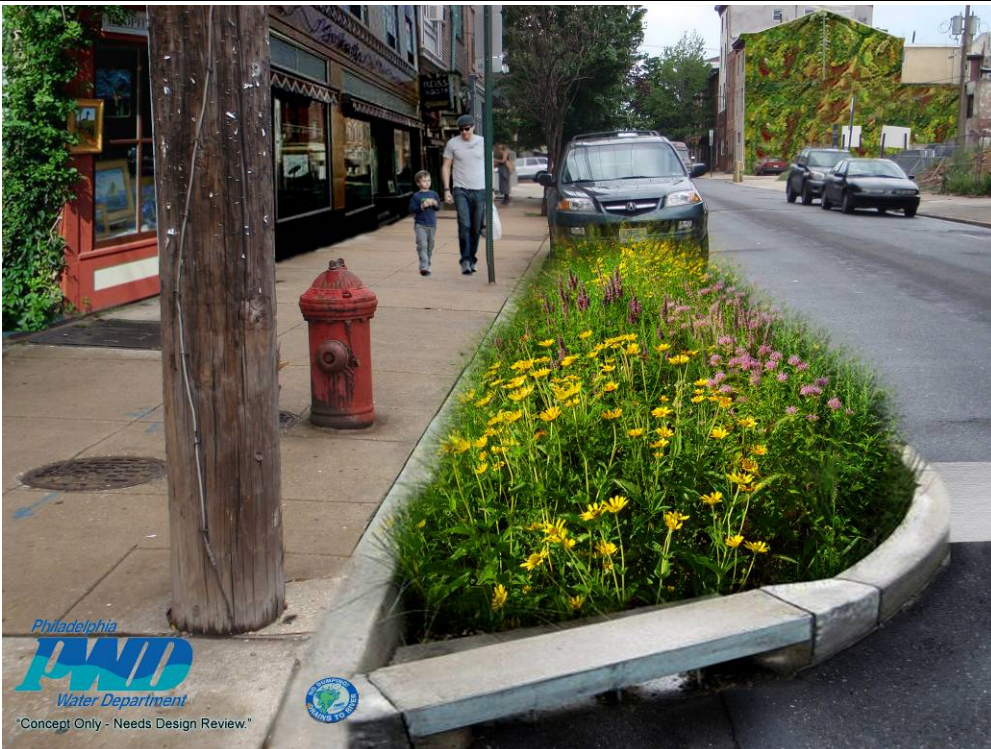
Figure II.G.1-8 Example of Model Neighborhoods Photo Simulation Set (3rd and Brown Streets, Northern Liberties)

PWD has developed a Model Neighborhoods overview brochure and informational handouts on trees and laterals, along with other outreach materials (**APPENDIX C: TABLE 6**). Photo simulations of green stormwater infrastructure elements have been created for each of the first three neighborhoods. The photo simulations depict a street before and after the implementation of green stormwater infrastructure projects, providing strong visuals to help residents better visualize a Green Street in their neighborhood. PWD also produced the Green Streets Community Orientation Packet. The document serves as a guide for Model Neighborhoods civic partners and included information to best prepare civic leaders reaching out to residents for Model Neighborhoods support. **FIGURE II.G.1-8** illustrates an example Green Street photo simulation set.

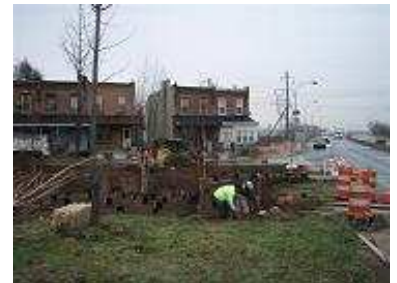
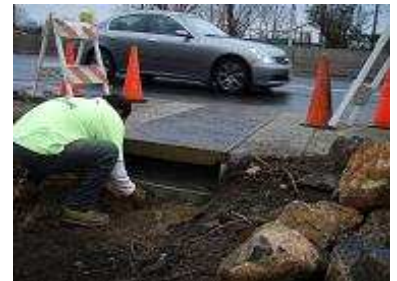
Traffic triangles are often under-utilized parcels within the urban landscape. The vegetated, but unused traffic triangle at the intersection of 47th and Grays Ferry in West Philadelphia was retrofitted with a rain garden to provide a gateway feature for the community and nearby university while managing stormwater from the adjacent streets.

Stormwater from Paschall Street and Grays Ferry Avenue is diverted into the traffic triangle through trench drains, where it can pond and infiltrate into the soil. The gardens are planted with trees, shrubs, and herbaceous plants that will tolerate the fluctuating conditions and provide year round interest as a gateway landscape.

- Reduces the flow of stormwater into the combined sewer system through on-site infiltration, thus reducing overflows to the river.
- Reduces non-point source pollution from stormwater runoff through vegetation and bioretention.
- Reduces nuisance flooding on Paschall Street
- Provides a gateway feature for the West Shore Neighborhood and University of the Sciences.

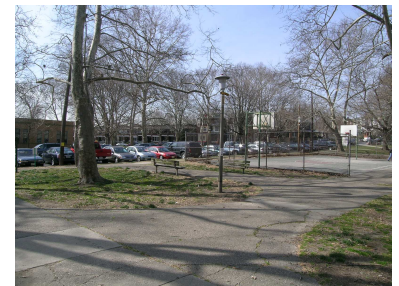
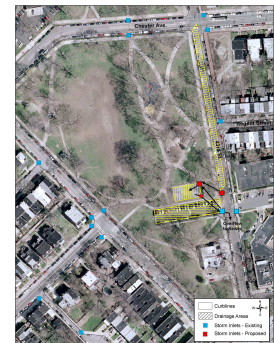
Clark Park Infiltration Bed...

A subsurface infiltration bed beneath a new basketball court at Clark Park will manage stormwater runoff from the basketball court, as well as from an adjacent street and parking lot. The system has been designed to capture about 1.5" of rainfall from the contributing drainage area, but with well-drained soil, it is anticipated that actual stormwater capture will be much greater.

- Infiltration of stormwater runoff will reduce CSO volume in one of Philadelphia's largest combined sewer areas.
- Opportunity to monitor long-term performance of a stormwater management strategy most often selected by private developers.
- Example of integrating management of runoff from the street into a planned capital improvement project on a City facility.

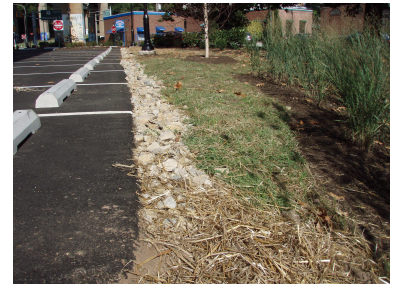
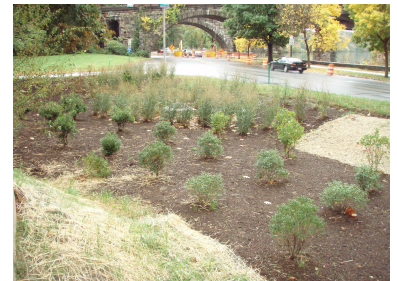
Parking Lot in East Falls...

The City of Philadelphia constructed a 50-space parking lot to serve the East Falls commercial district and Kelly Drive recreational trail users. The lot was designed with a rain garden that manages the majority of surface runoff from the parking lot. The system serves as a demonstration of an encouraged stormwater management practice and provides an opportunity for stormwater education and awareness in a riverside community. The bioinfiltration garden is located in a high traffic location and also serves as a gateway to the East Falls Neighborhood.

- Provides highly visible demonstration of bioretention for parking lot runoff management.
- Helps manage nonpoint source pollution in priority sourcewater area.
- Provides an attractive gateway to the East Falls neighborhood.

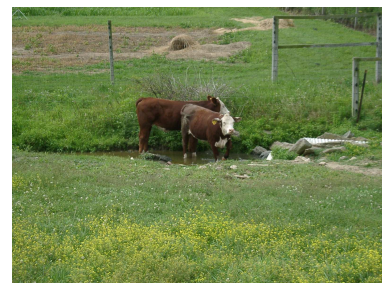
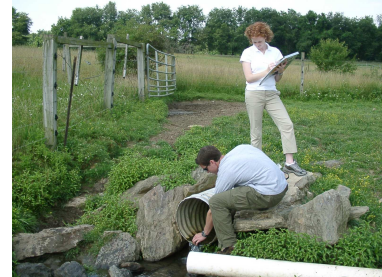
Riparian Restoration at Fox Chase Farms...

Prior to project implementation, cows on Fox Chase Farm had free access to a small tributary which runs through the farm. The surrounding pasture was mowed right to the tributary's edge. This combination resulted in extremely high concentrations of fecal coliform and E. Coli in the tributary and the Pennypack Creek downstream of the farm. This project aims to reduce the impact of farm runoff through the construction of a cattle crossing over the tributary and the installation of a 1.85 acre riparian buffer. In 2002, approximately 400 trees and 700 shrubs were planted on the farm, creating a 15 yard buffer on either side of the tributary. In 2006, water lines were installed to further limit the impact of cows on the stream.

- Reduced concentration of nutrients and harmful pathogens from the farm entering the Pennypack Creek
- Addition of native plant species to the site
- Enhanced biological habitat in the tributary and the Pennypack
- Lower water temperatures in the Pennypack through improved shading along the tributary

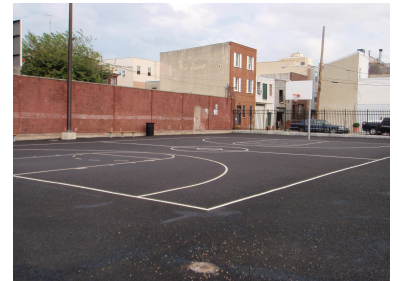
Herron Playground...

Herron Playground, a city-owned facility managed by the Philadelphia Department of Recreation (PDR), is located in a neighborhood served by a combined sewer system. The Philadelphia Water Department collaborated with PDR and the City's Capital Program Office to design and construct an infiltration system as part of an overall reconstruction of the Playground to manage both on-site and off-site runoff from the adjacent streets. The existing basketball court was reconstructed and resurfaced with porous asphalt. A subsurface infiltration system was installed beneath the basketball court area and to manage stormwater runoff from portions of Earp St. and American St. The total area managed is approximately 13,000 SF.

- Reduces runoff into the combined sewer
- Improved park amenities for neighborhood
- Pilot project for collaboration between City Departments

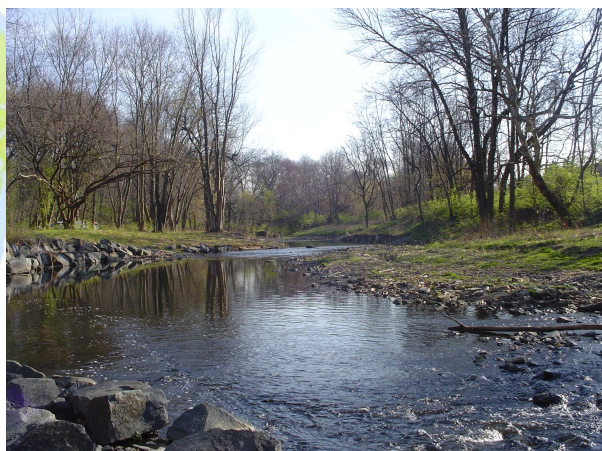
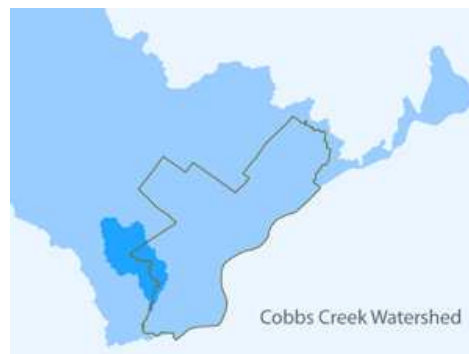
Downstream view of Cobbs Creek post construction

- Implemented restoration techniques targeted at removing stream impairments and restoring ecological resources.
- Served as a pilot project for habitat restoration, stream bank stabilization, natural channel design, water quality improvement, and infrastructure protection.
- Mitigated the impacts of urban runoff and non-point source pollution.
- Restored native vegetation to the riparian corridor to enhance bank stability.
- Reduced the likelihood of further stream erosion and exposure of sanitary sewage infrastructure.
- Completed a fluvial geomorphologic assessment of the Cobbs Creek to serve as a tool for integrated bank stabilization/habitat restoration for this and future projects.

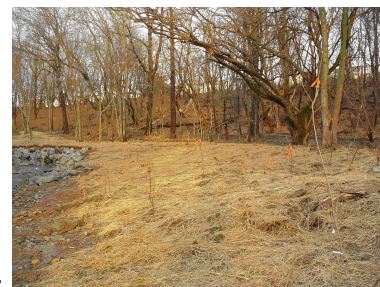
Tree and shrub planting at restoration site

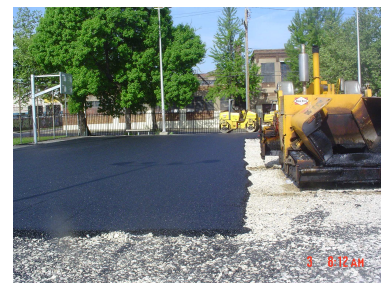
The porous basketball court at Mill Creek

The Mill Creek Playground is heavily used by the community for sports, activities, and meetings. The site includes two basketball courts, play equipment, a recreation center, a baseball field and a swimming pool, which were all built above the streambed of the buried Mill Creek, which is now one of the largest combined sewers in Philadelphia. The basketball courts at the playground were cracked and deteriorating, with low spots that became puddles after storms. To improve the quality of the courts and reduce the volume of stormwater that flows into the combined sewer, the basketball courts were retrofitted with porous asphalt over an infiltration bed.

- 90 percent of the stormwater that falls on the courts infiltrates into the soil.
- Opportunity for long-term monitoring and replication at other basketball courts in the City.
- Courts dry immediately after rainstorm and create a better playing experience
- Neighbors have reported that the courts are quieter and the children like playing on them better.
- Rain that falls on the basketball courts passes through the porous surface and is stored in a subsurface stone bed until it can soak into the ground.

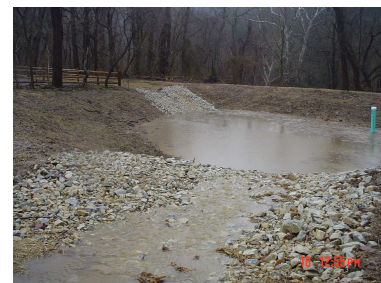
The Philadelphia Water Department is partnering with the Fairmount Park Commission (FPC) to address stormwater and agricultural runoff at Monastery Stables, an FPC property along the Wissahickon Creek. Lack of proper stormwater management controls, a sloping topography towards the bordering creek, and the intensity of horse activity on the site make Monastery Stables a potentially significant source of contamination to the Wissahickon Watershed. This project introduced stormwater management controls to increase stormwater infiltration, and direct and treat stormwater runoff, reducing sediment, nutrient, and harmful pathogen loadings on the Wissahickon Creek.

- Reduces concentration of nutrients and harmful pathogens from the farm from entering the Wissahickon Creek.
- Enhances biological habitat in the Wissahickon Creek.
- Contaminated stormwater runoff is managed through subsurface storage tanks and vegetated swales.

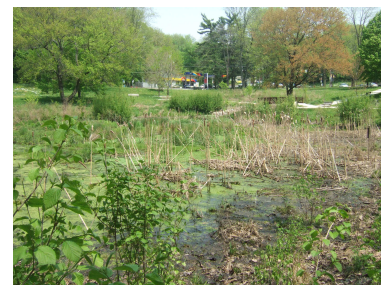
A one-acre stormwater wetland was constructed in the fall of 2005 on a parcel of Fairmount Park known as Saylor Grove. The wetland is designed to treat a portion of the 70 million gallons of urban stormwater generated in the storm sewershed per year before it is discharged into the Monoshone Creek. The Monoshone Creek is a tributary of the Wissahickon Creek- a source of drinking water for the City of Philadelphia. The function of the wetland is to treat stormwater runoff in an effort to improve source water quality and to minimize the impacts of storm-related flows on the aquatic and structural integrity of the riparian ecosystem. This project is a highly visible Urban Stormwater BMP Retrofit in the historic Wissahickon Watershed.

- Filter a large portion of the 70 million gallons of stormwater per year which runs off from the sewershed
- Remove total suspended solids from the Monoshone Creek
- Increase the total area of wetland habitat in the watershed
- Improve the aesthetics of the Saylor Grove area
- Improve the flow variability of storm related flows on the Monoshone Creek
- Increase the biodiversity of the park area
- Create two outdoor educational signs about the importance of wetlands and their functions
- Implement actions items of the Wissahickon River Conservation Plan
- Help improve stormwater flows into an impaired water body

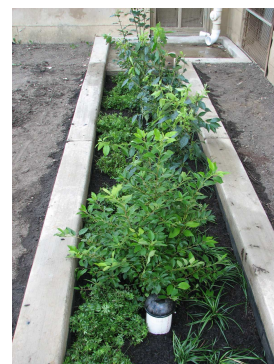
The Office of Watersheds is working with the Philadelphia Department of Recreation (PDR) and the Pennsylvania Horticultural Society (PHS) to incorporate stormwater management into Waterview Recreation Center's master plan in ways that can demonstrate effective stormwater management strategies while enhancing recreation programs and improving site aesthetics. The following components are incorporated into the plan:

1. A subsurface infiltration tree trench and new porous concrete sidewalk to provide management of street and sidewalk runoff and provide more tree canopy.
2. Flow through planter boxes adjacent to the main building entrance to manage roof runoff and beautify the entrance.

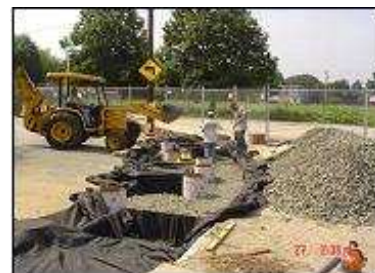
Runoff from the street and sidewalk is diverted into a stormwater tree trench at the intersection of Ogden and Ramsey Streets in West Philadelphia through modified inlet structures. Trees are planted in pockets of soil within a continuous stone trench that stores stormwater until it can infiltrate. Porous pavers replaced the brick sidewalk over the trench and allow runoff from the sidewalk to infiltrate into trench. The continuous trench provides also provides the tree roots with better access to air and water.

- Reduces stormwater volume, thereby reducing combined sewer overflows from the Mill Creek Sewer.
- Provides healthier conditions for urban street trees
- Adds tree canopy in a dense urban area, thereby reducing urban heat island effect and improving air quality.

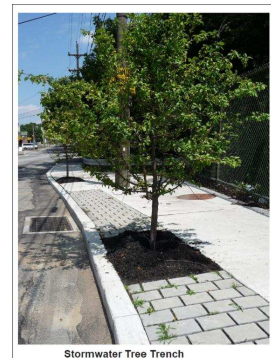
Stormwater Tree Trench

Streets and sidewalks are by far the largest single category of impervious cover, accounting for roughly 38% of the impervious cover within the combined sewer system. To mitigate the impact of this impervious area, PWD has developed green street designs that use a combination of vegetated and engineered strategies to manage runoff at its source. Using a variety of green stormwater infrastructure tools, including stormwater tree trenches, stormwater planters, and stormwater bumpouts, a green street captures the first inch of runoff from streets and sidewalks, infiltrates it into the soil to recharge groundwater, and reduces the amount of stormwater runoff that would otherwise make its way into Philadelphia's combined sewer system.

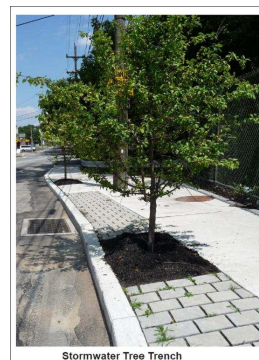
Stormwater Tree Trench

Streets and sidewalks are by far the largest single category of impervious cover, accounting for roughly 38% of the impervious cover within the combined sewer system. To mitigate the impact of this impervious area, PWD has developed green street designs that use a combination of vegetated and engineered strategies to manage runoff at its source. Using a variety of green stormwater infrastructure tools, including stormwater tree trenches, stormwater planters, and stormwater bumpouts, a green street captures the first inch of runoff from streets and sidewalks, infiltrates it into the soil to recharge groundwater, and reduces the amount of stormwater runoff that would otherwise make its way into Philadelphia's combined sewer system.

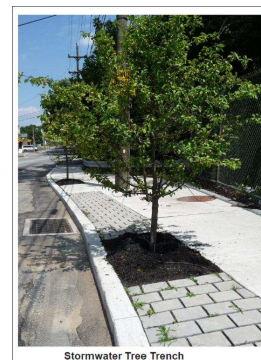
Stormwater Tree Trench

Streets and sidewalks are by far the largest single category of impervious cover, accounting for roughly 38% of the impervious cover within the combined sewer system. To mitigate the impact of this impervious area, PWD has developed green street designs that use a combination of vegetated and engineered strategies to manage runoff at its source. Using a variety of green stormwater infrastructure tools, including stormwater tree trenches, stormwater planters, and stormwater bumpouts, a green street captures the first inch of runoff from streets and sidewalks, infiltrates it into the soil to recharge groundwater, and reduces the amount of stormwater runoff that would otherwise make its way into Philadelphia's combined sewer system.

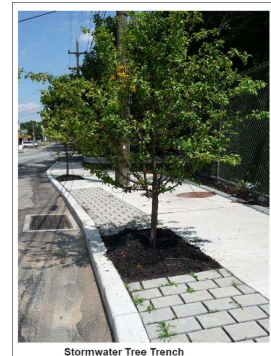
Stormwater Tree Trench

Streets and sidewalks are by far the largest single category of impervious cover, accounting for roughly 38% of the impervious cover within the combined sewer system. To mitigate the impact of this impervious area, PWD has developed green street designs that use a combination of vegetated and engineered strategies to manage runoff at its source. Using a variety of green stormwater infrastructure tools, including stormwater tree trenches, stormwater planters, and stormwater bumpouts, a green street captures the first inch of runoff from streets and sidewalks, infiltrates it into the soil to recharge groundwater, and reduces the amount of stormwater runoff that would otherwise make its way into Philadelphia's combined sewer system.

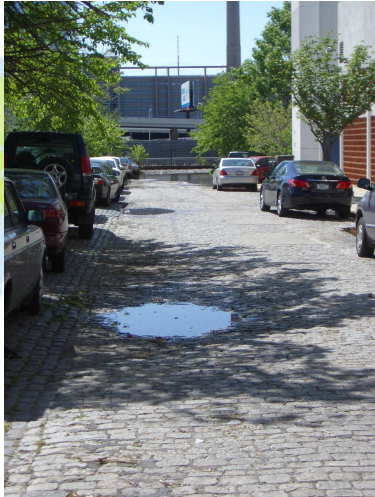
View of Cherry Street looking west

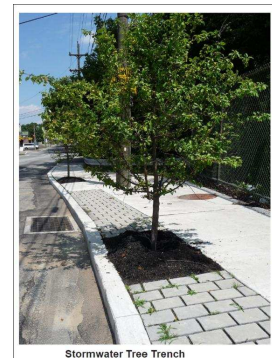
Stormwater Tree Trench

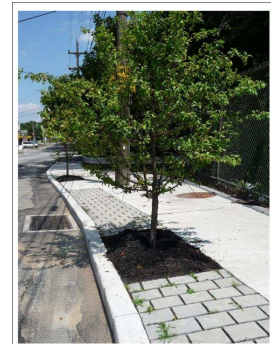
Stormwater Tree Trench

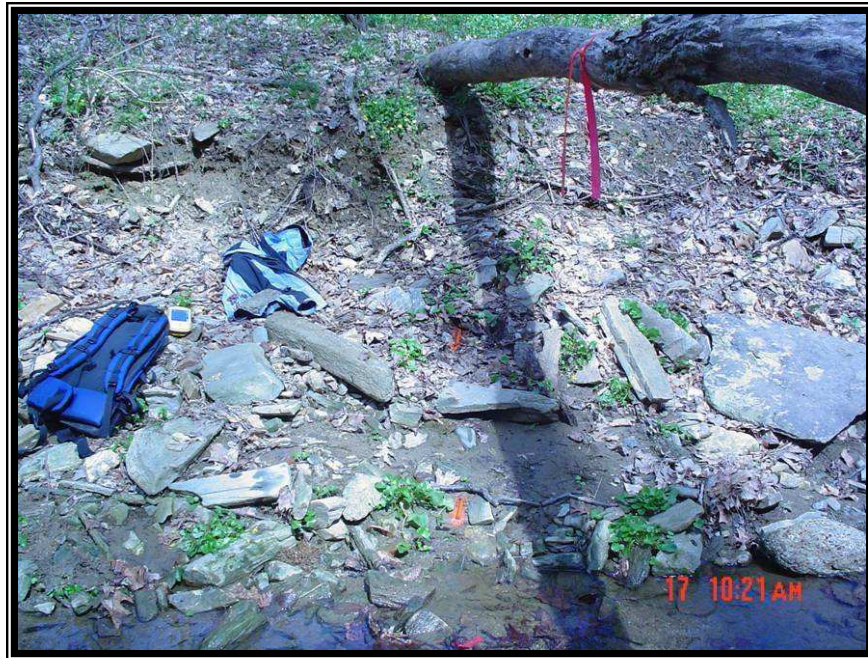
BM1120

BEHI = Moderate Erosion Rate = 0.063 ft/yr

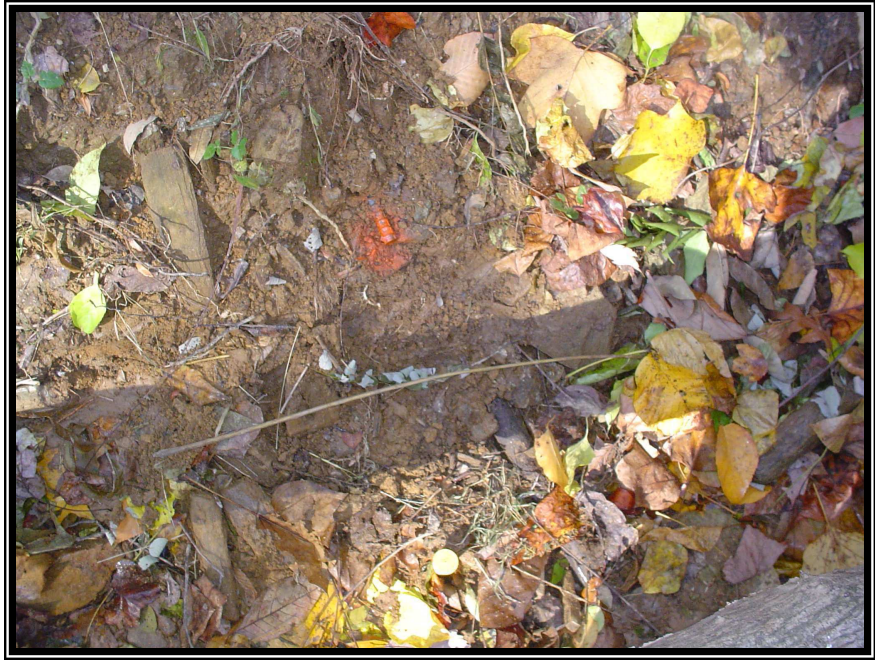
BM13

BEHI = High Erosion Rate = -0.21 ft/yr

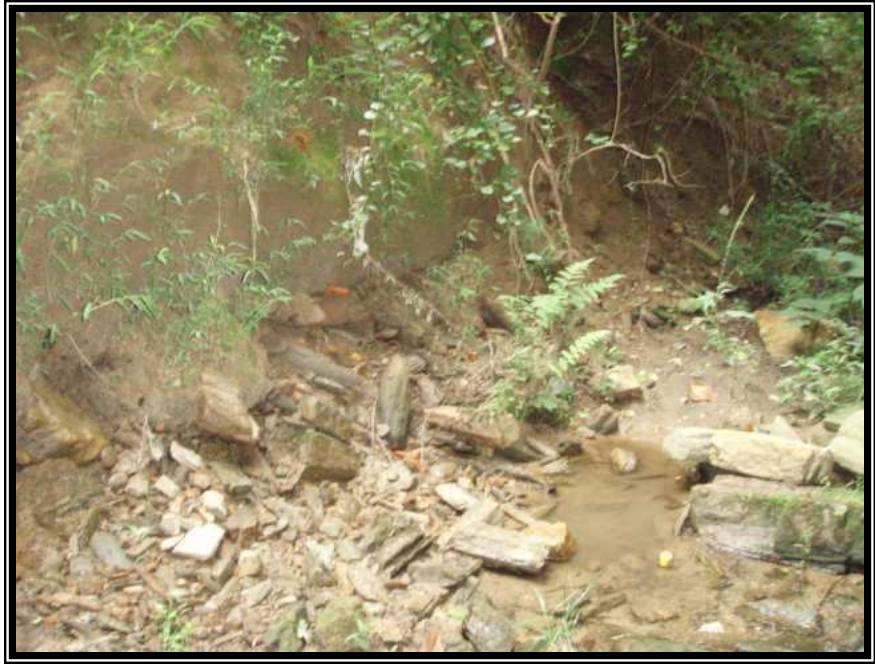
BM16

BEHI = High Erosion Rate = -0.18 ft/yr

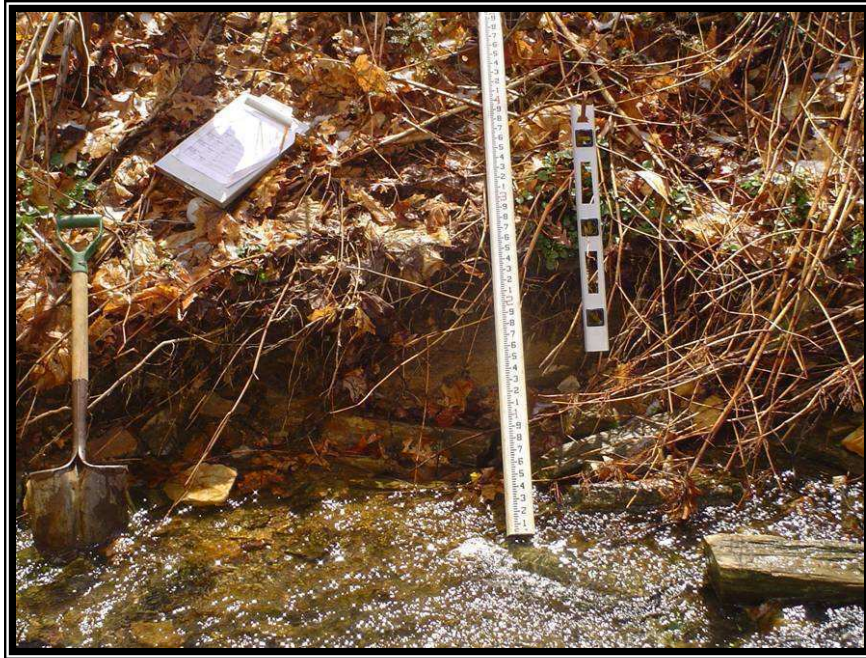
BM21

BEHI = Moderate Erosion Rate = -0.24 ft/yr

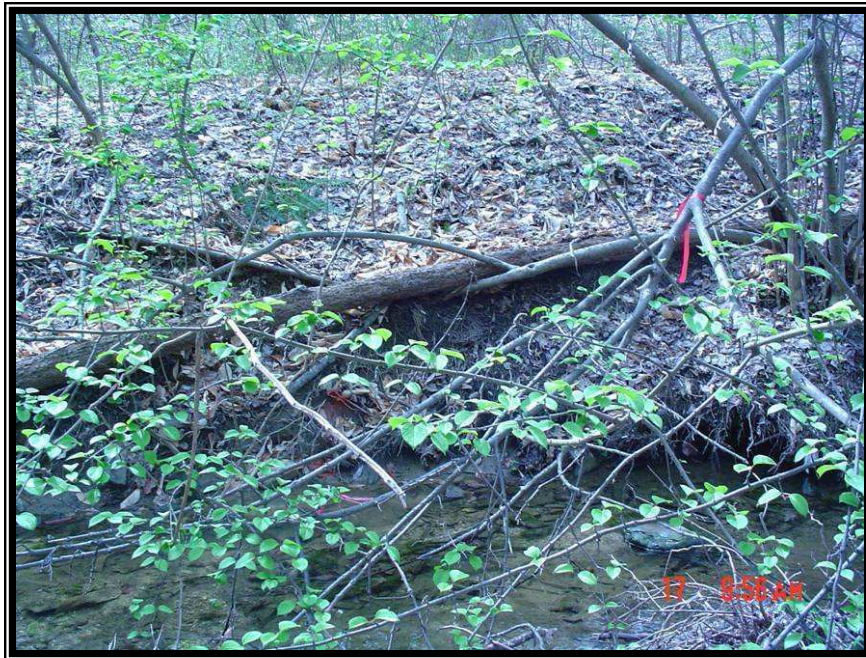
BM2450

BEHI = Moderate Erosion Rate = -0.072 ft/yr

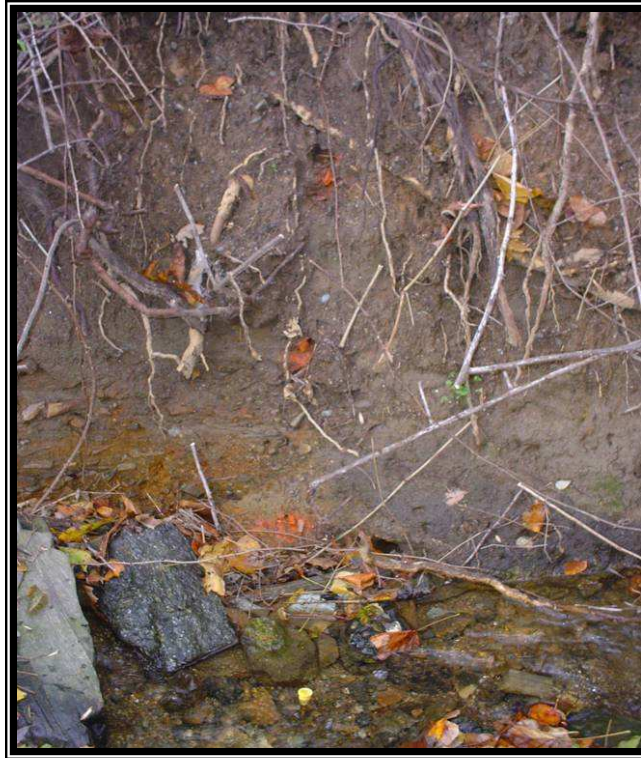
BM25

BEHI = Moderate Erosion Rate = -0.38 ft/yr

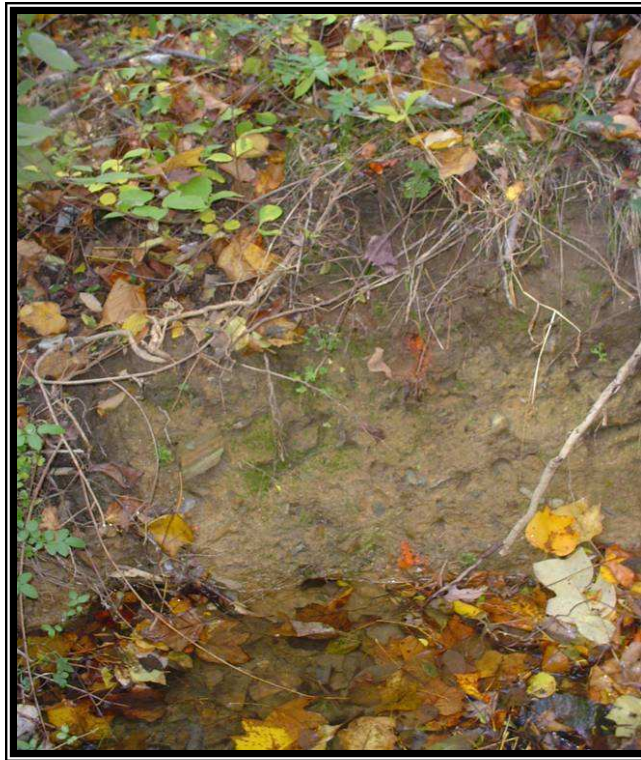
BM31

BEHI = High Erosion Rate = -0.10 ft/yr

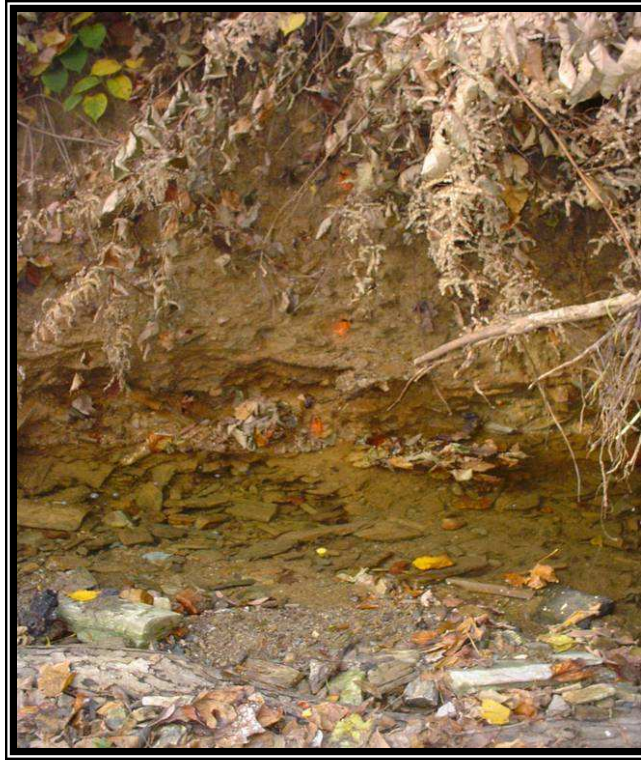
BM35

BEHI = High Erosion Rate = 0.56 ft/yr

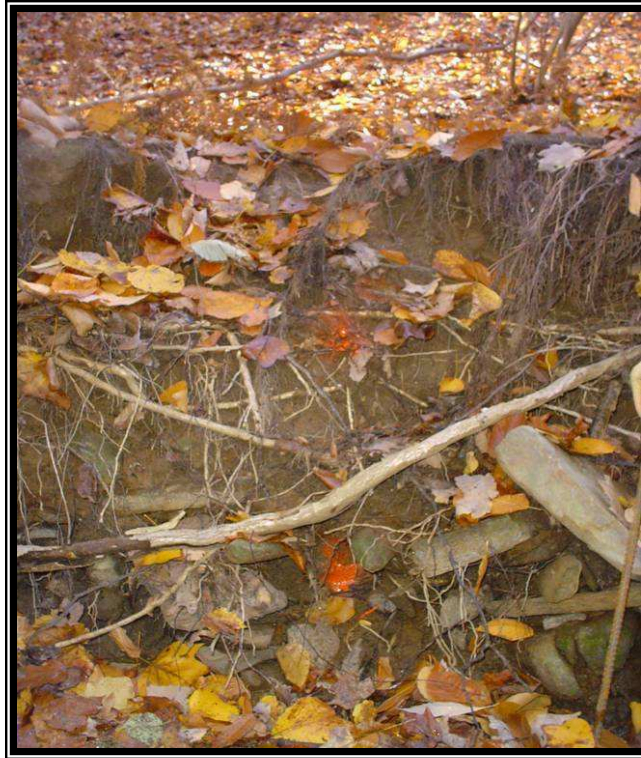
BM4

BEHI = Moderate Erosion Rate = -0.039 ft/yr

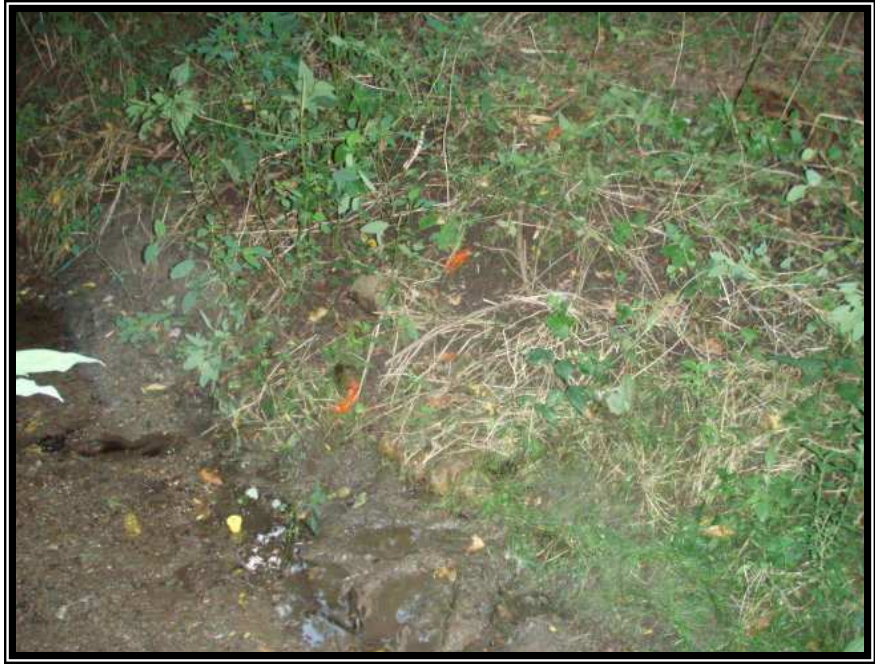
BM414

BEHI = Low Erosion Rate = 0.12 ft/yr

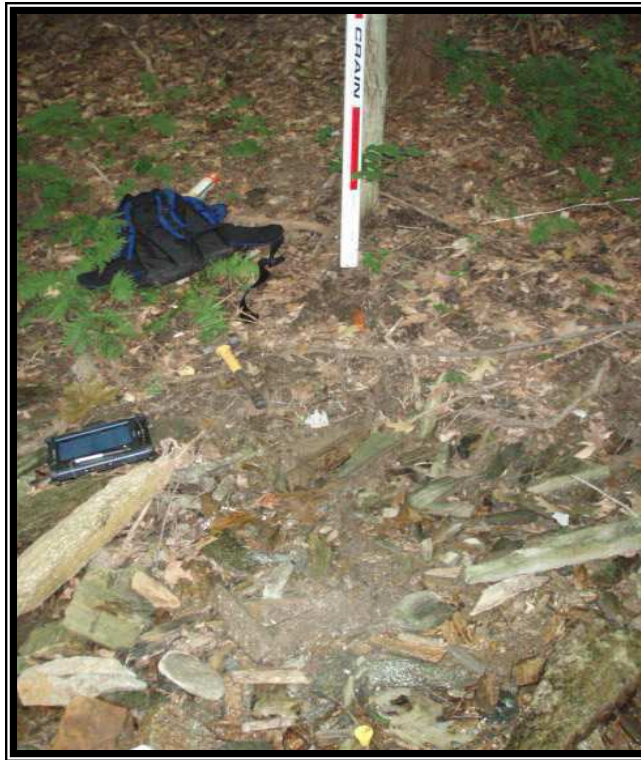
BM422

BEHI = Low Erosion Rate = 0.15 ft/yr

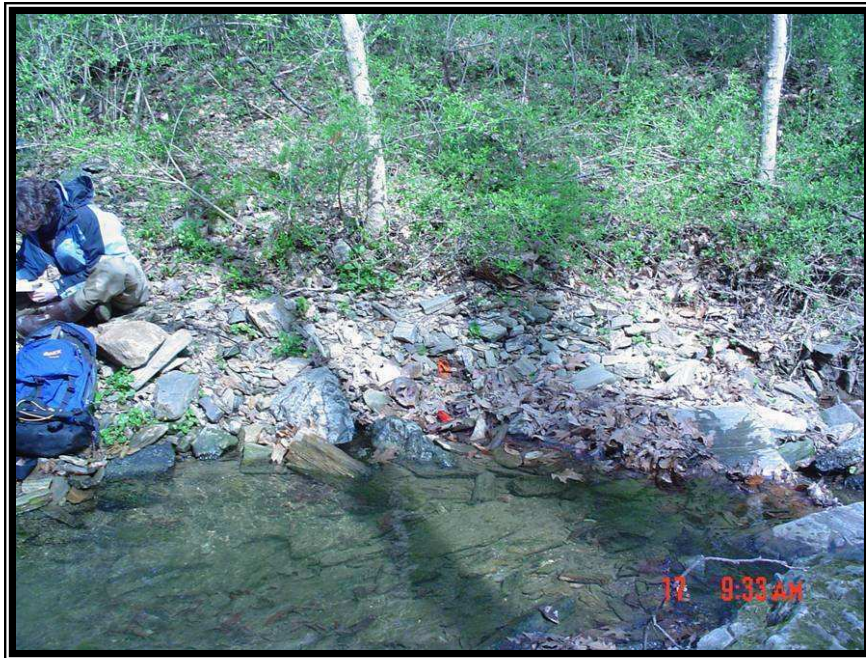
BM530

BEHI = Low Erosion Rate = -0.086 ft/yr

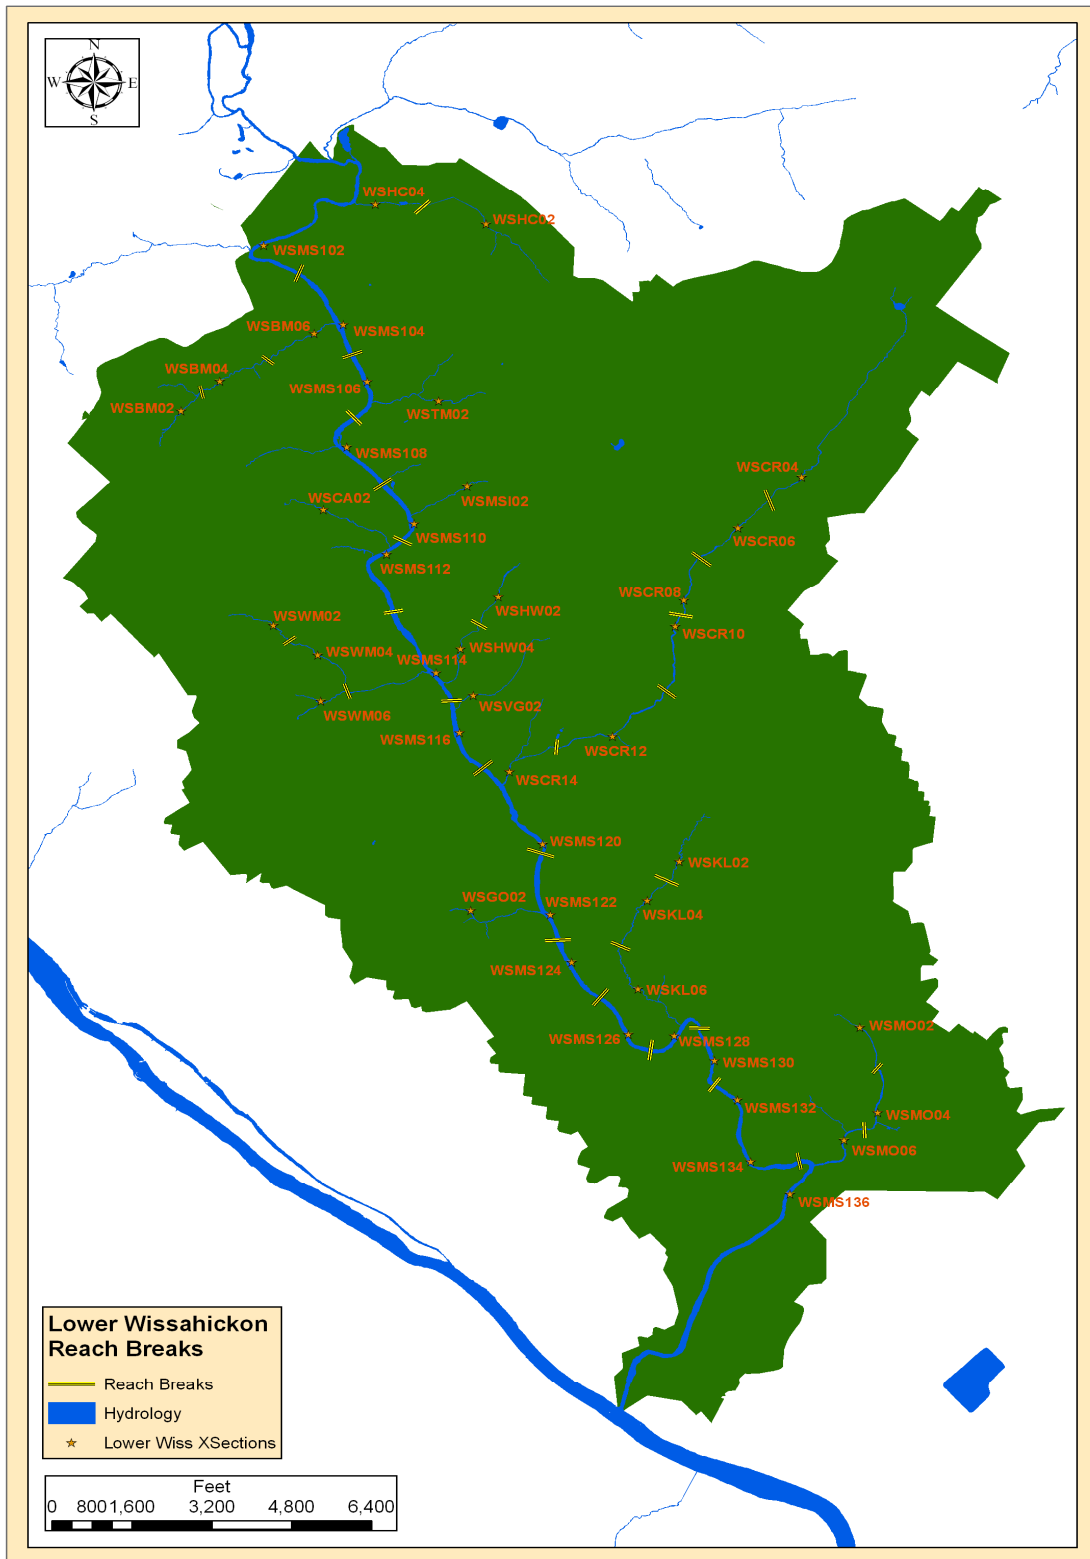
Figure 2-4: Lower Wissahickon Reach Breaks (Small Tributary reach breaks at confluences)

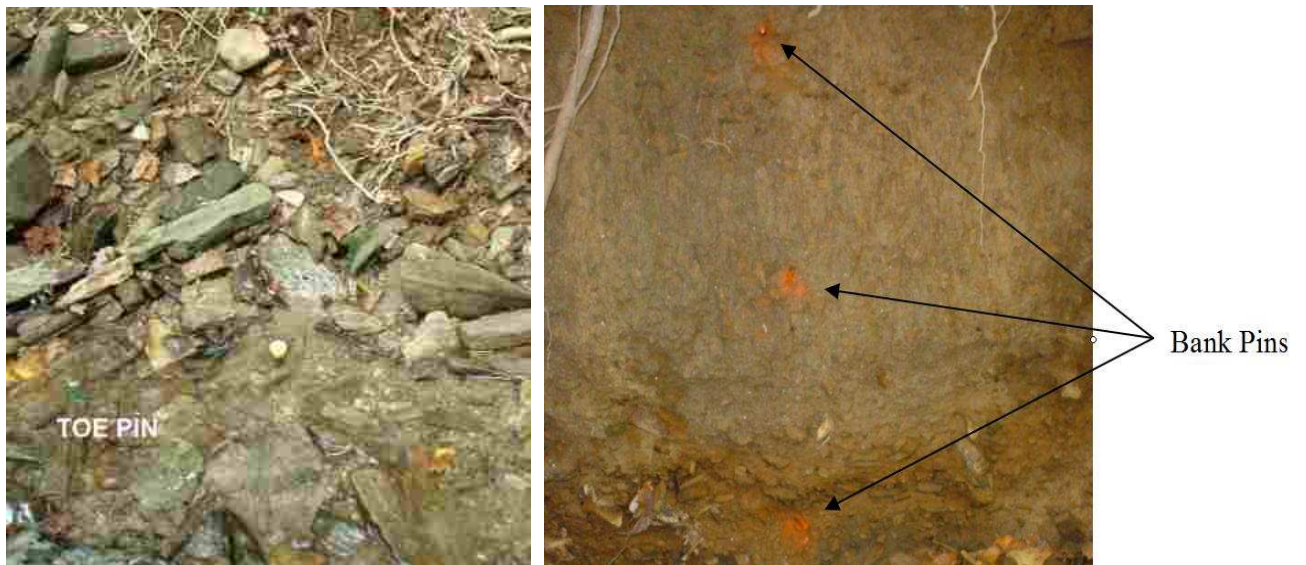
Figure 2-6: Example of Toe Pin (left) and Bank Pin (right) Setup along stream bank

To field verify predictions made by the BANCS model, bank pins (18" lengths of 1/2" or 5/8" iron rebar) were driven horizontally into the stream bank normal to the curve of the bank at the location where radius of curvature was minimized (most severe bend). At least one bank pin was installed below field-estimated bankfull elevation. Depending on bank height, one or two additional pins were installed, spaced no closer than 1 foot apart, such that the total number of bank pins at a site ranged from one to three (Figure 2-6). In order to enable measurement of lateral erosion, toe pins (12" lengths of 5/8" rebar) were also installed at each site. Toe pins were driven vertically into the stream bed at the toe of slope inline with the bank pins along a line normal to the curve in the bank. Toe pin locations were captured using GPS (Xplore technologies model iX140C2 tablet PC with GPS module) and yellow plastic survey caps were installed. To further assist field teams in re-locating bank pin sites, orange spray paint was applied to bank pins and survey flagging was hung from nearby vegetation.

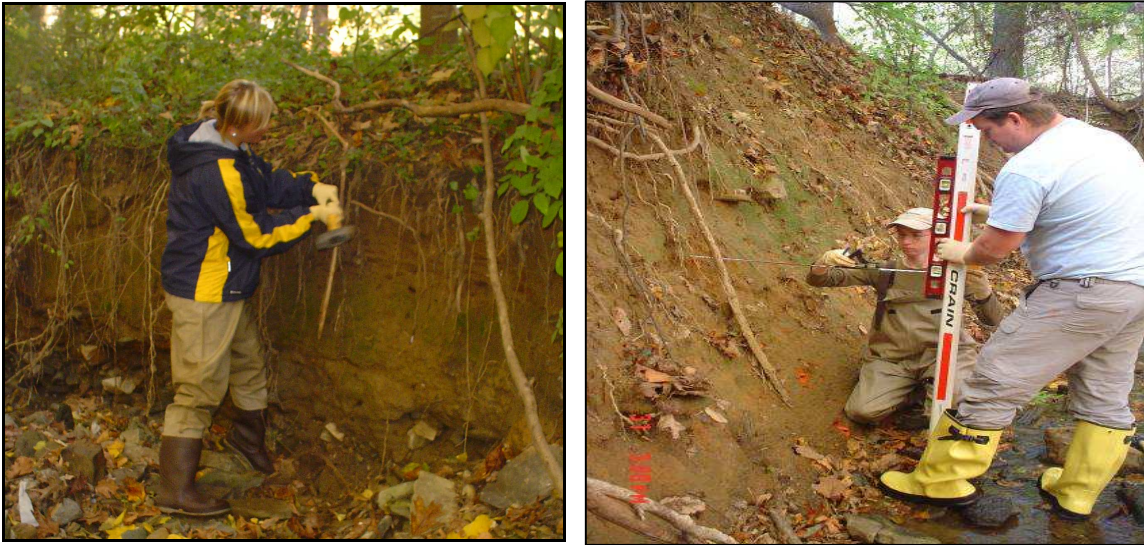
Figure 2-8: Example of bank pin installation (left) and bank pin measurement (right) by PWD staff

Measurements were made using a survey rod (CRAIN, SFR Series Leveling Rod), a flexible “pocket rod” (Keson, Inc.) and two small cylindrical spirit levels (Figure 2-8). The survey rod was placed on the edge of the toe pin and held vertical using a level. The pocket rod was placed over the bank pin up against the bank and leveled with the second level. The distance from the bank to the edge of the survey rod closest to the bank was recorded on the field data sheet. Lateral erosion or aggradation of the stream bank was determined by measuring changes in bank pin distance from a line extending vertically from the toe pin. In order to obtain a better measurement of bank profile, a series of vertical reference points were measured in addition to the bank pins for several of the bank pin sites. These vertical reference points were measured at predetermined vertical points on the survey rod.

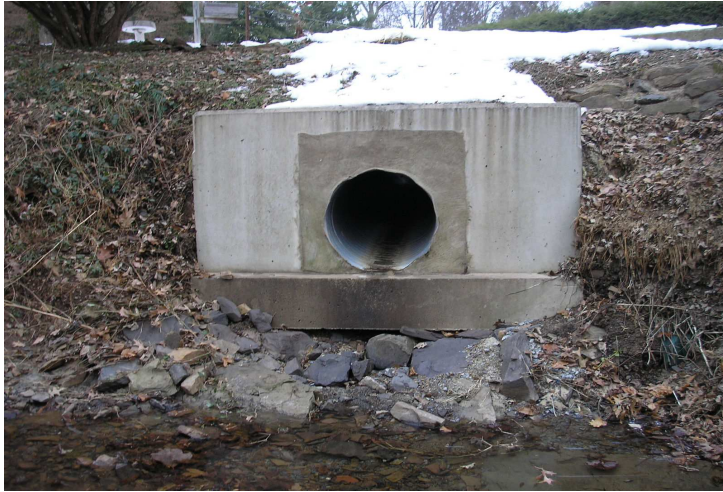
An outfall was defined as the end of a pipe which releases either stormwater, combined sewage, or an encapsulated creek into the waterway (Figure 2-9). Data was collected on outfalls larger than 12 inches. The data collected for each outfall included the pipe diameter, height and width of the outfall including the presence of an apron, the construction material (i.e. metal, concrete, terra cotta, etc.), structural condition (i.e. good, fair, or poor), presence of, and quality of dry weather flow, bank location (right or left), and submergence depth.

Figure 2-9: Example of an outfall point assessed in infrastructure trackdown

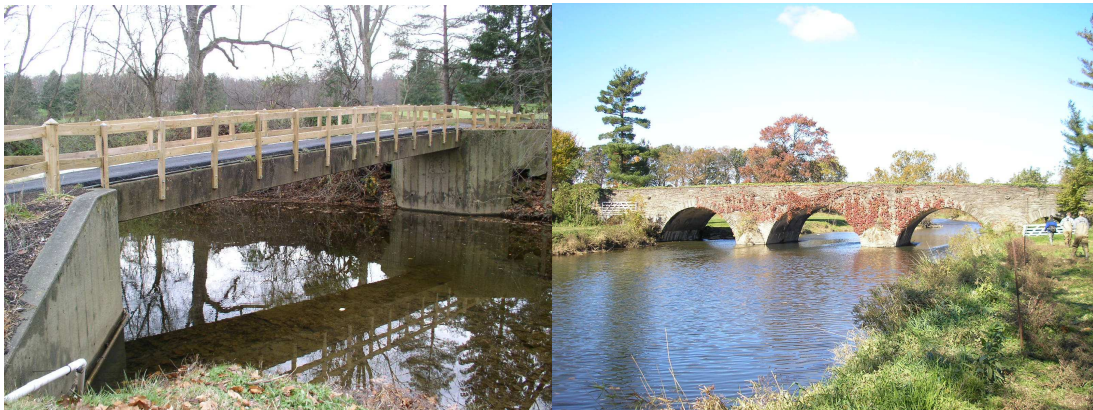
A bridge was defined as a structure that spanned a stream over which a road or walkway passes (Figure 2-10). Bridges mapped in this report are shown as one point at the center of the bridge along the creek. The data collected for each bridge included the approximate height, width and depth of the bridge opening, the construction material (i.e. metal, concrete, wood, stone, etc.), and structural condition (i.e. good, fair, or poor).

Figure 2-10: Examples of bridges assessed in infrastructure trackdown

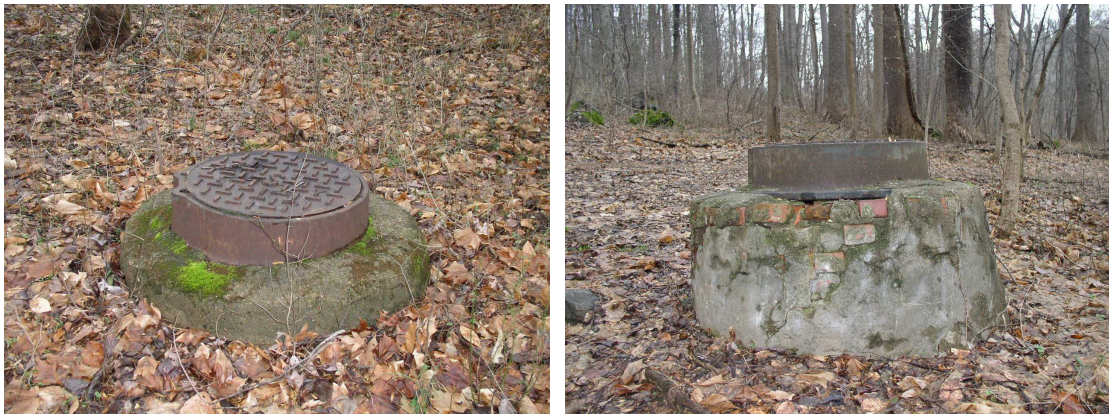
A manhole was defined as the covered opening that allows access to an existing utility (Figure 2-11). Data was collected for manholes either located within the creek or in close proximity to the stream banks. The data collected for each manhole included the approximate diameter of the manhole, the construction material (i.e. concrete or terra cotta), the height of the portion of manhole exposed above the ground or water surface, structural condition (good, fair, or poor), bank location (left or right) and the presence and description of any odor.

Figure 2-11: Examples of manholes assessed in infrastructure trackdown.

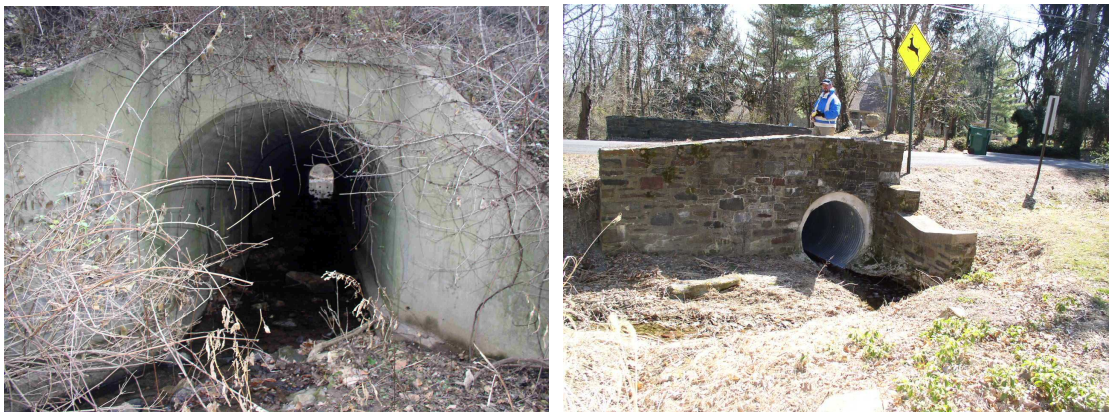
A culvert was defined as a conduit which carried the stream under a roadway, sidewalk, building, or miscellaneous structure (Figure 2-12). Culverts were mapped by taking GPS coordinates at the start and end of the culvert with photos taken at each point. The data collected for each culvert included the approximate dimensions, construction material (e.g. stone, concrete, brick, etc.), structural condition (i.e. good, fair, or poor), presence and quality of dry weather flow, and bank location (left or right).

Figure 2-12: Examples of culverts assessed in infrastructure trackdown.

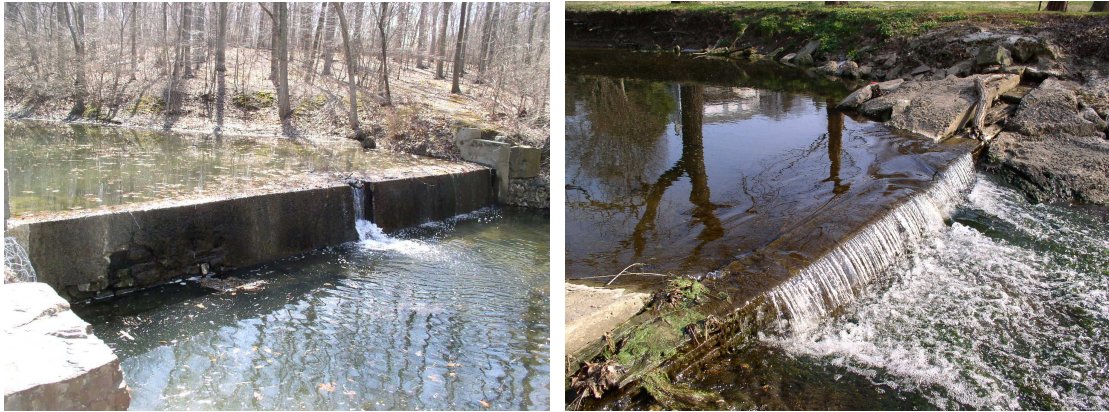
A dam was defined as an obstruction that impounded stream flow (Figure 2-13). Data was only collected for manmade dams and did not include natural debris jams caused by coarse woody debris (CWD). The data collected for each dam included the approximate dimensions, construction material, structural condition (good, fair, or poor) and bank location (left, right, or across the creek).

Figure 2-13: Examples of dams assessed in infrastructure trackdown.
