PHILADELPHIA'S WET WEATHER MANAGEMENT PROGRAMS

COMBINED SEWER MANAGEMENT PROGRAM ANNUAL REPORT

STORMWATER MANAGEMENT PROGRAM ANNUAL REPORT

Reporting Period July 1st 2009 to June 30th 2010

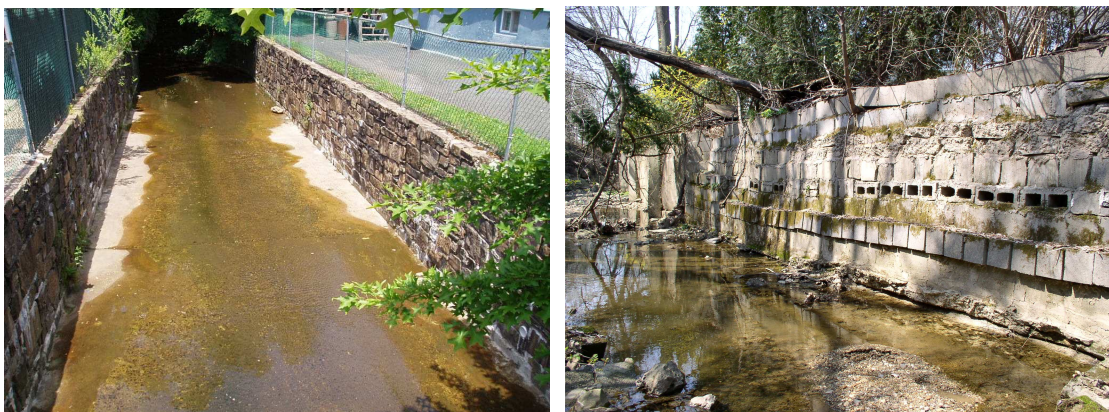
A channel was defined as a straightening and reinforcement of stream bed and/or banks with manmade materials such as concrete (Figure 2-14). Channels were located on one or both banks, as well as on the bottom of the stream bed. Each channel was mapped by taking GPS coordinates at the start and end of the channel with photos taken at each point. The data collected for each channel included approximate dimensions, structural condition (good, fair, or poor), the portion of stream that was channelized (i.e. left bank, right bank or bottom), and construction material (stone or concrete).

Figure 2-14: Examples of channels assessed in infrastructure trackdown.

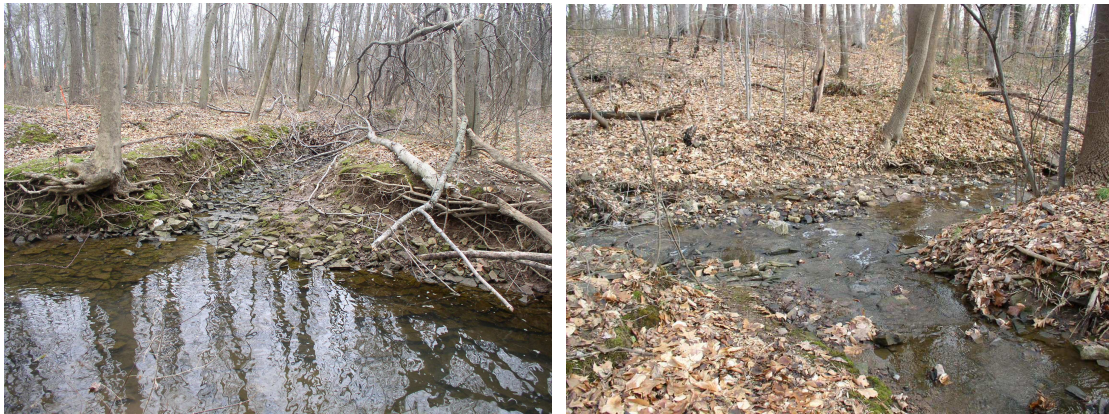
Figure 2-15: Examples of confluences assessed in infrastructure trackdown.

A confluence was defined as the junction where two streams meet (Figure 2-15). The data collected for each confluence included the GPS coordinates of the larger stem bank location looking downstream (left or right) and width of the stream entering the larger stem.

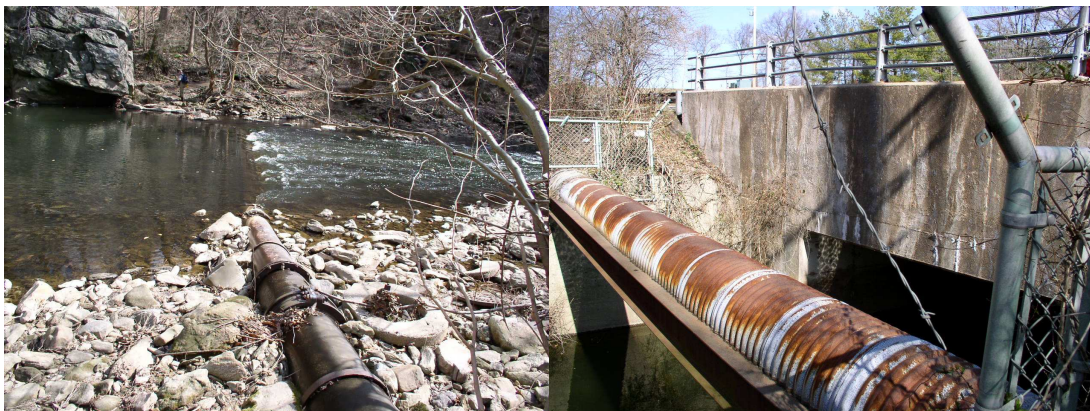
A pipe was defined as a conduit for carrying a utility across the stream (Figure 2-16). The data collected for each pipe included the approximate diameter, construction material (i.e. concrete, metal, terra cotta, etc.), the length and height above the water or ground surface of the exposed portion, structural condition (i.e. good, fair, or poor), presence and quality of dry weather flow, bank location (i.e. left, right or across the creek), and submergence depth.

Figure 2-16: Example of a pipe assessed in infrastructure trackdown.

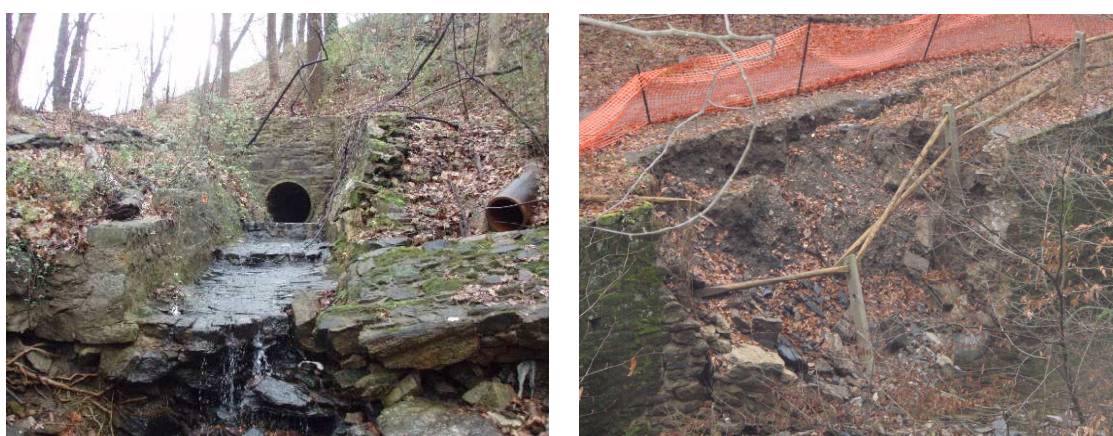
Figure 3-34: Degraded section of WScha280 (left). Degraded section of WScha142 (right).

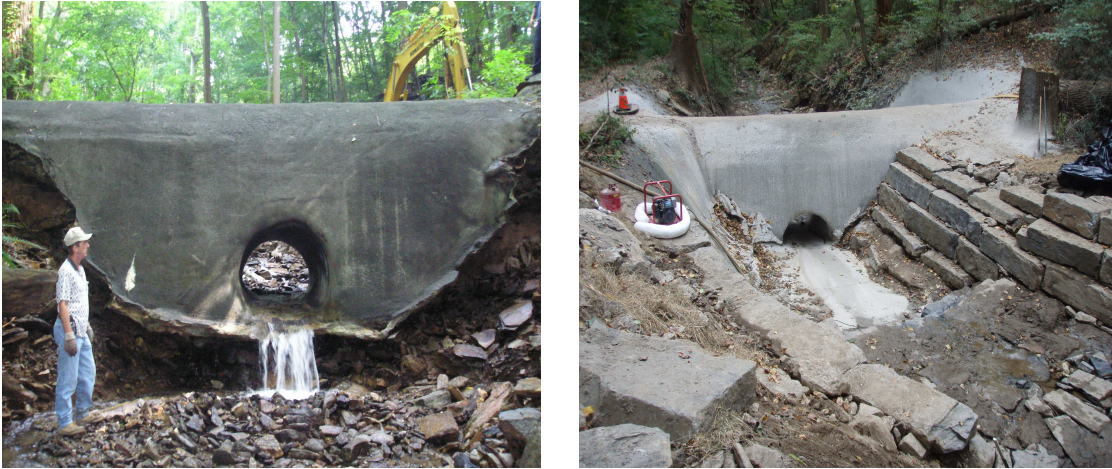
Figure 3-101: Upstream view of WScul116 pre-construction (left); Downstream view of WScul116 post-construction (right).

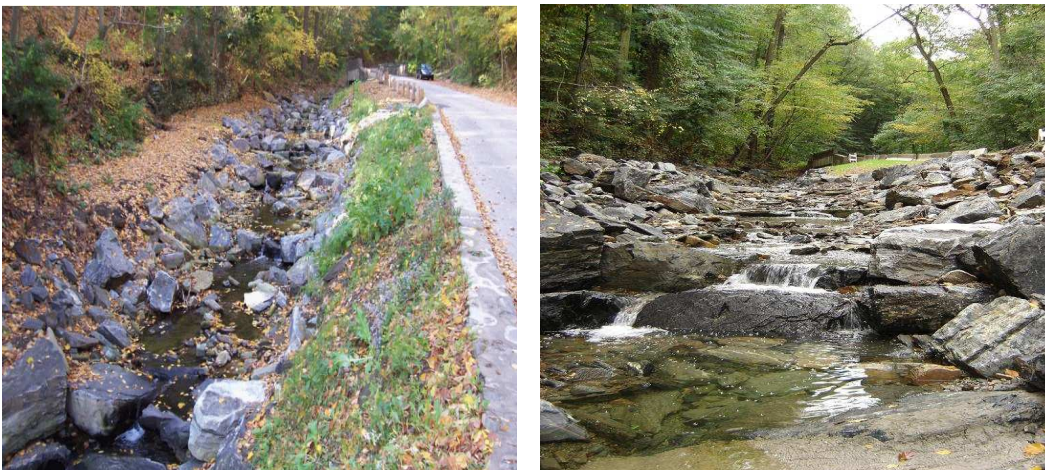
Figure 3-102: View of boulder step-pool system looking upstream (left): scour pool at the base of the step-pool system (right).

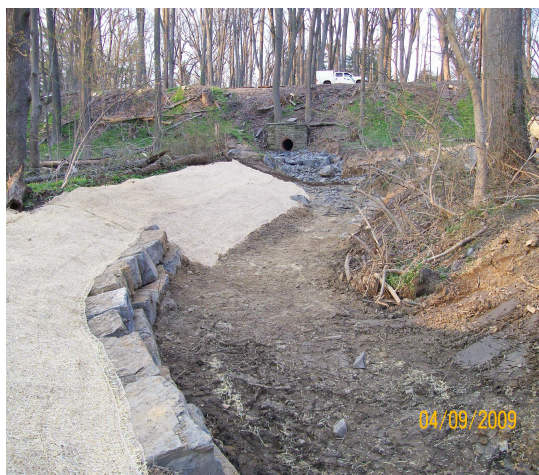
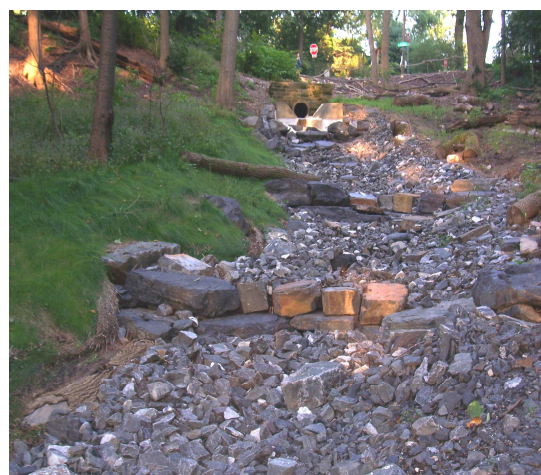
Figure 3-103: WSout513 conveyance channel during (left) and after (right) construction

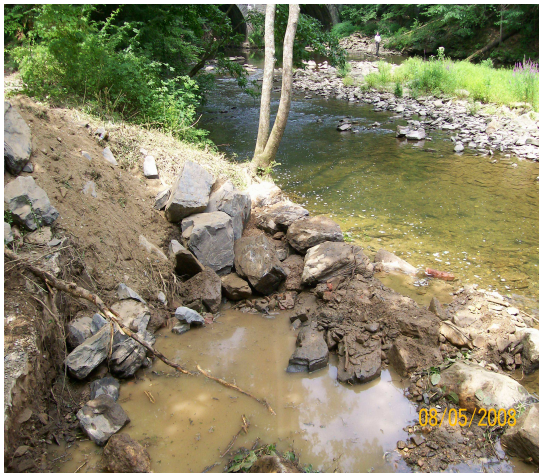
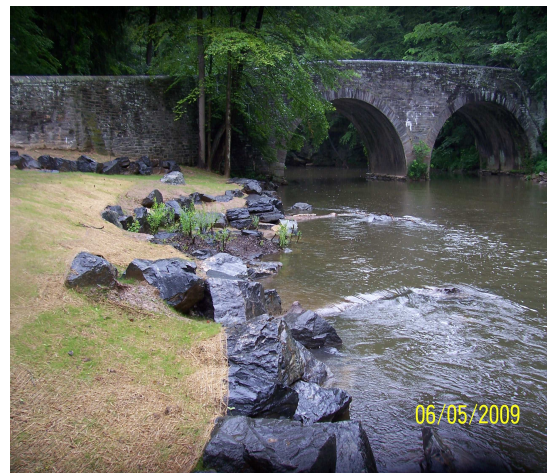
Figure 3-105: DSR bank in reach WSMS110 following emergency repairs (left); DSR bank following bank stabilization and instream flow structure installation (right).

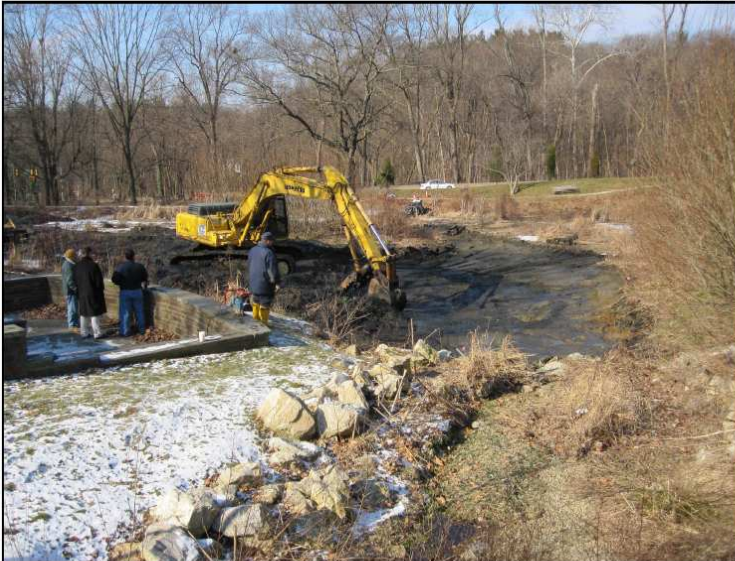
1/11/2010

Dredging of forebay pond. View from footbridge.

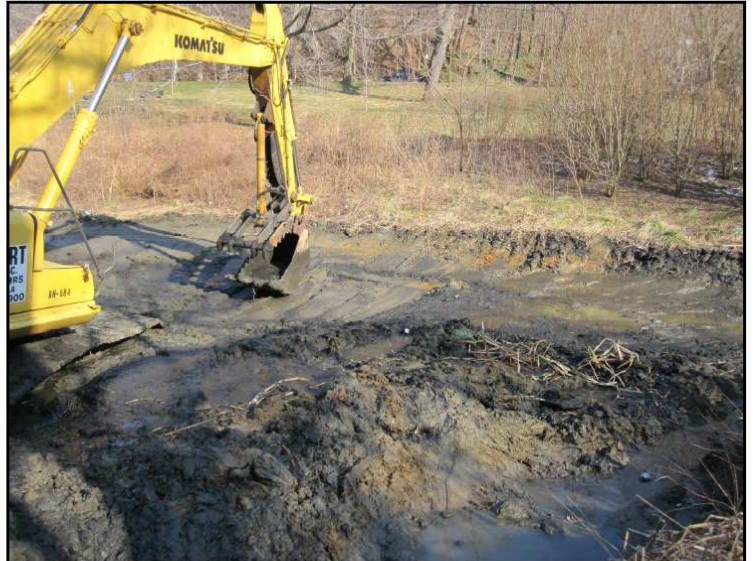
1/11/2010

Dredging of forebay pond.

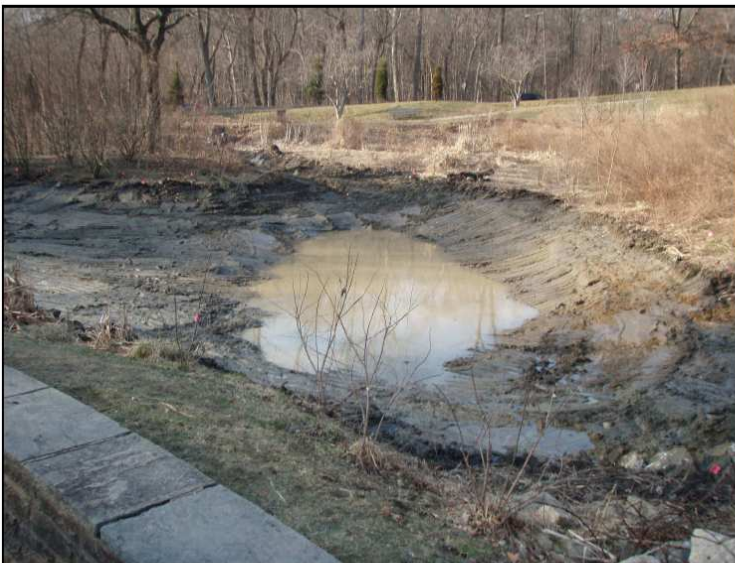
1/15/2010

Forebay pond after dredging.

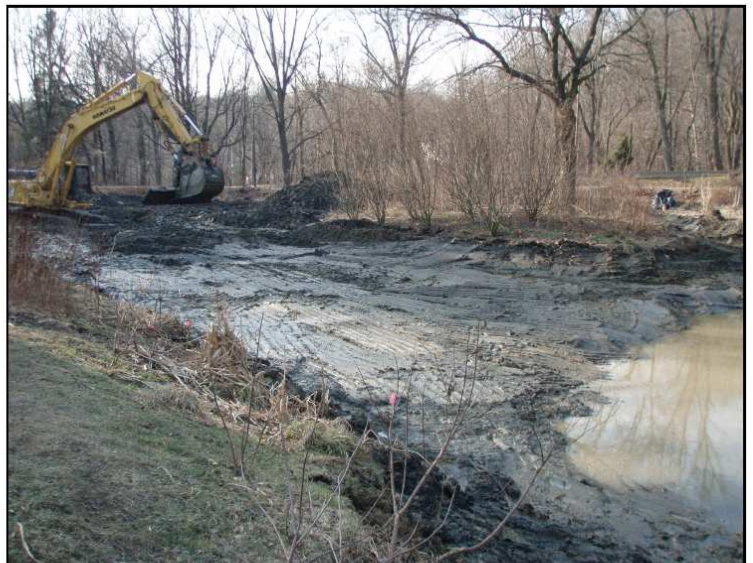
1/15/2010

Grading the southwest area away from forebay pond.

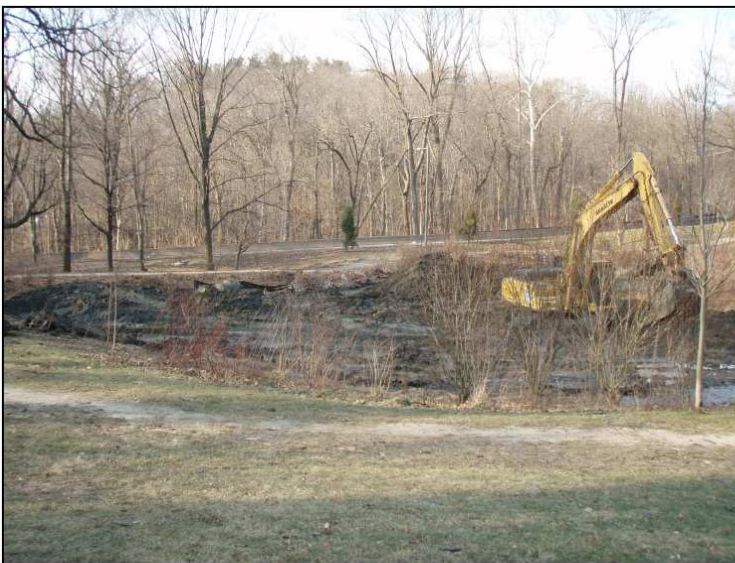
1/15/2010

Dredging and grading southwest area.

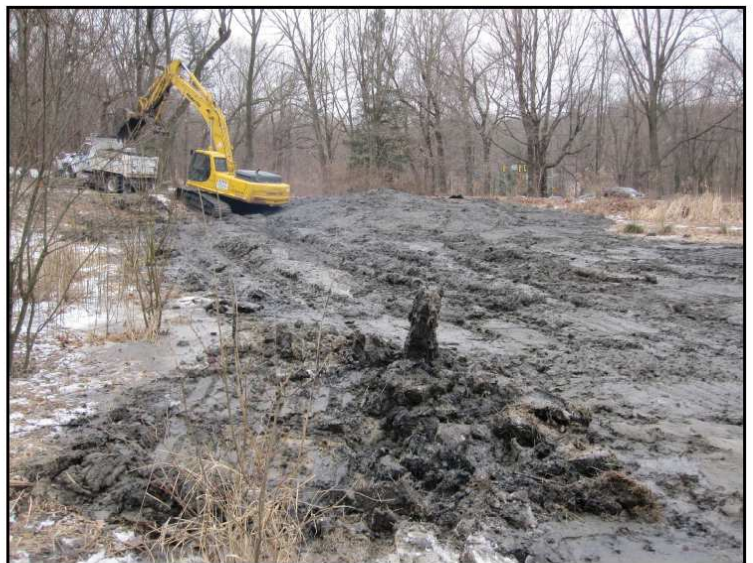
1/15/2010

Loading dredged material onto trucks for transfer and disposal.

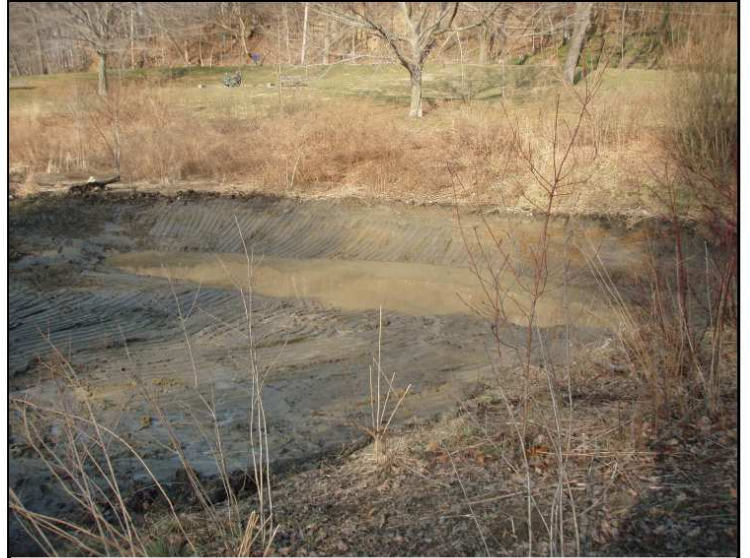
Dredged forebay pond. View from south.

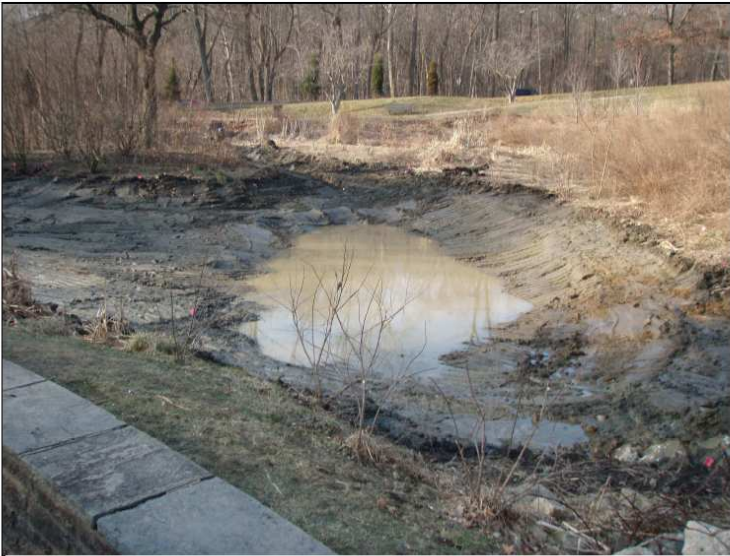
Dredged forebay pond. View from fountain.

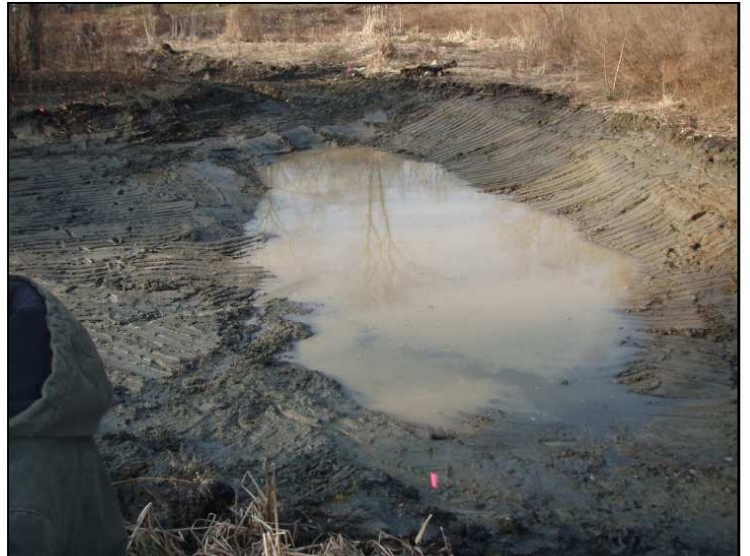
Dredged forebay pond. View from over fountain.

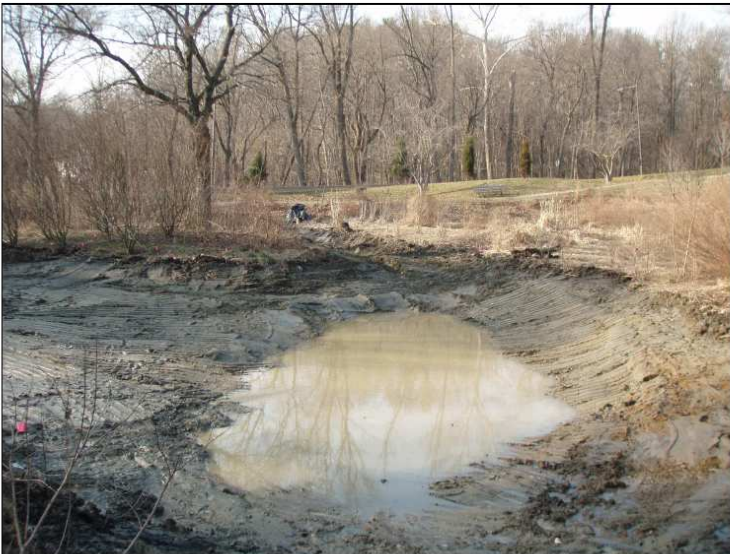
Dredged forebay pond. View from channel.

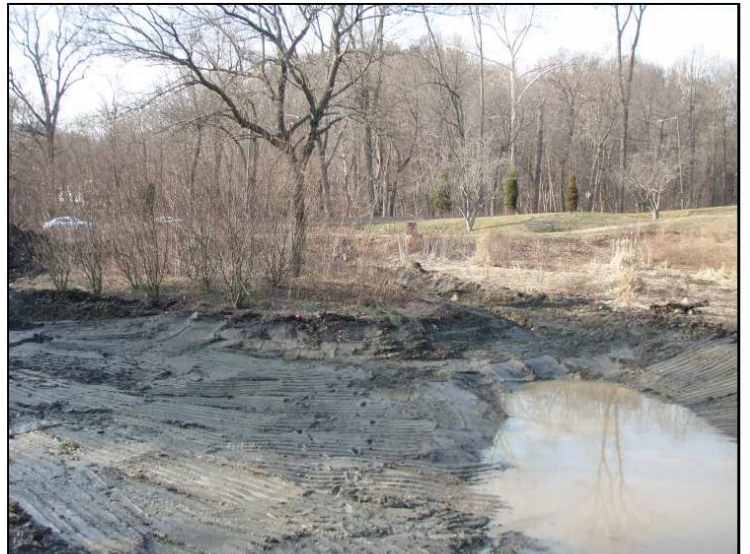
Grading around forebay pond area.

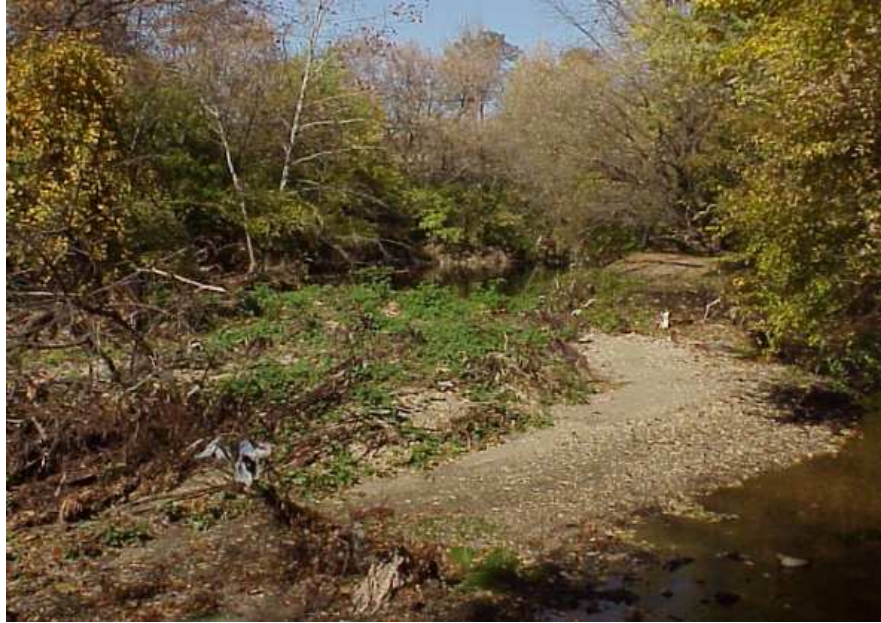
Photo 1 - Channel Bar Formation in Creek Due to Upstream Bridge Abutments

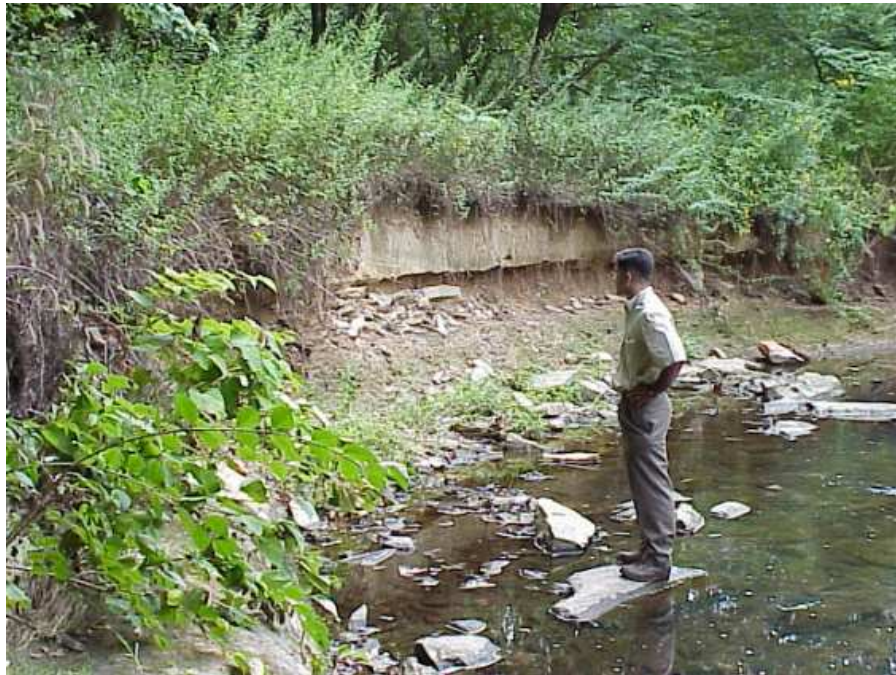
Photo 2 - Severe Bank Erosion along the Marshall Road Project Reach

Specifically, abandoned bridge abutments upstream of the project area were constricting flow and directing it downstream into an outside meander bend. Additionally, high flows were being diverted around the outside of one of the abutments, accelerating erosion downstream and subsequently depositing sediment into the middle of the channel. As a result, a sanitary sewer line (Photo 3) had become exposed and its structural integrity was jeopardized. The erosion

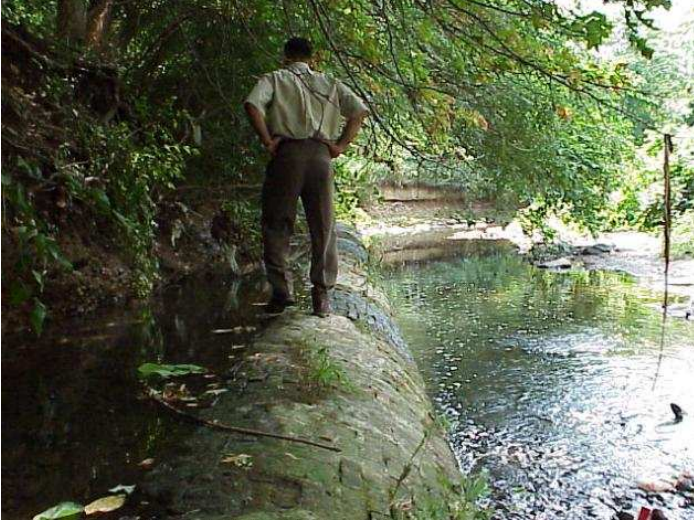
Photo 3 - Exposed Sewer Line

and sedimentation was also causing the loss of riparian vegetation and increasing the embeddedness of downstream substrate. As a result, fine particles of soil were being deposited on the streambed, covering gravel and cobbles, and making the bed unsuitable for macro-invertebrate habitat and fish

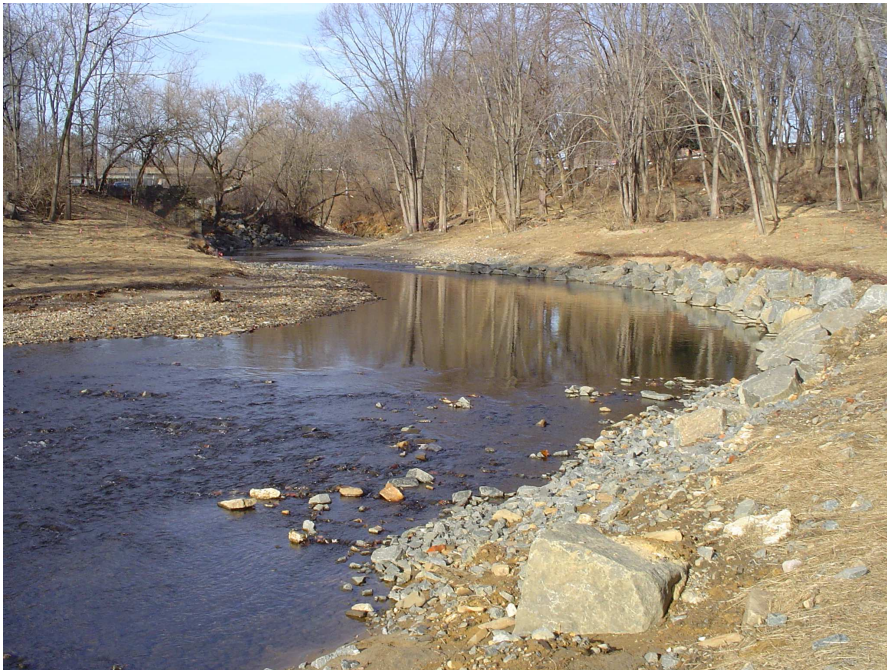
In early December, 2004, Buckley & Company finished all of the partially completed components listed above (Photo 4, Photo 5).

Photo 4 - Upstream View of Cobbs Creek

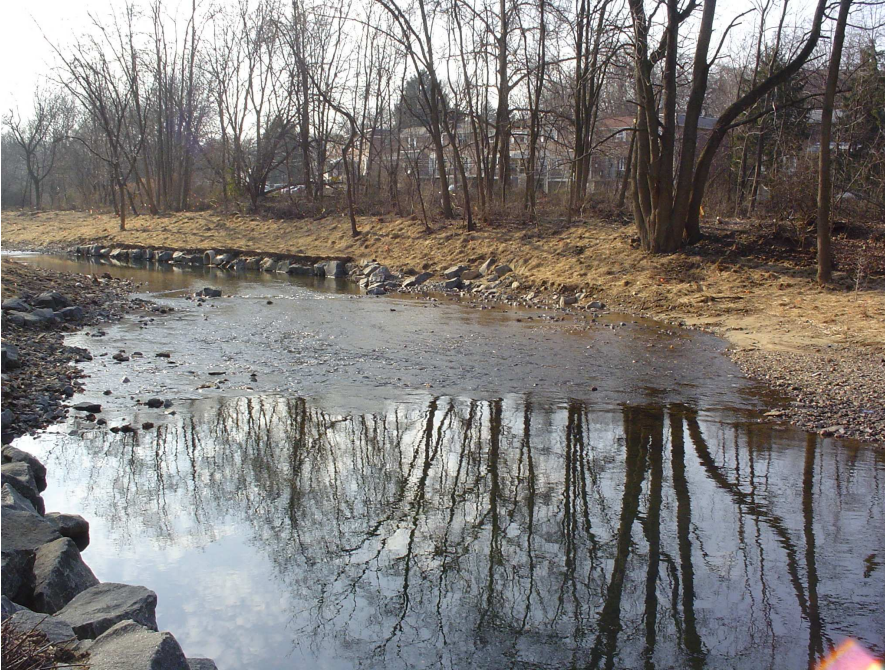
Photo 5 - Downstream View of Cobbs Creek

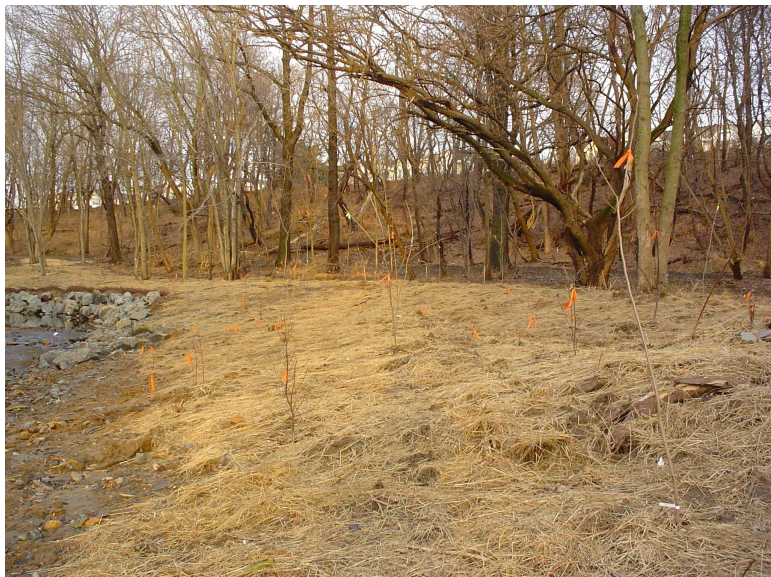
The planting of trees, shrubs, live branch layering, and native seeding and mulching began in mid-December. Native riparian vegetation was established along each stream bank to provide shade, detritus, and to intercept and filter stormwater runoff from surrounding upland areas. The Fairmount Park Commission provided assistance in identifying appropriate native plantings for the riparian corridor that were consistent with the natural lands restoration master plan and serviceable by commission maintenance staff (Photo 6).

Photo 6 - Tree and Shrub Planting at the Restoration Site

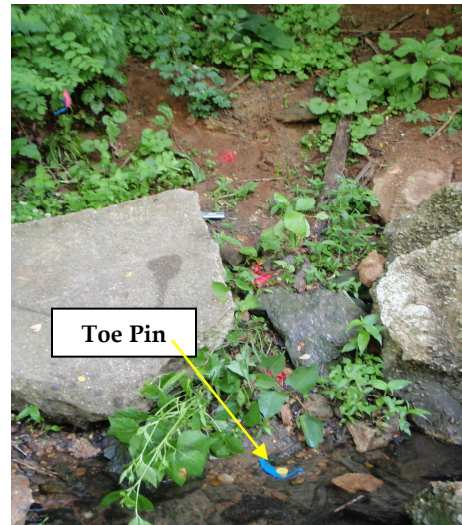
total number of bank pins at a site ranged from one to three (Figure 8). To enable measurement of lateral erosion, toe pins (12" lengths of 5/8" rebar) were also installed at each site. Toe pins were driven vertically into the stream bed at the toe of slope in line with the bank pins along a line normal to the curve in the bank (Figure 9). Toe pin locations were captured using a Total Station (Topcon GT235) and yellow plastic survey caps were installed. To further assist field teams in re-locating bank pin sites, pink spray paint was applied to bank pins and survey flagging was hung from nearby vegetation.

Figure 9 - Bank Pin Monitoring Site showing installation of toe pin relative to bank pin locations

Measurements were made using a survey rod (CRAIN, SFR Series Leveling Rod), a flexible "pocket rod" (Keson, Inc.) and two small cylindrical spirit levels. The survey rod was placed on the edge of the toe pin and held vertical using a level. The pocket rod was placed above the bank pin flush with the streambank and leveled with the second level. The distance from the bank to the edge of the survey rod closest to the bank was recorded on the field data sheet. Lateral erosion or aggradation of the stream bank will be determined by measuring annual changes in bank pin distance from a line extending vertically from the toe pin. In order to obtain a better measurement of bank profile, a series of vertical reference points were measured in addition to the bank pins for several of the

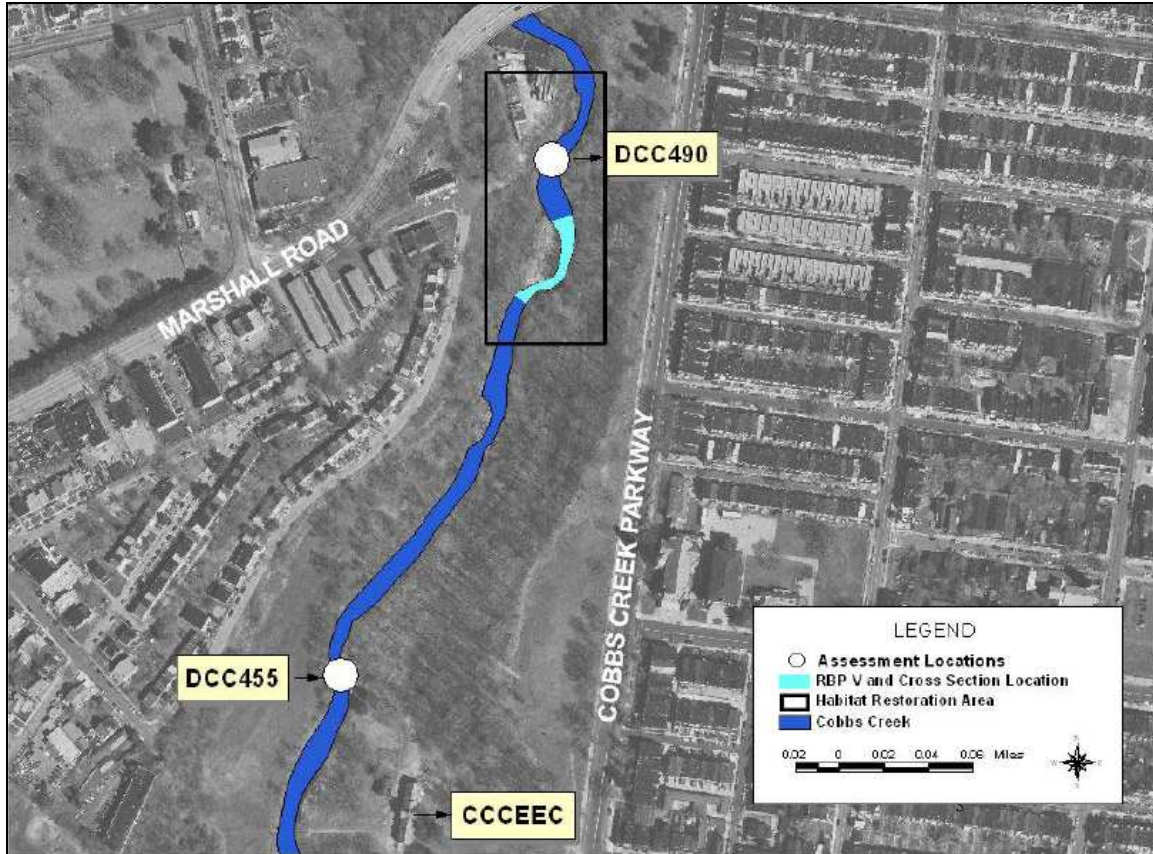
Macroinvertebrate, fish and habitat assessments were conducted at two sites (DCC490 and DCC455) in 2002 (Figure 19), along the reach that spans from Marshall Road at the upstream extent to the Cobbs Creek Community and Environmental Education Center at the downstream extent. Habitat and biological results were similar for both sites and indicated considerable water quality impairment as well as habitat degradation. Habitat scores for DCC490 and DCC455 were 133 and 145 respectively, which classified those sites as “partially supporting”.

Figure 19 - Pre-construction Biomonitoring Sites (2002)

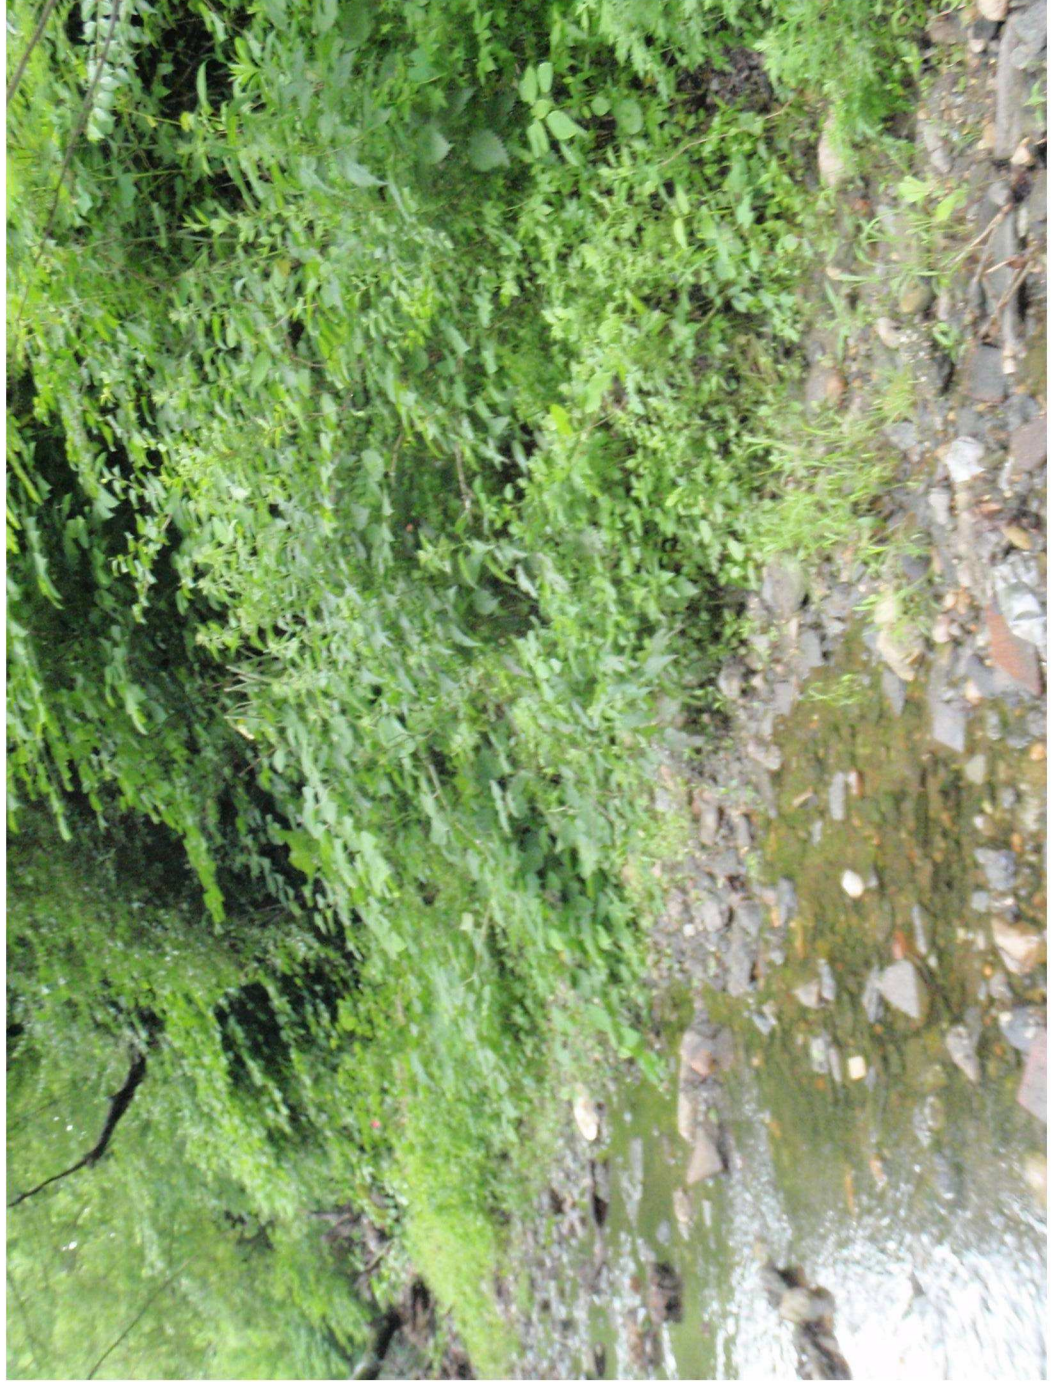
Marshall Road
Philadelphia Water Department
Office of Watersheds
BEHI Reaches
1R 0+00
June 4th, 2009

BEHI: Moderate
NBS: Very Low

Stream: Cobbs Creek	Location: Marshall Road
Station: 1R 0+00	Observers: EH, RH, MM
Date: 6-4-09	Stream Type: B4c Valley Type: V

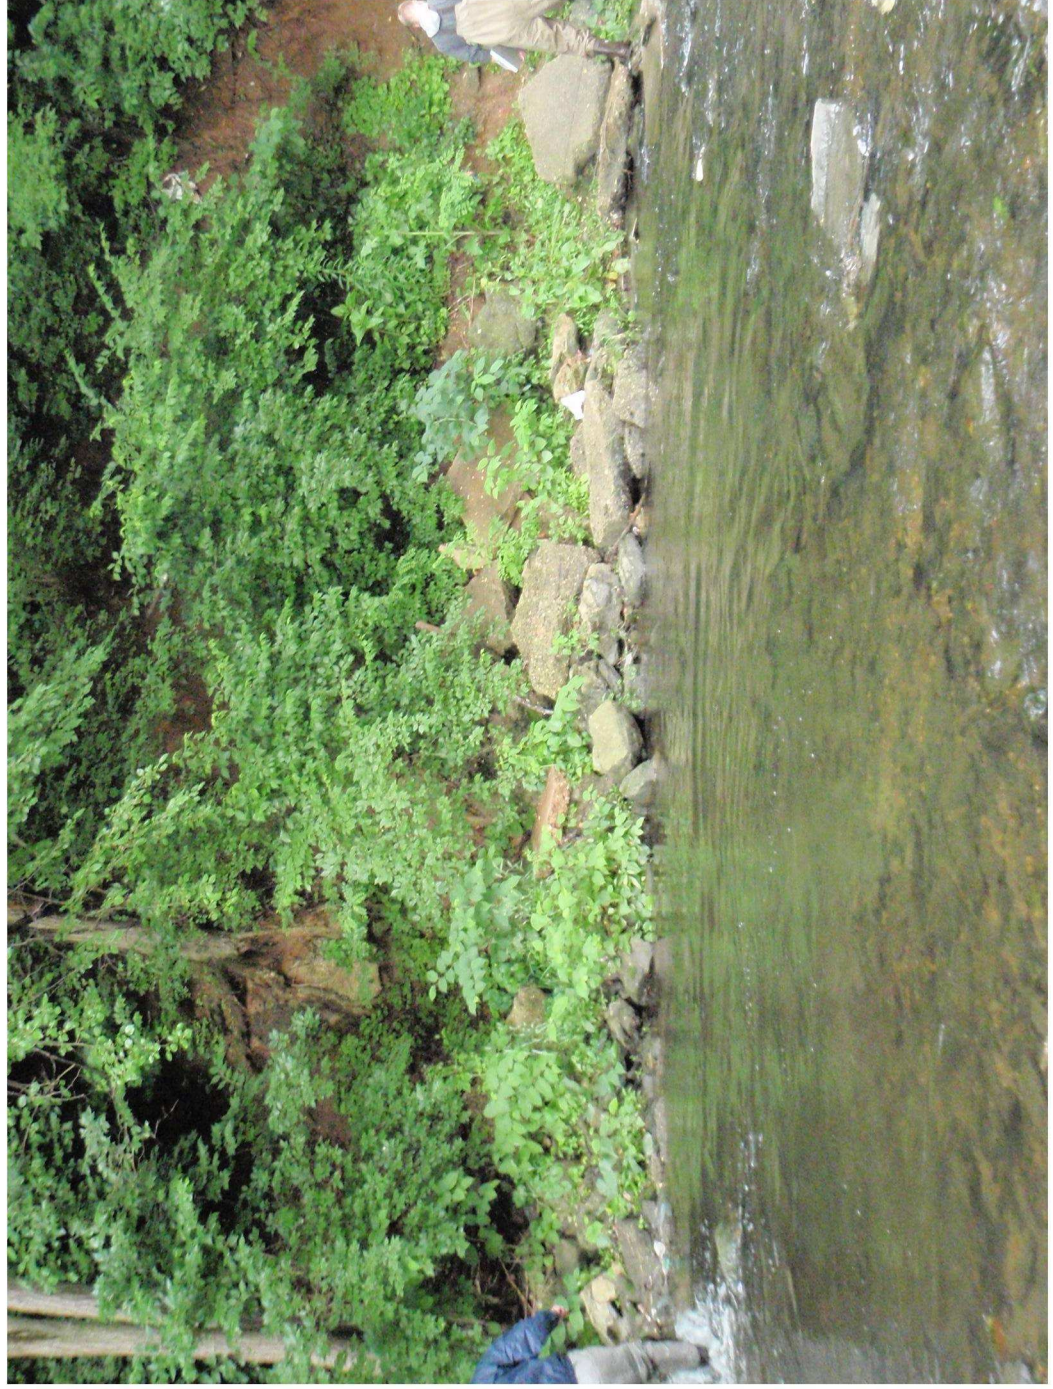
Stream: Cobbs Creek	Location: Marshall Road
Station: 1L 0+00	Observers: EH, RH, MM
Date: 6-4-09	Stream Type: B4c Valley Type: V

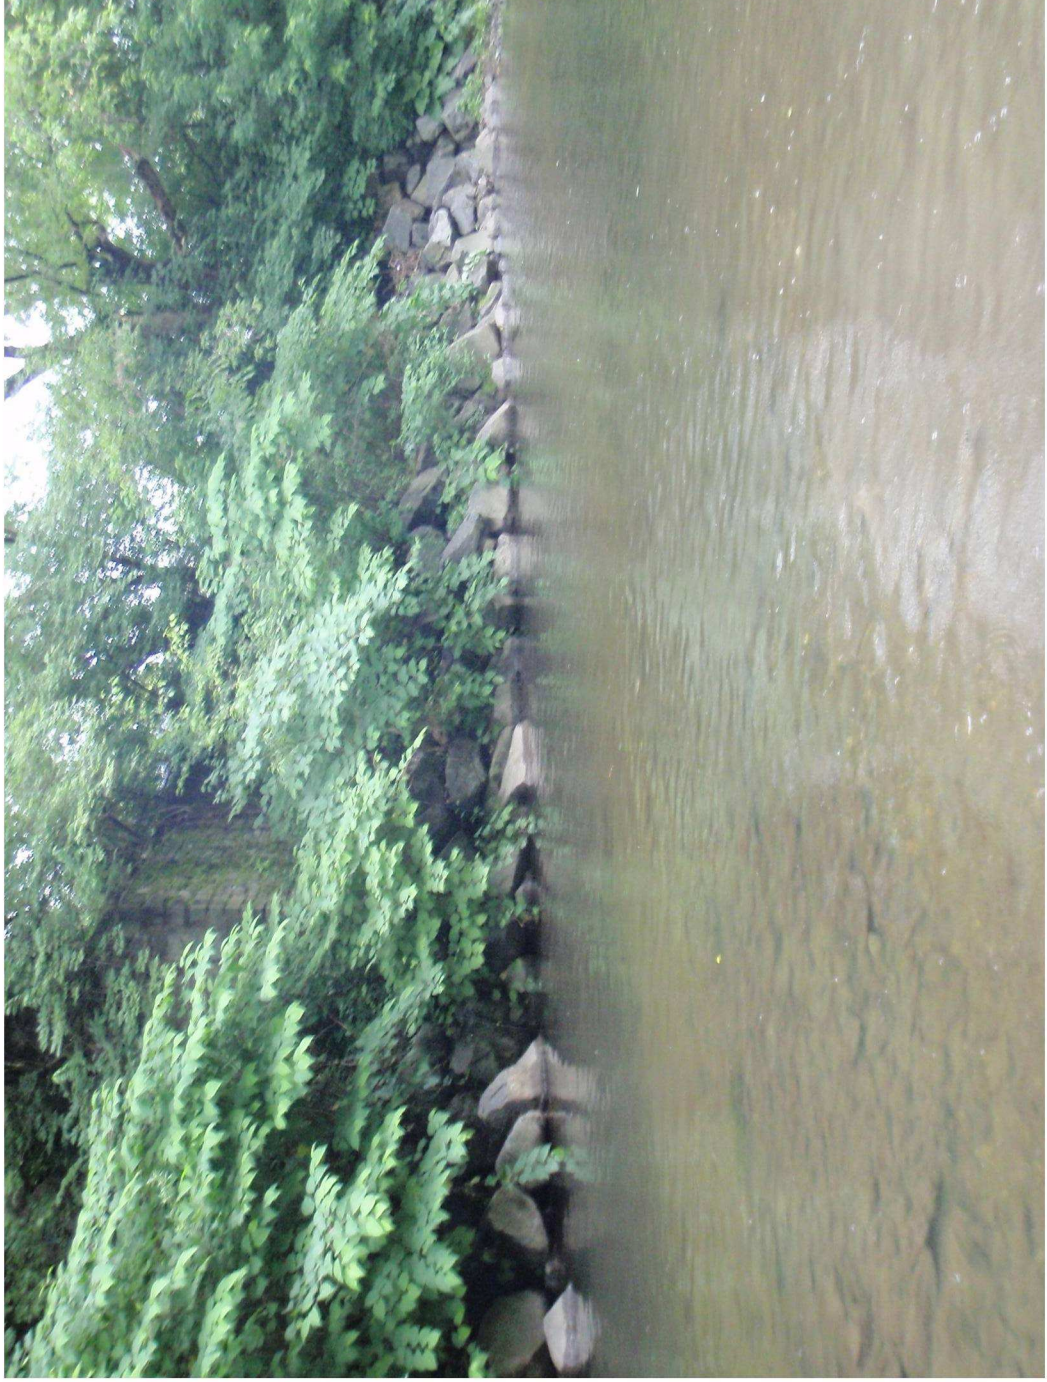
2R 0+99

Stream: Cobbs Creek	Location: Marshall Road
Station: 2R 1+04	Observers: EH, RH, MM
Date: 6-4-09	Stream Type: B4c Valley Type: V

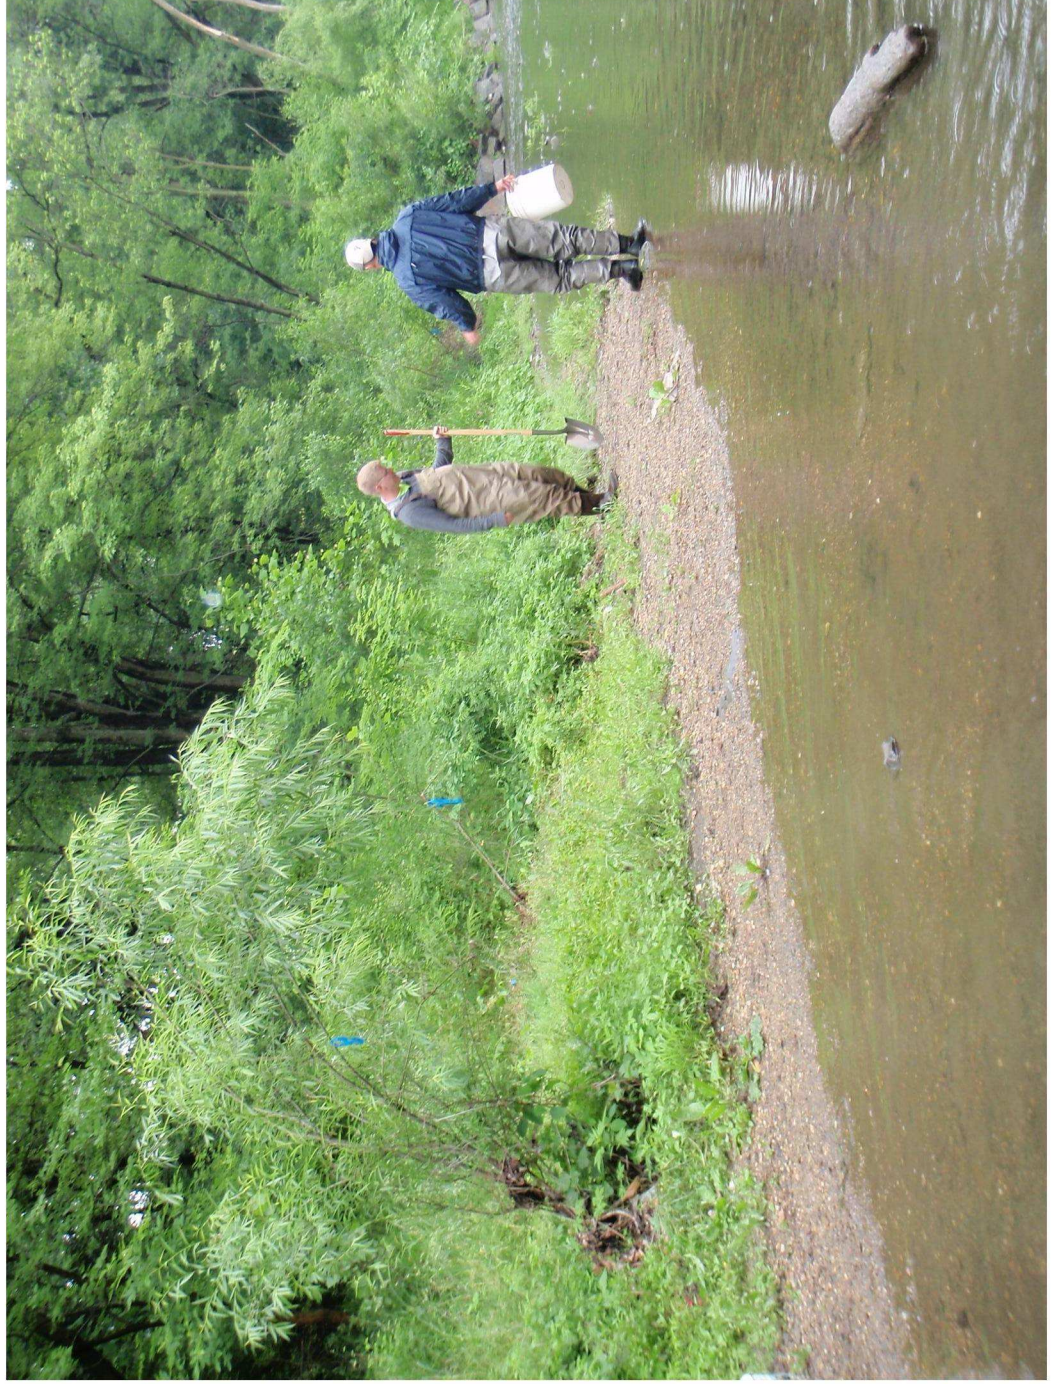
2L 1+22
June 4th, 2009

BEHI: Low
NBS: Very Low

Stream: Cobbs Creek	Location: Marshall Road
Station: 2L 1+12	Observers: EH, RH, MM
Date: 6-4-09	Stream Type: B4c Valley Type: V

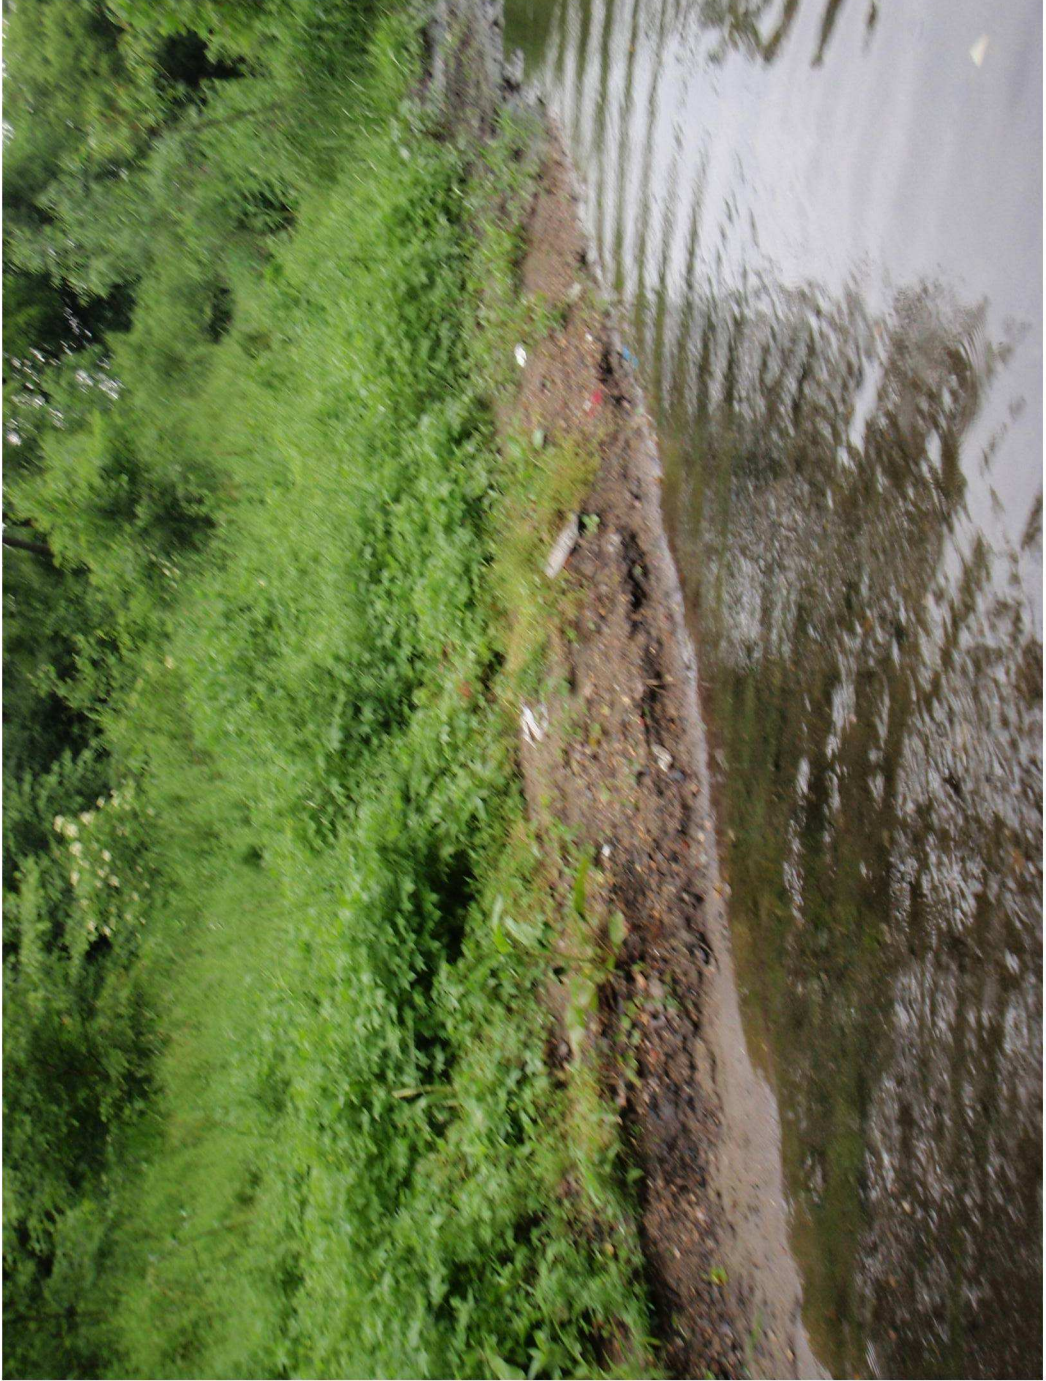
BEHI: Low

NBS: Low

Stream: Cobbs Creek	Location: Marshall Road
Station: 3R 2+75	Observers: EH, RH, MM
Date: 6-4-09	Stream Type: B4c Valley Type: V
