PHILADELPHIA'S WET WEATHER MANAGEMENT PROGRAMS

COMBINED SEWER MANAGEMENT PROGRAM ANNUAL REPORT

STORMWATER MANAGEMENT PROGRAM ANNUAL REPORT

Reporting Period July 1st 2009 to June 30th 2010

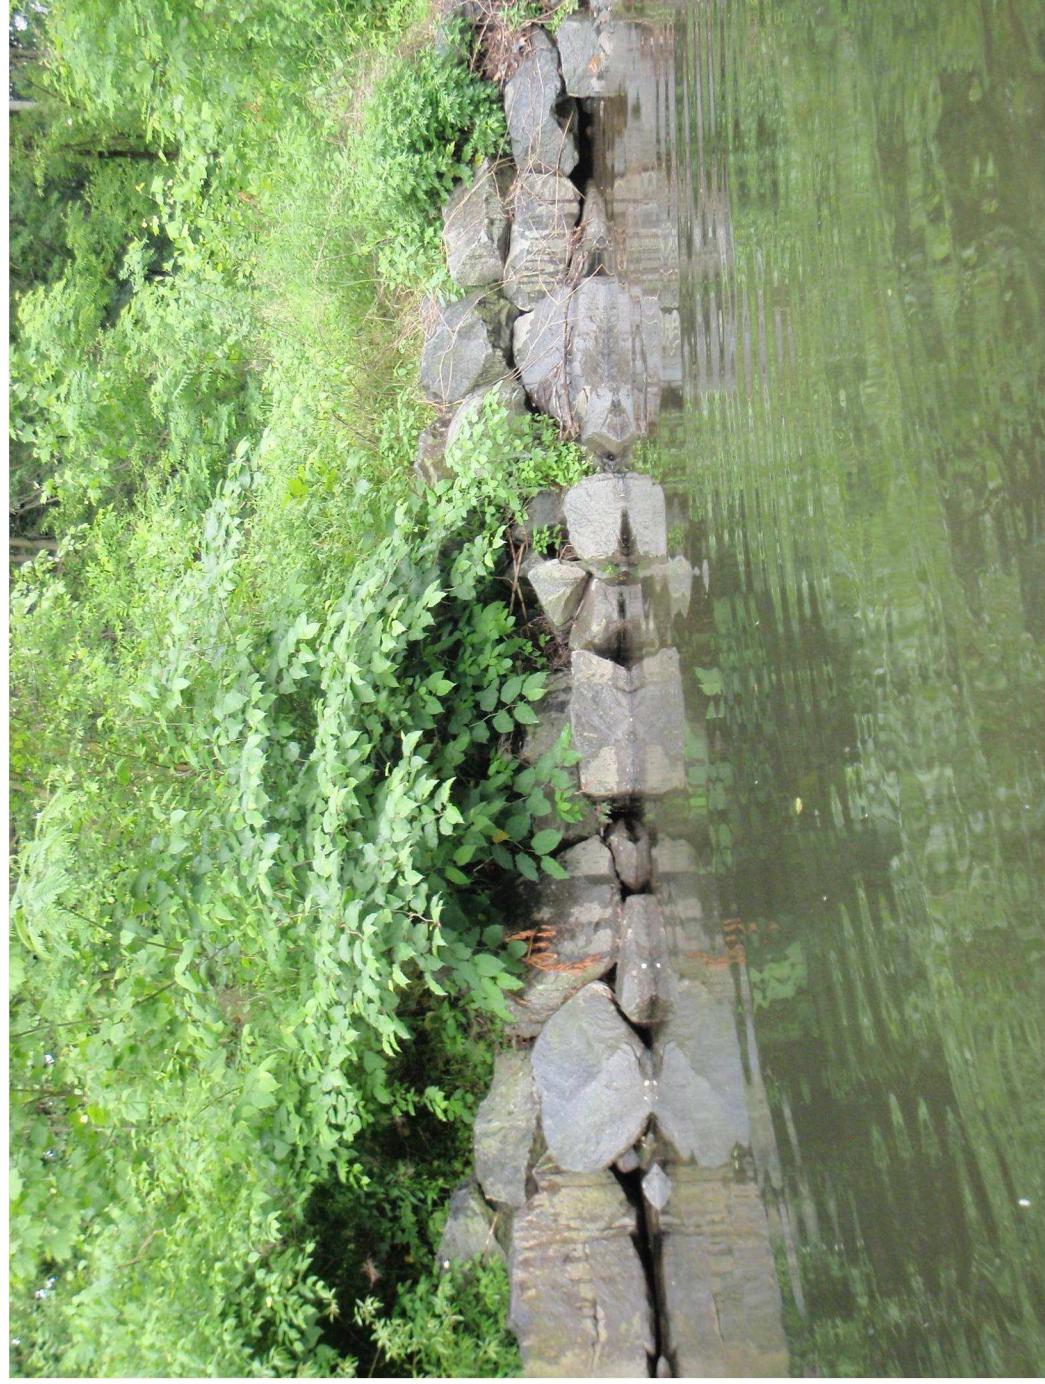
BEHI: Very Low

NBS: Low

Stream: Cobbs Creek	Location: Marshall Road
Station: 3L 3+04	Observers: EH, RH, MM
Date: 6-4-09	Stream Type: B4c Valley Type: V

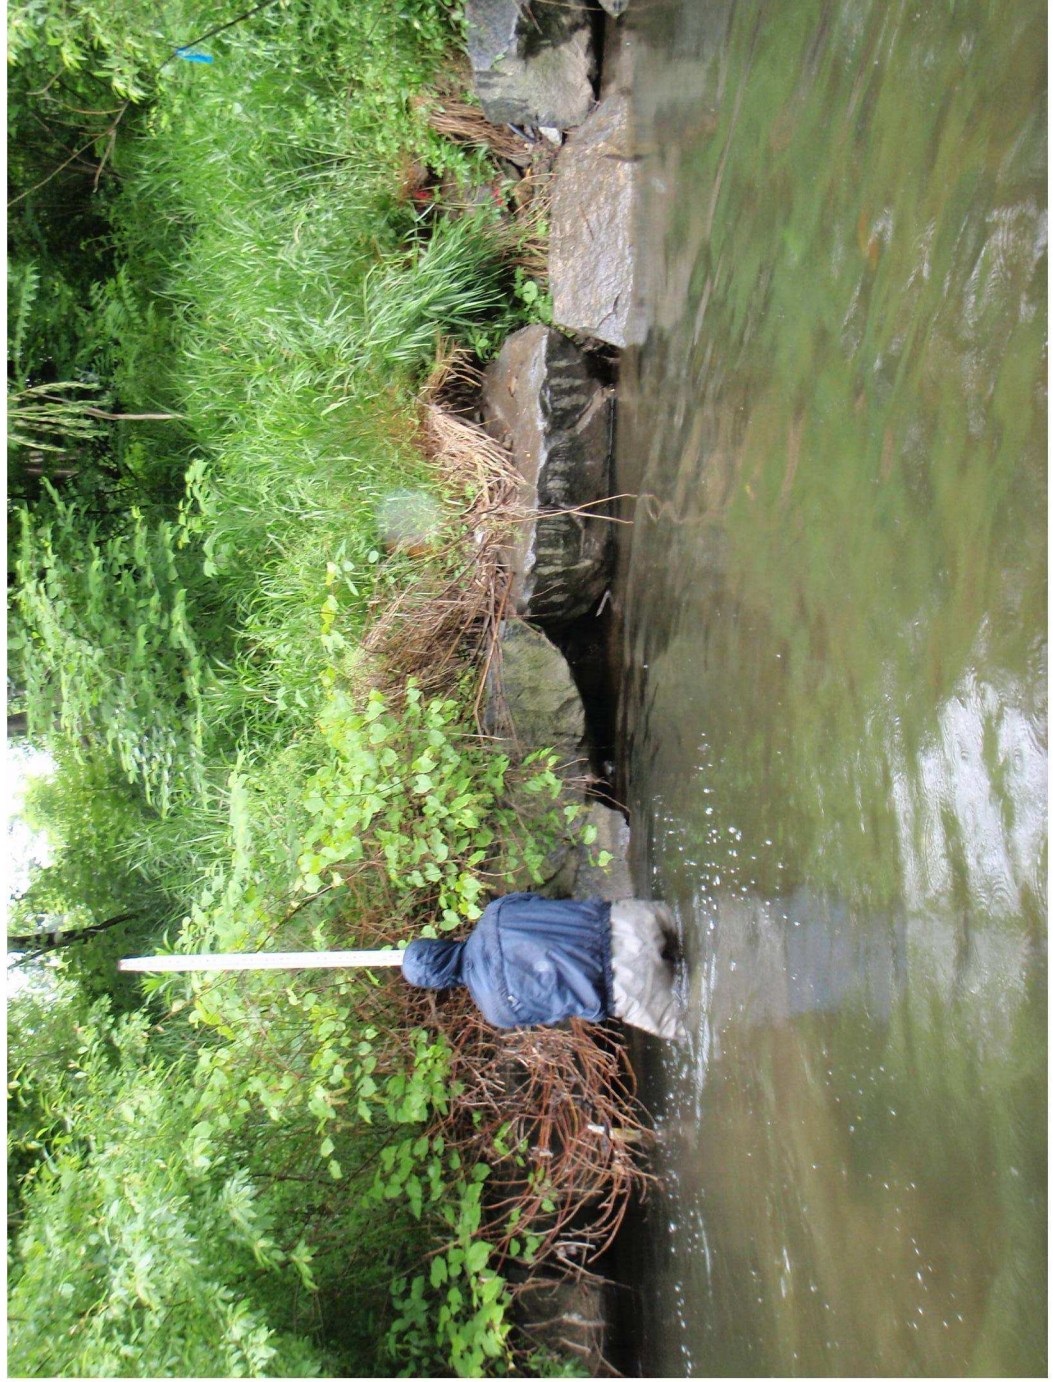
BEHI: Very Low

NBS: Low

Stream: Cobbs Creek	Location: Marshall Road
Station: 4R 5+33	Observers: EH, RH, MM
Date: 6-4-09	Stream Type: B4c Valley Type: V

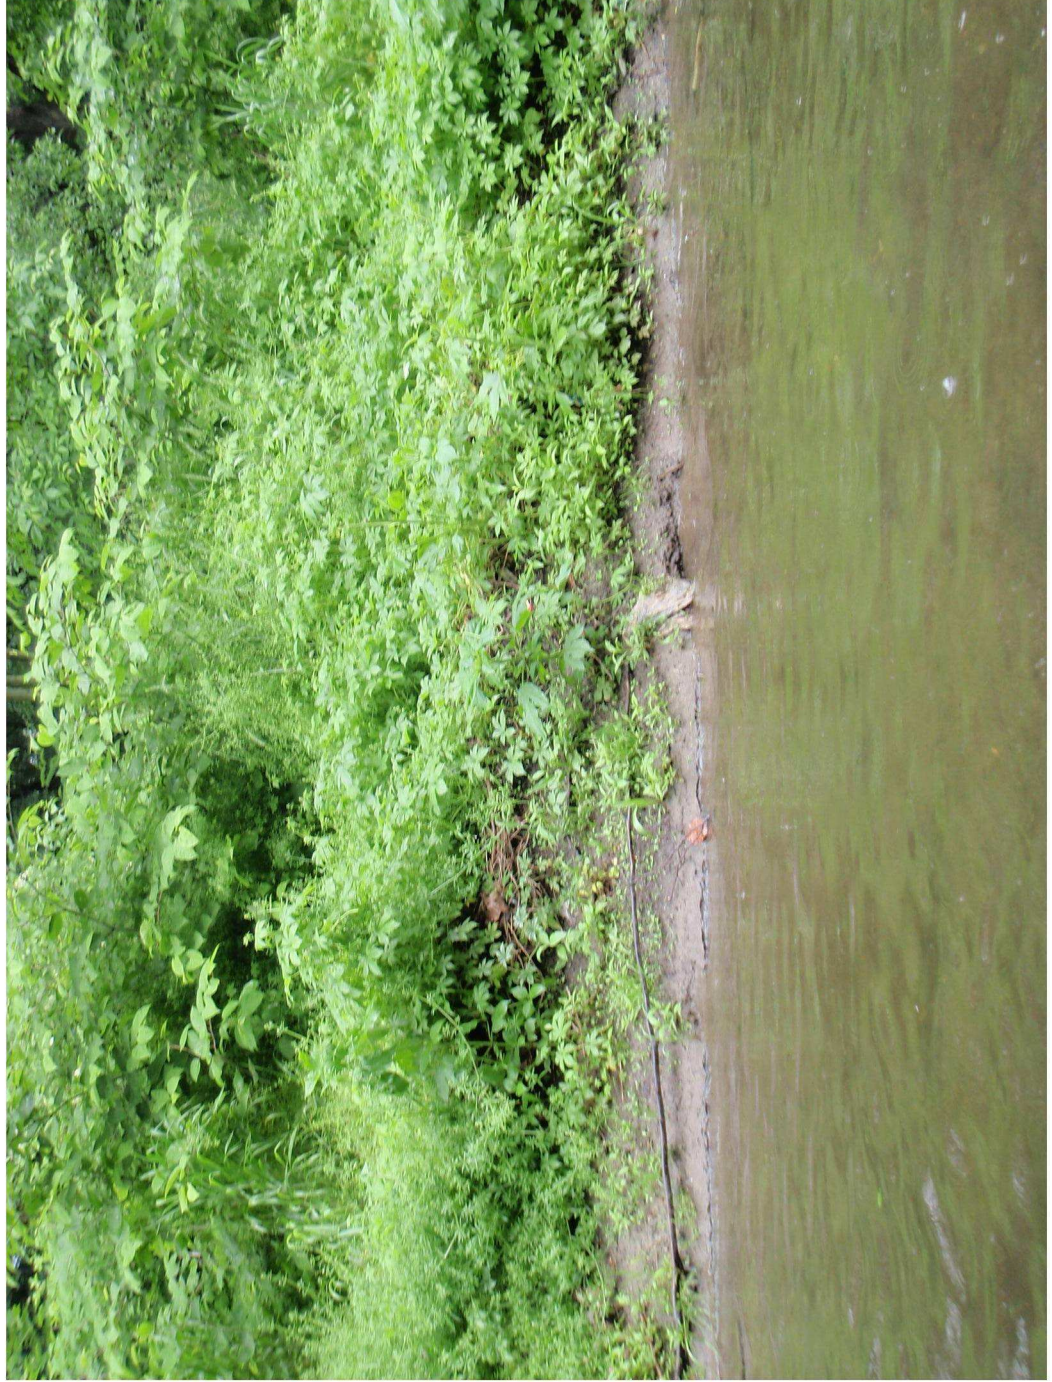
BEHI: Low

NBS: Moderate

Stream: Cobbs Creek	Location: Marshall Road
Station: 4L 5+27	Observers: EH, RH, MM
Date: 6-4-09	Stream Type: B4c Valley Type: V

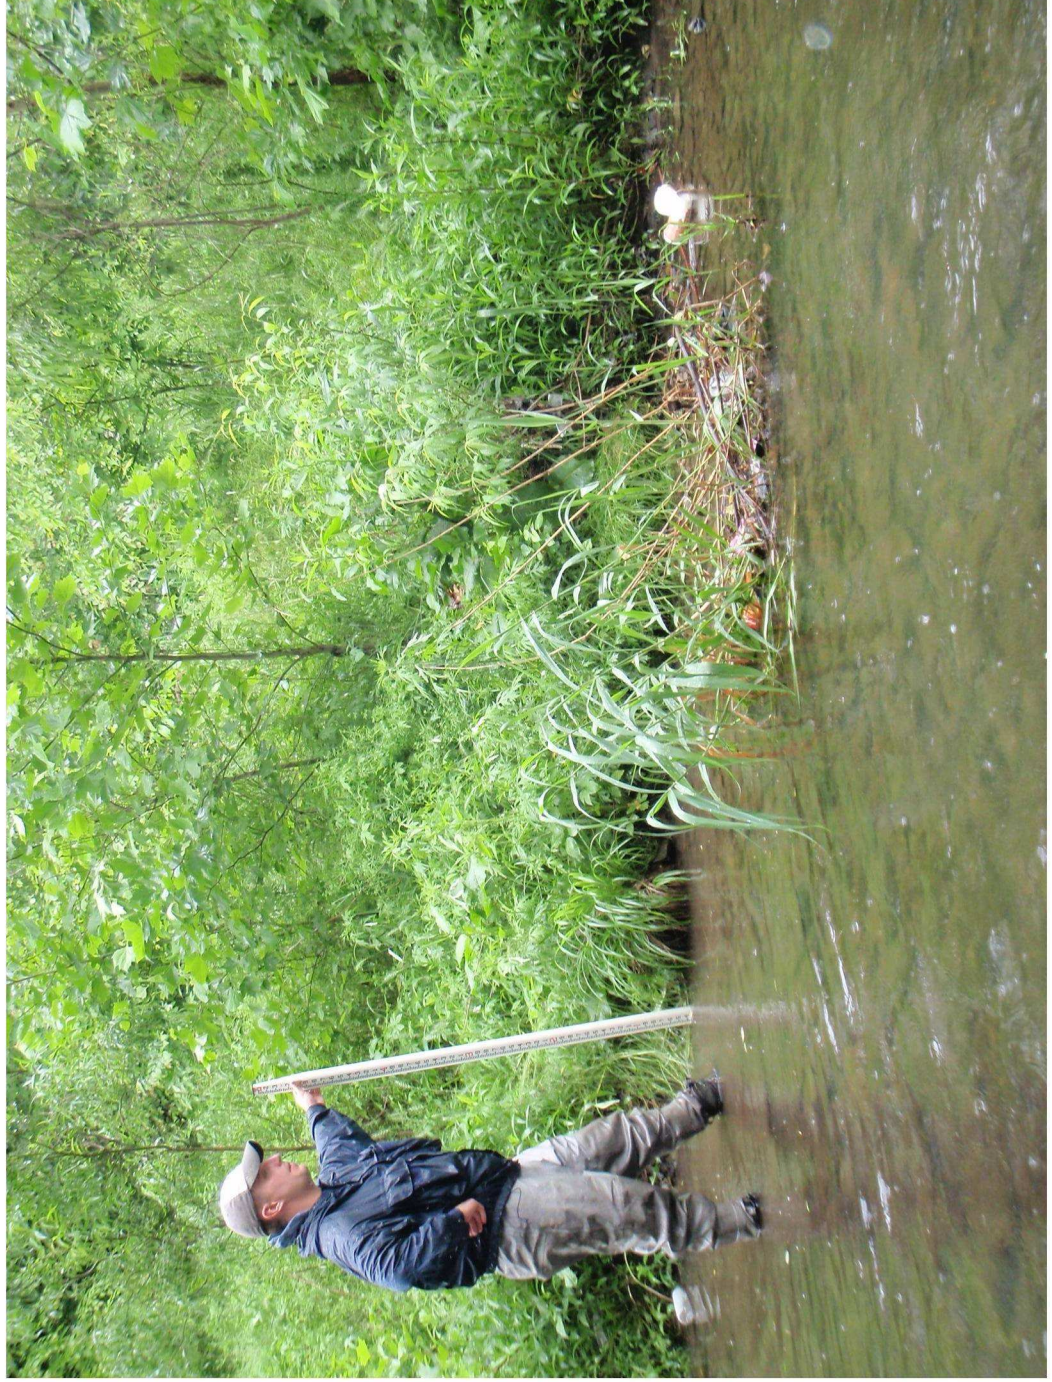
5R 7+51
June 4th, 2009

NBS: Low

Stream: Cobbs Creek	Location: Marshall Road
Station: 5R 6+91	Observers: EH, RH, MM
Date: 6-4-09	Stream Type: B4c Valley Type: V

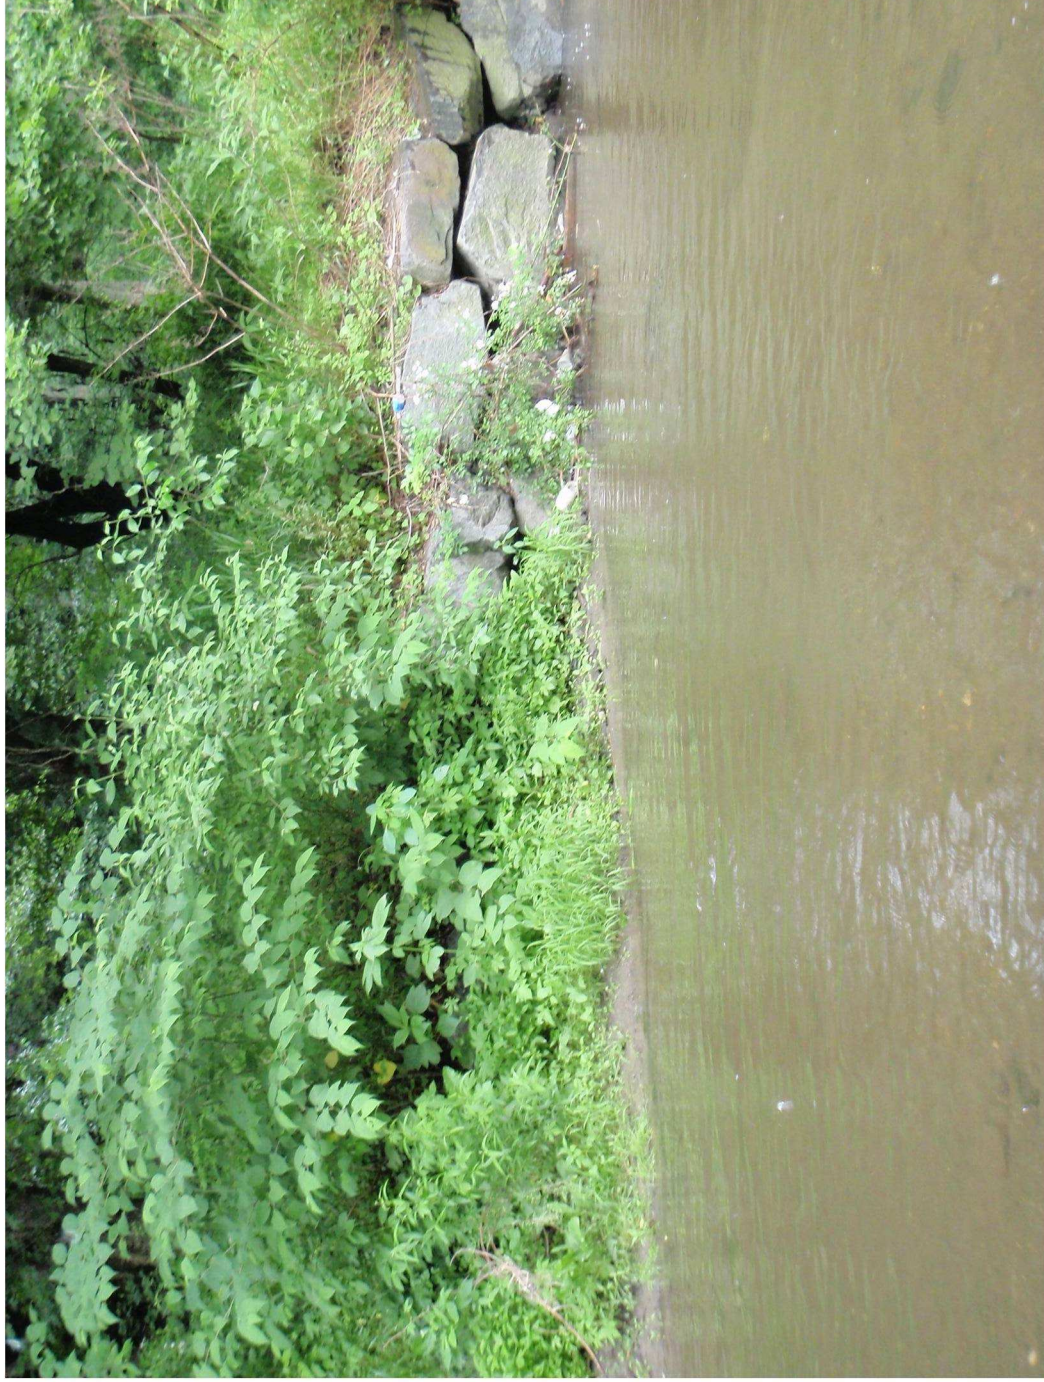
5L 7+51

Stream: Cobbs Creek	Location: Marshall Road
Station: 5L 6+99	Observers: EH, RH, MM
Date: 6-4-09	Stream Type: B4c Valley Type: V

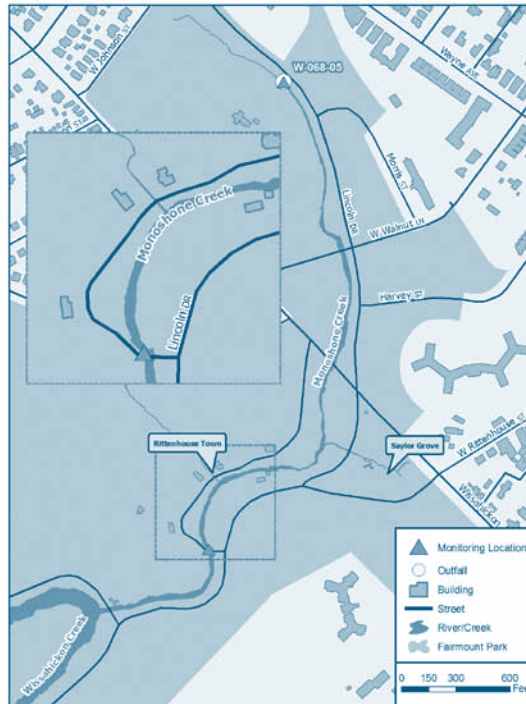
Overview of the Monoshone Watershed: This map shows the Monoshone Creek and the locations of the Water Department's stormwater outfalls along the creek. Outfall Number 5, which receives the largest volume of stormwater runoff due to the size of the drainage area, is the location where PWD takes its quarterly fecal coliform sample. At the same time, a sample will be taken just south of Historic RittenhouseTown.

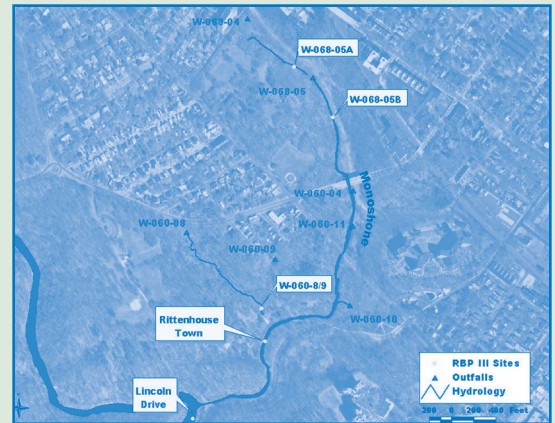
Aerial View of the Monoshone Watershed:

The above aerial photograph shows the Monoshone Creek and the locations of the Water Department's stormwater outfalls along the creek. Outfall Number 5, which receives the largest volume of stormwater runoff due to the size of the drainage area, is the location where PWD takes its quarterly fecal coliform sample.
