# **PHILADELPHIA'S WET WEATHER MANAGEMENT PROGRAMS**

## **COMBINED SEWER MANAGEMENT PROGRAM ANNUAL REPORT**

## **STORMWATER MANAGEMENT PROGRAM ANNUAL REPORT**

Reporting Period July 1<sup>st</sup> 2020 to June 30<sup>th</sup> 2021

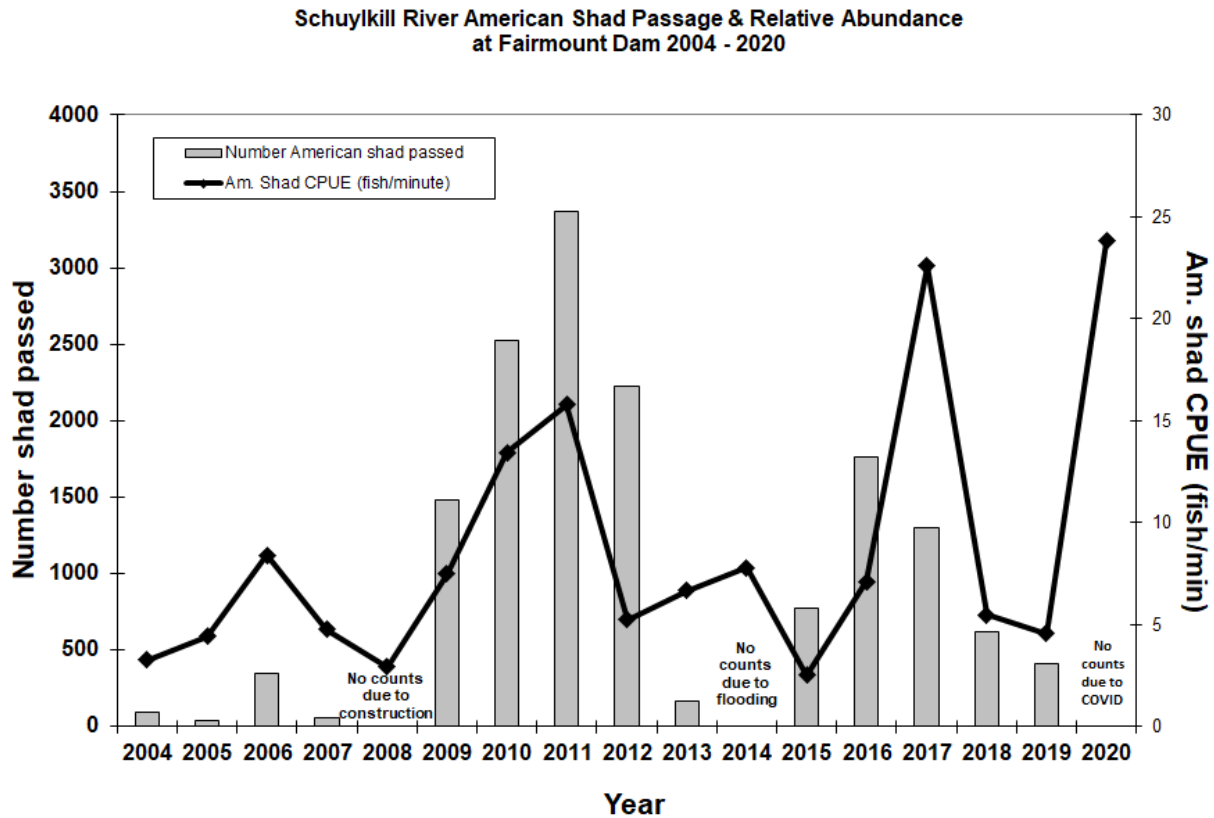
Figure III.C.2.5 -1 Catch-Per-Unit-Effort and Fish Passage of American Shad

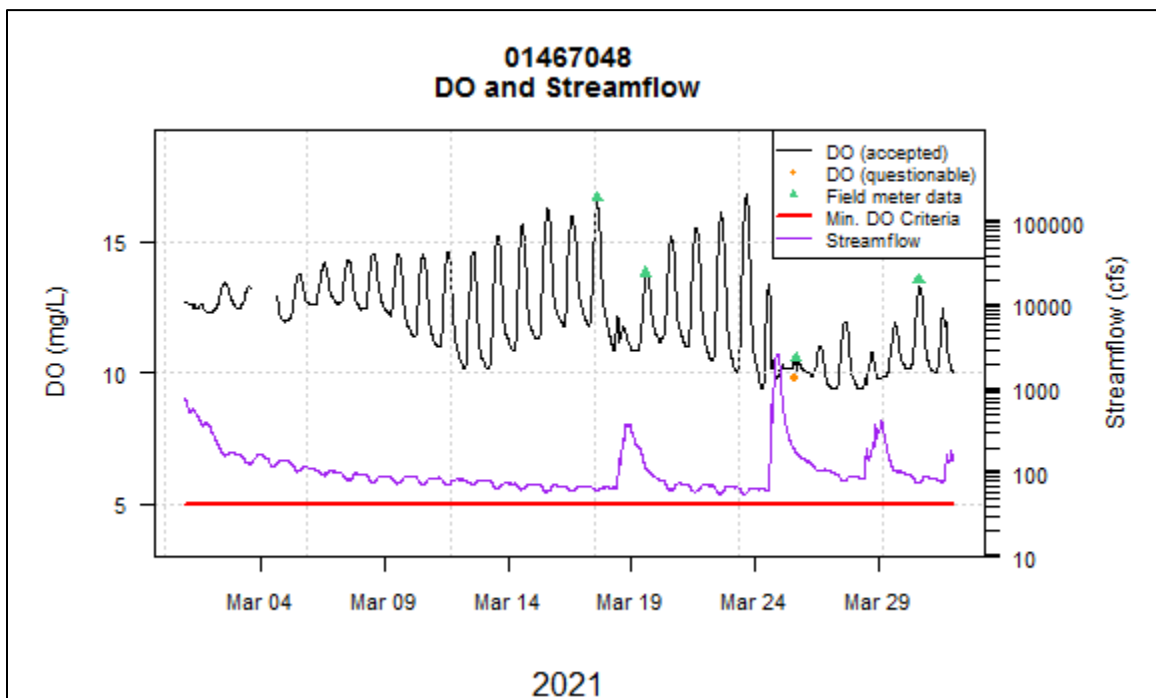
Figure 32. Gage 01467048, Dissolved Oxygen and Streamflow, March 2021.
