PHILADELPHIA'S WET WEATHER MANAGEMENT PROGRAMS

COMBINED SEWER MANAGEMENT PROGRAM ANNUAL REPORT

STORMWATER MANAGEMENT PROGRAM ANNUAL REPORT

Reporting Period July 1st 2021 to June 30th 2022

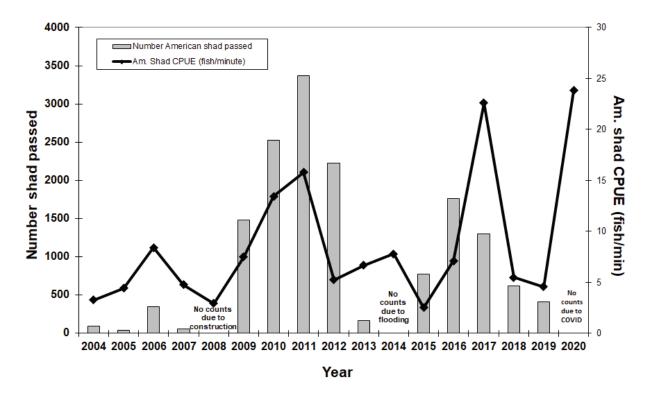
Schuylkill River American Shad Passage & Relative Abundance at Fairmount Dam 2004 - 2020

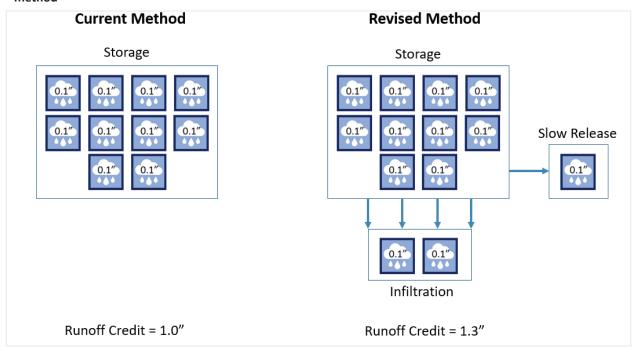
Figure 1-1: Diagram representing the accounting of runoff using the former method as compared to the revised method

The Year 10 EAP reported 2,196 GAs that were calculated using the former GA calculation method. **Appendix 4** presents the reported Year 10 EAP projects with their revised GA value as calculated using the method outlined in Section 2 and Appendix B of the Year 10 EAP. The recalculated Year 10 GA values now reflect a one-time increase of 335 in the Year 10 EAP reported GAs.

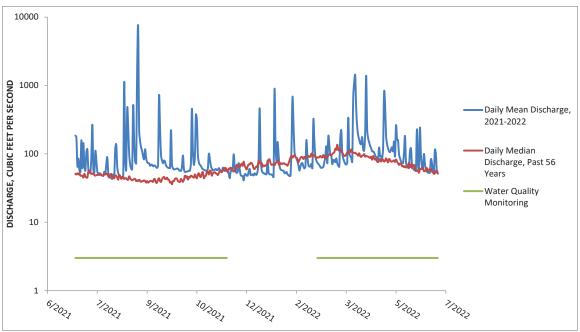
Figure 2. Daily mean flow July 1, 2021 – June 30, 2022 and daily median flow for 56 years of record at USGS gage 01474000 (Wissahickon Creek at Mouth.).

In order to summarize hydrologic conditions during the monitoring period, daily mean discharge was plotted along with the median of all daily flows for USGS gage 01474000 (Wissahickon Creek at Mouth.). The period of record for this gage is 56 years. The influence of severe storms such as Hurricane Ida in early September can be observed as peaks in streamflow in Figure 2.

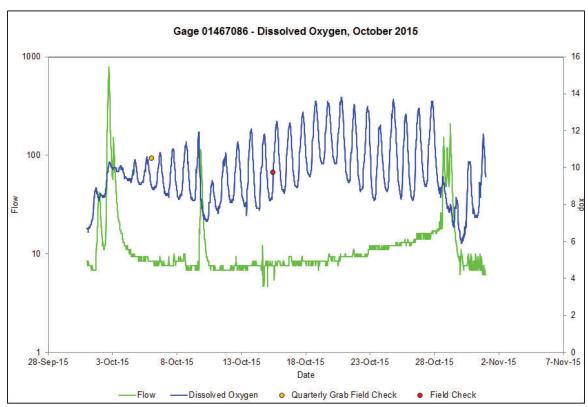
Figure 3. Example of an Excel-generated data processing/analysis plot; Gage 0146786, Dissolved Oxygen, October 2015.

OOW independently maintains databases of water quality and streamflow via automated regular retrievals of these data from USGS NWIS. On a monthly basis, the databases are queried and results for each gage are imported into MS Excel workbooks. If available, any field data collected during that period (e.g., hand meter readings from field maintenance checks, water quality grab samples, etc.) are also imported. Once all required data have been entered, separate plots are produced for each parameter (dissolved oxygen, turbidity, pH, specific conductance, and temperature) to enable a subjective review of data quality.

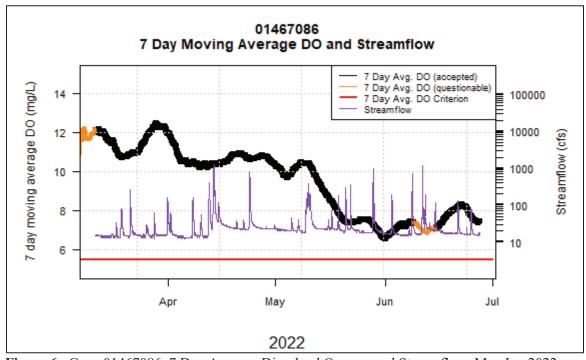
Figure 6. Gage 01467086, 7 Day Average Dissolved Oxygen and Streamflow, Mar-Jun 2022.

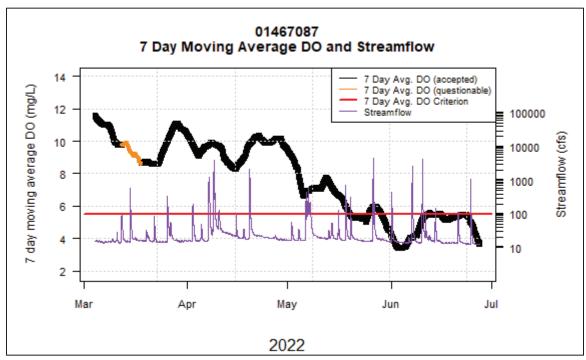
Figure 8. Gage 01467087, 7 Day Average Dissolved Oxygen and Streamflow, Mar-Jun 2022.

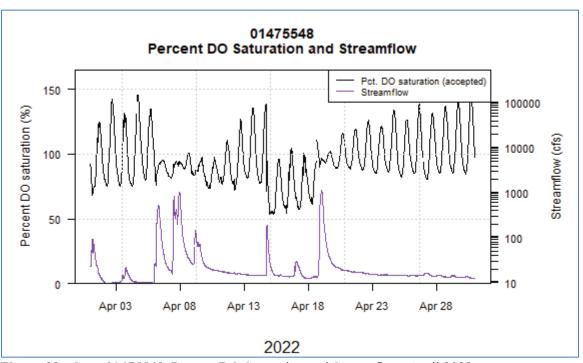
Figure 22. Gage 01475548, Percent DO Saturation and Streamflow, April 2022.

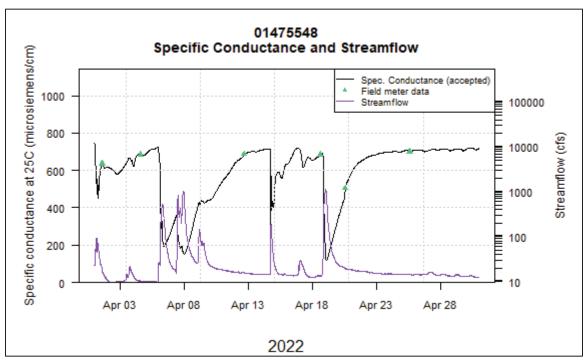
Figure 26. Gage 01475548, Specific Conductance and Streamflow, April 2022.

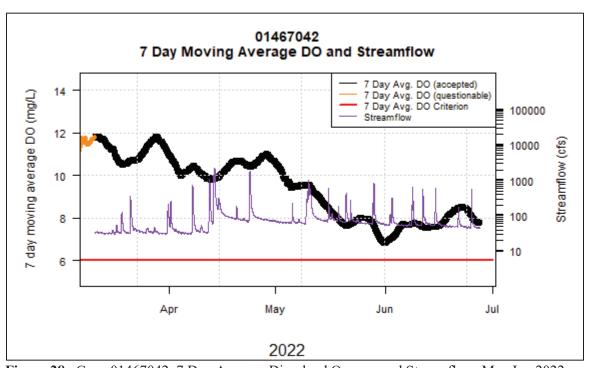
Figure 28. Gage 01467042, 7 Day Average Dissolved Oxygen and Streamflow, Mar-Jun 2022.

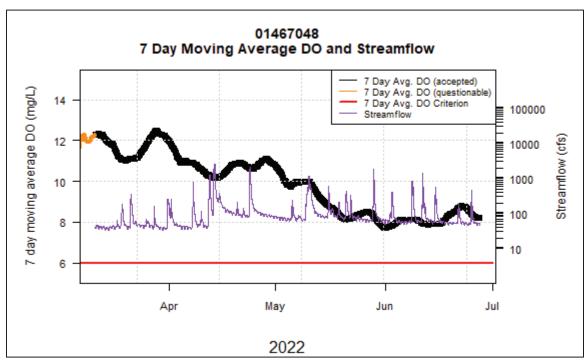
Figure 30. Gage 01467048, 7 Day Average Dissolved Oxygen and Streamflow, Mar-Jun 2022.

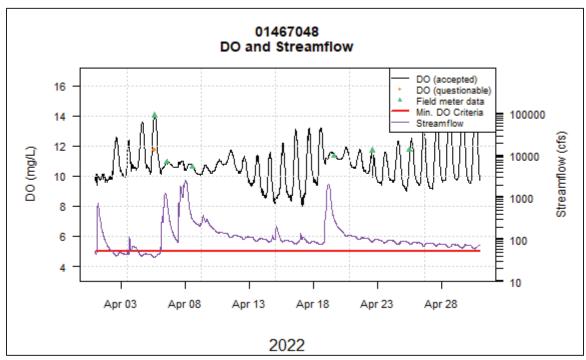
Figure 32. Gage 01467048, Dissolved Oxygen and Streamflow, April 2022.

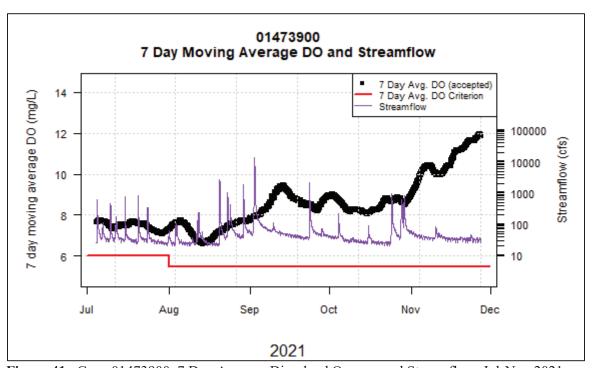
Figure 41. Gage 01473900, 7 Day Average Dissolved Oxygen and Streamflow, Jul-Nov 2021.

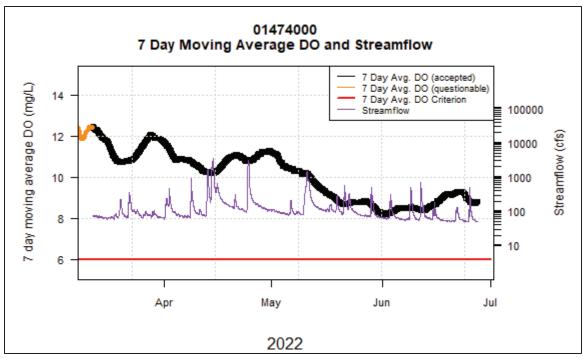
Figure 44. Gage 01474000, 7 Day Average Dissolved Oxygen and Streamflow, Mar-Jun 2022.

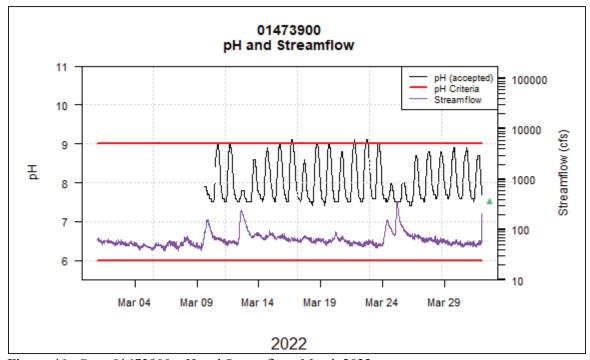
Figure 46. Gage 01473900, pH and Streamflow, March 2022.

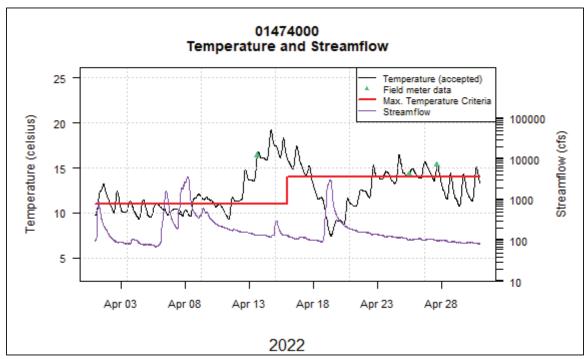
Figure 52. Gage 01474000, Temperature and Streamflow, April 2022.

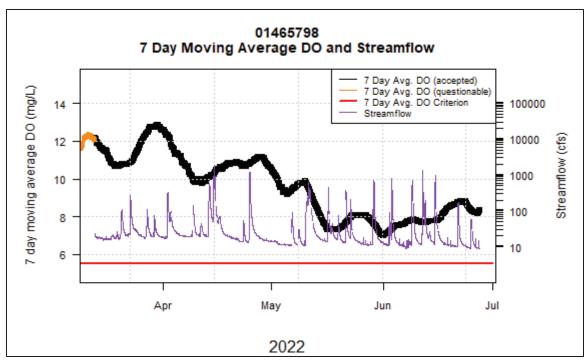
Figure 54. Gage 01465798, 7 Day Average Dissolved Oxygen and Streamflow, Mar-Jun 2022.

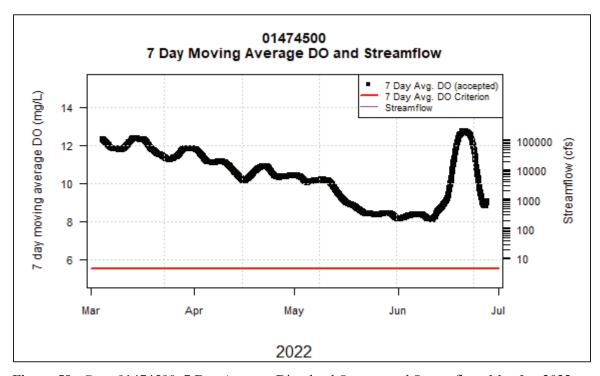
Figure 59. Gage 01474500, 7 Day Average Dissolved Oxygen and Streamflow, Mar-Jun 2022.

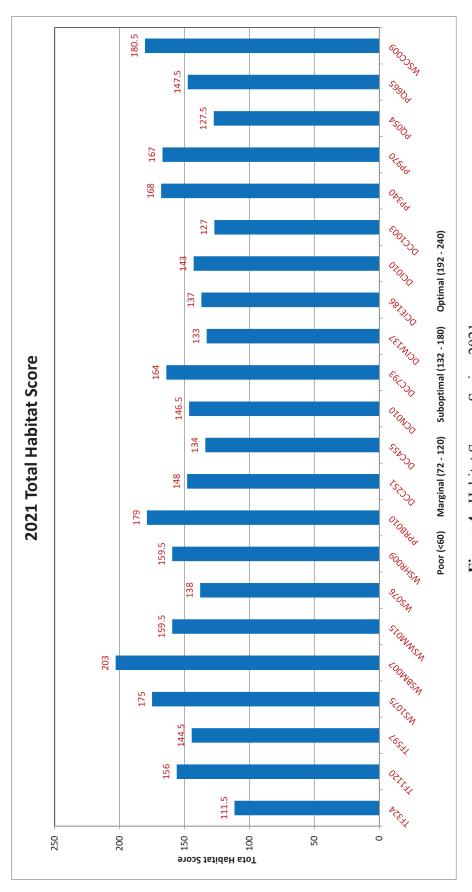
Figure 4. Habitat Scores, Spring 2021

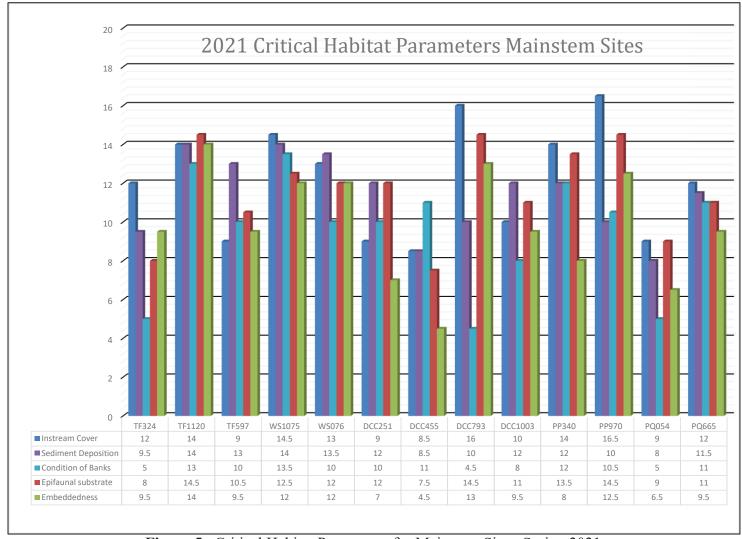
Figure 5. Critical Habitat Parameters for Mainstem Sites, Spring 2021

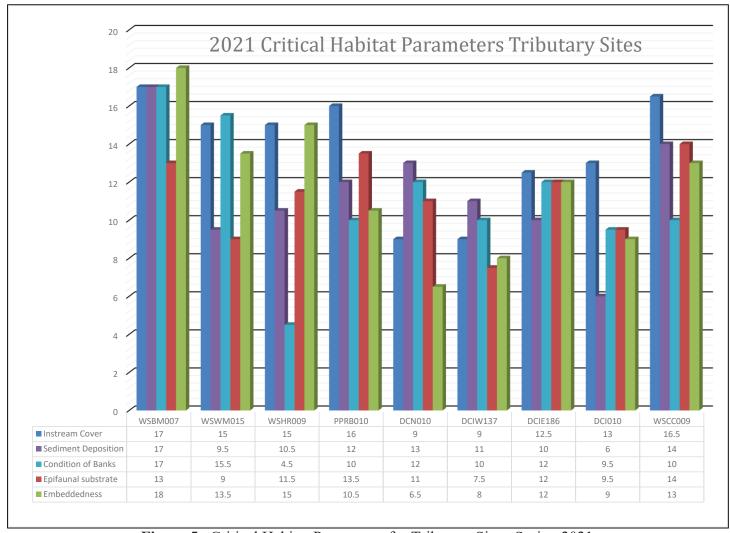
Figure 5. Critical Habitat Parameters for Tributary Sites, Spring 2021
