Tookany/Tacony-Frankford Creek Watershed
Fluvial Geomorphologic Survey

Tacony Creek, Philadelphia, PA
Fluvial Geomorphologic Survey

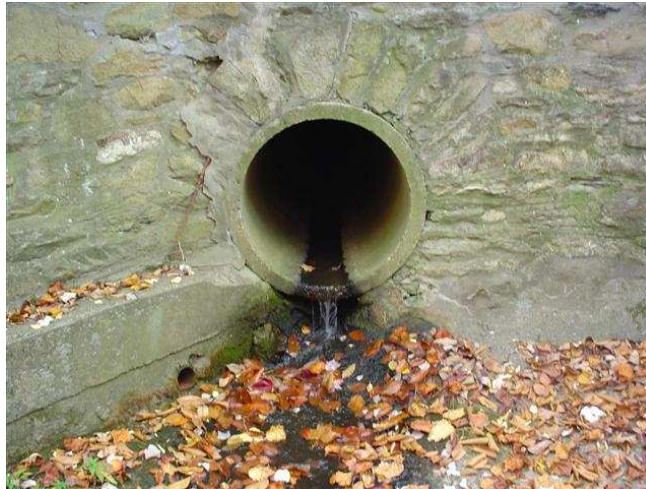
Figure 6 - Example of an outfall collected during infrastructure assessment

An outfall was defined as the end of a pipe which releases either stormwater, combined sewage, or an encapsulated creek into the waterway. Data was collected on outfalls larger than 12 inches. The data collected for each outfall included the diameter or height and width of the outfall, the construction material (metal, concrete, terra cotta, etc.), structural condition (good, fair, or poor), presence of, and quality of dry weather flow, bank location (right or left), and submergence amount.

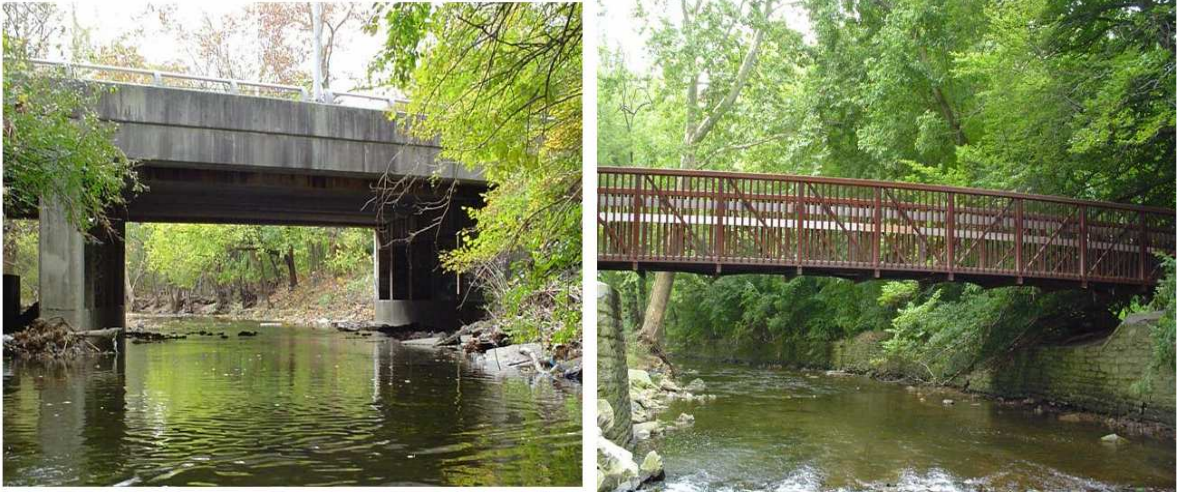
Figure 7 - Examples of bridges collected during infrastructure assessment

A bridge is a structure that spans a stream over which a road or walkway passes. The data collected for each bridge included the height, width and depth of the bridge opening, the construction material (metal, concrete, wood, stone, etc.), and structural condition (good, fair, or poor).

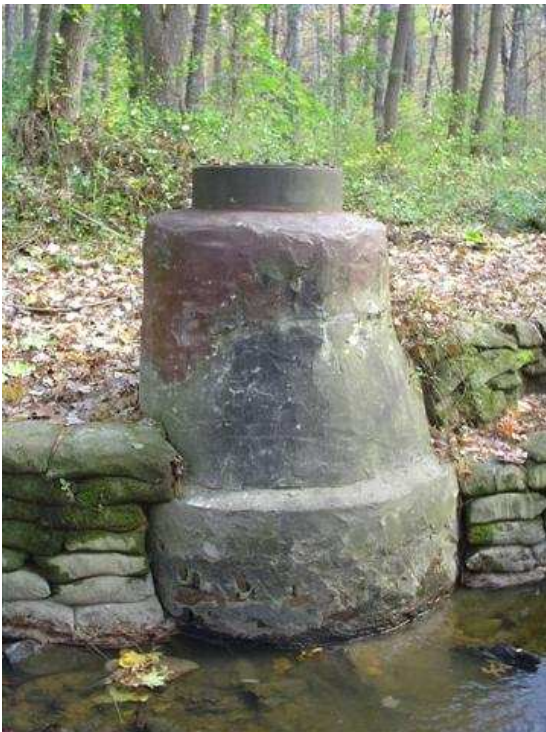
Figure 8 - Example of a manhole collected during infrastructure assessment

A manhole is the covered opening that allows access to a sewer. Data was collected for manholes either located within the creek or close proximity to the creek within the banks. The data collected for each manhole included the diameter of the manhole, the construction material (concrete or terra cotta), the height of the portion of manhole exposed above the ground or water surface, structural condition (good, fair, or poor), bank location (left or right), presence and description of odor, and submergence amount.

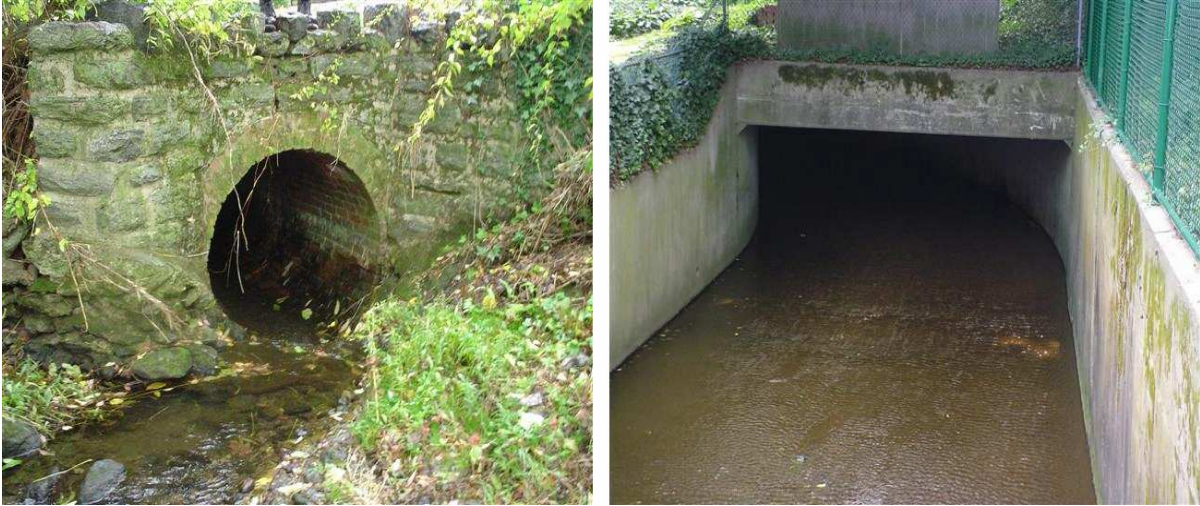
Figure 9 - Examples of culverts collected during infrastructure assessment

A culvert is a conduit which carries the stream under a roadway, sidewalk, building, or miscellaneous structure. The data collected for each culvert included the physical dimensions, construction material (stone, concrete, brick, etc.), structural condition (good, fair, or poor), presence and quality of dry weather flow, and bank location (left or right).

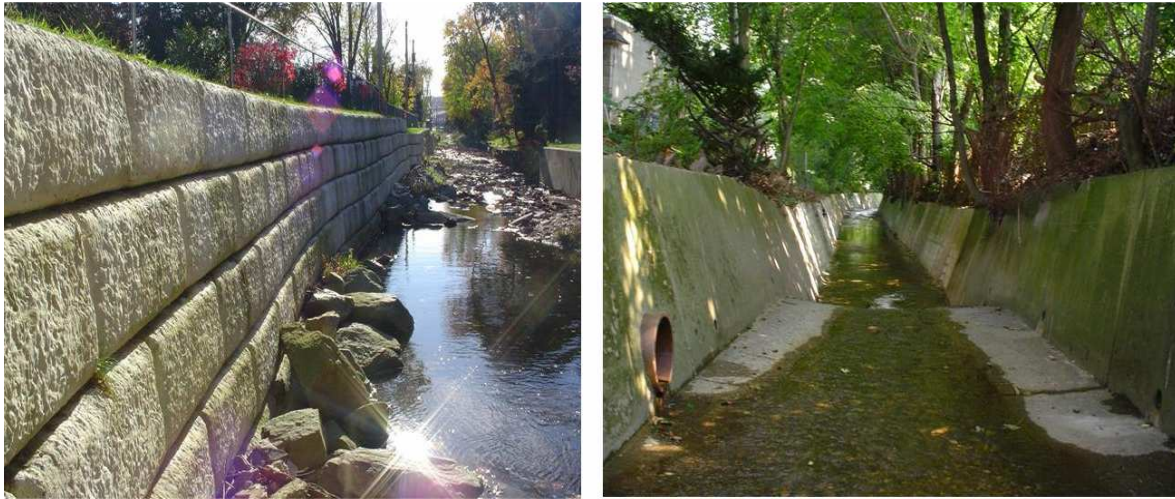
Figure 11 - Examples of channels collected during infrastructure assessment

A channel is a straightening and reinforcement of stream bed and/or banks with manmade materials such as concrete. Channels can be on one or both banks, as well as on the bottom of the stream bed. The data collected for each channel included physical dimensions, structural condition (good, fair, or poor), the portion of stream that was channelized (left bank, right bank or bottom), and construction material (stone or concrete).

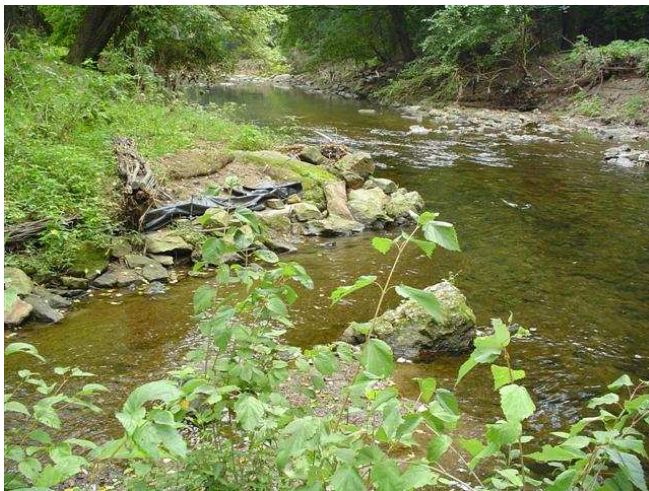
Figure 12 - Example of a confluence collected during infrastructure assessment

A confluence is the junction where two streams meet. The data collected for each Confluence included the larger stem bank location looking downstream (left or right) and width of the stream entering the larger stem.

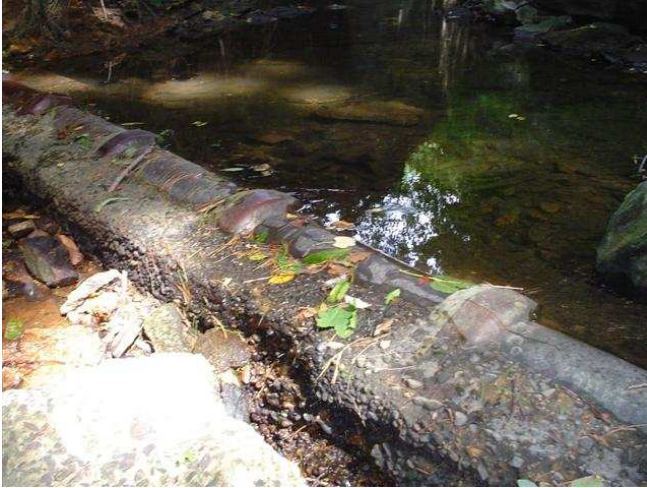
Figure 13 - Example of a pipe collected during infrastructure assessment

A pipe was defined as a conduit for carrying water or sewage. The data collected for each pipe included the diameter, construction material (concrete, metal, terra cotta, etc.), the length and height above the water or ground surface of the exposed portion, structural condition (good, fair, or poor), presence and quality of dry weather flow, bank location (left, right or across the creek), and submergence amount.

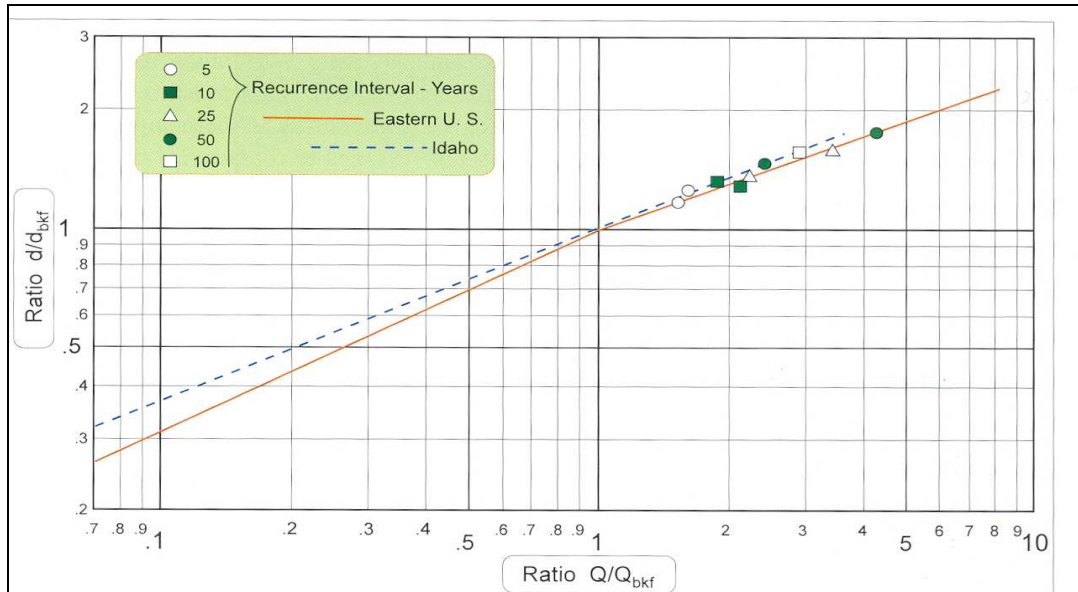
Figure 16- Dimensionless rating curve for two regions, eastern US & Idaho

To address the disagreement between Q_{FP} and the $Q/A_{Drainage}$ rating curve, further consultation of Rosgen revealed that the use of an alternate dimensionless variable would provide a viable solution. Dunne and Leopold established that the two dimensionless ratios, D/D_{BF} and Q/Q_{BF} , are related as illustrated in **Figure 16**. Therefore, rather than choosing D/D_{BF} as the ratio upon which the flood-prone area is based, Q/Q_{BF} can be utilized instead. The use of Q , rather than D , allows for the flow balance to hold and remain consistent with Rosgen considering that $Depth = f(Q, \text{channel geometry})$.

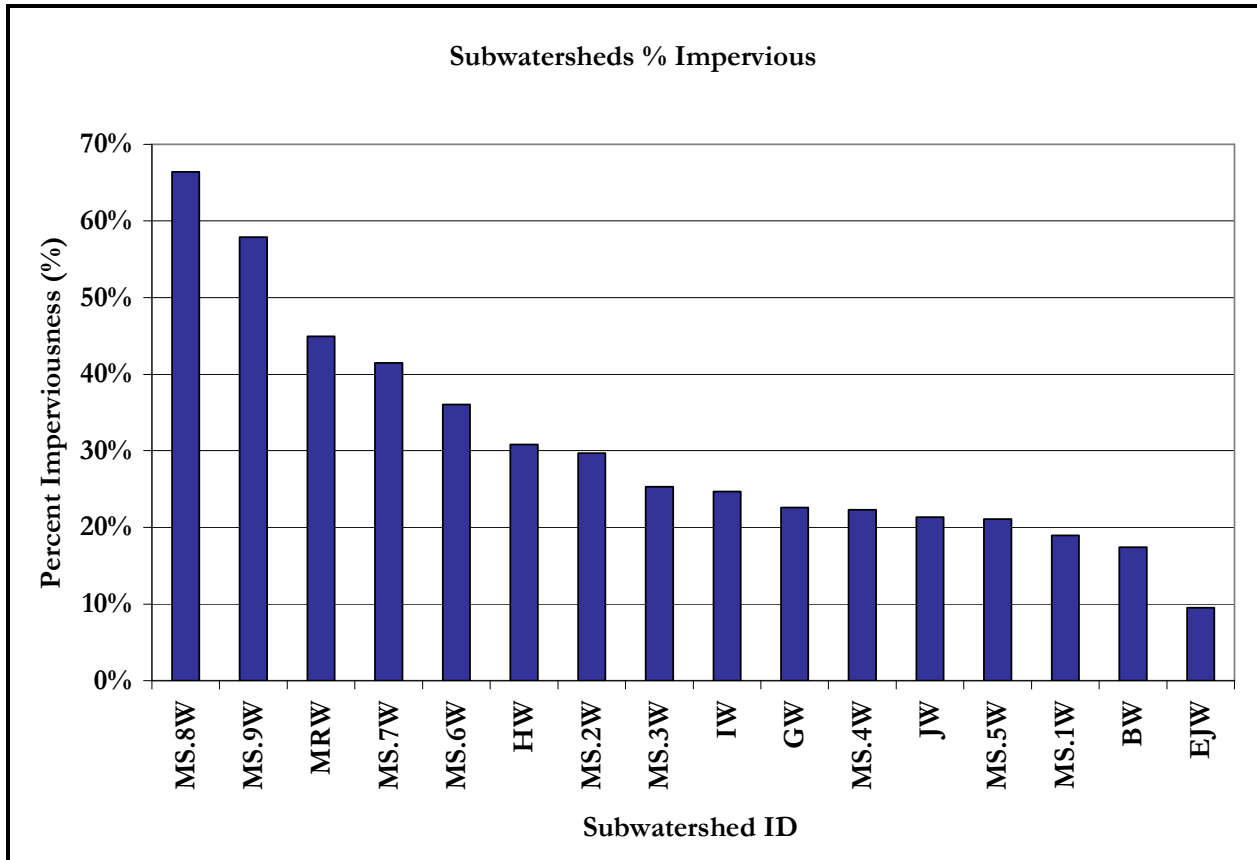
Figure 19– Subwatershed % Imperviousness

As expected, the more urbanized areas within the City of Philadelphia which contribute to the Tookany/Tacony-Frankford Creek had the greatest relative amount of impervious surfaces (**Figure 19**). MS.7, MS.8, and MS.9 are subwatersheds that are almost entirely within the City limits, with MS.6 including areas both inside and outside the City limits. The sub-watersheds within the City of Philadelphia contrasted with the sub-watersheds in the surrounding suburbs, as percent imperviousness values inside the City were generally much greater than in the suburbs.
