# WISSAHICKON CREEK STREAM ASSESSMENT STUDY LOWER WISSAHICKON WATERSHED

Philadelphia Water Department Office of Watersheds 2010

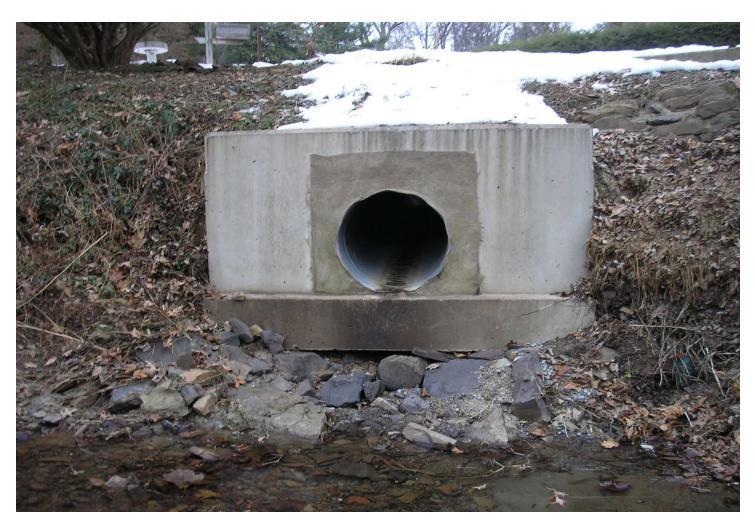
Figure 2-9: Example of an outfall point assessed in infrastructure trackdown

An outfall was defined as the end of a pipe which releases either stormwater, combined sewage, or an encapsulated creek into the waterway (Figure 2-9). Data was collected on outfalls larger than 12 inches. The data collected for each outfall included the pipe diameter, height and width of the outfall including the presence of an apron, the construction material (i.e. metal, concrete, terra cotta, etc.), structural condition (i.e. good, fair, or poor), presence of, and quality of dry weather flow, bank location (right or left), and submergence depth.

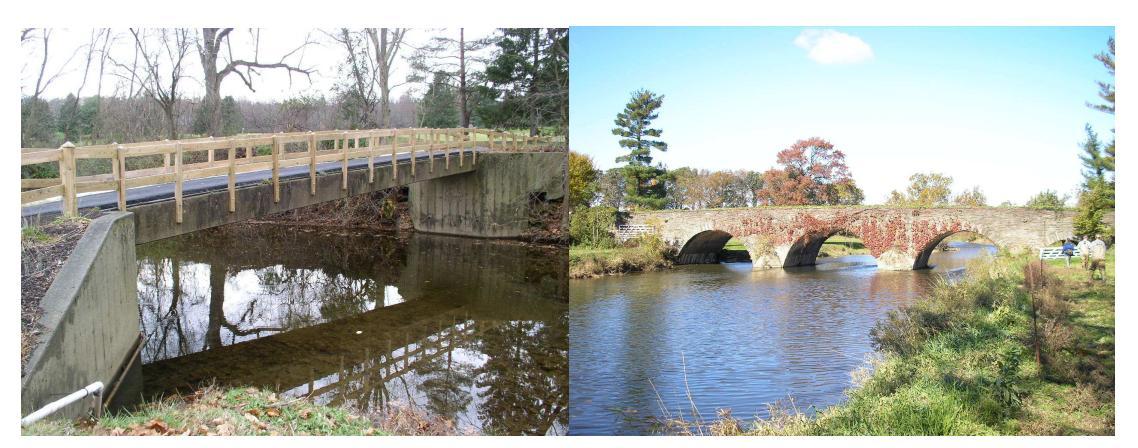
Figure 2-10: Examples of bridges assessed in infrastructure trackdown

A bridge was defined as a structure that spanned a stream over which a road or walkway passes (Figure 2-10). Bridges mapped in this report are shown as one point at the center of the bridge along the creek. The data collected for each bridge included the approximate height, width and depth of the bridge opening, the construction material (i.e. metal, concrete, wood, stone, etc.), and structural condition (i.e. good, fair, or poor).

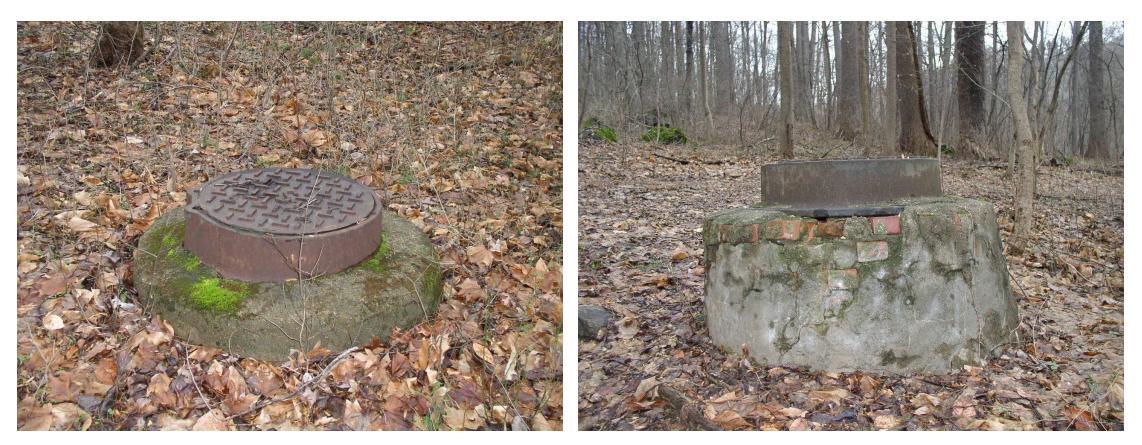
Figure 2-11: Examples of manholes assessed in infrastructure trackdown.

A manhole was defined as the covered opening that allows access to an existing utility (Figure 2-11). Data was collected for manholes either located within the creek or in close proximity to the stream banks. The data collected for each manhole included the approximate diameter of the manhole, the construction material (i.e. concrete or terra cotta), the height of the portion of manhole exposed above the ground or water surface, structural condition (good, fair, or poor), bank location (left or right) and the presence and description of any odor.

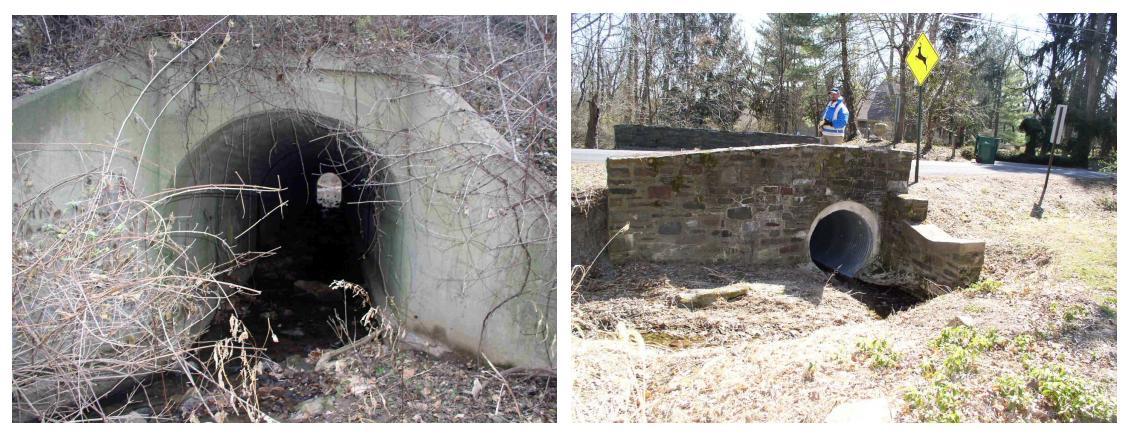
Figure 2-12: Examples of culverts assessed in infrastructure trackdown.

A culvert was defined as a conduit which carried the stream under a roadway, sidewalk, building, or miscellaneous structure (Figure 2-12). Culverts were mapped by taking GPS coordinates at the start and end of the culvert with photos taken at each point. The data collected for each culvert included the approximate dimensions, construction material (e.g. stone, concrete, brick, etc.), structural condition (i.e. good, fair, or poor), presence and quality of dry weather flow, and bank location (left or right).

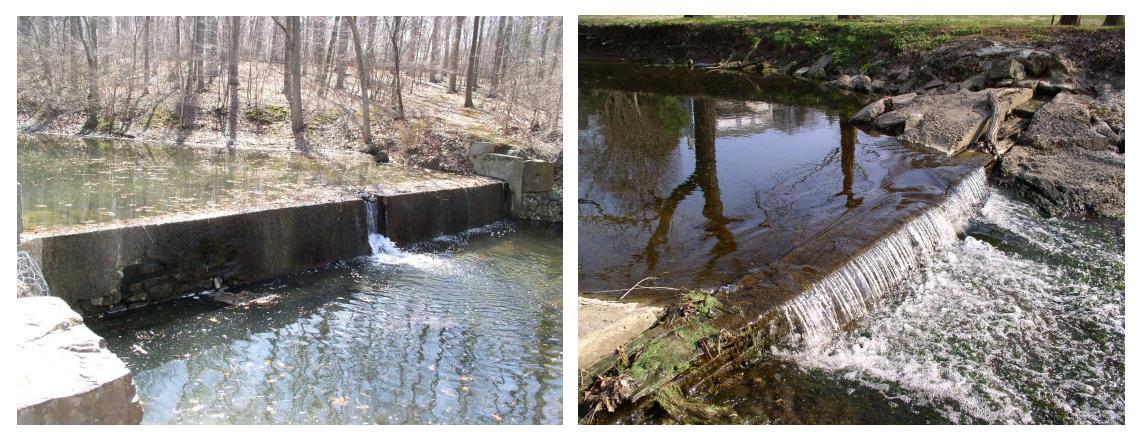
Figure 2-13: Examples of dams assessed in infrastructure trackdown.

A dam was defined as an obstruction that impounded stream flow (Figure 2-13). Data was only collected for manmade dams and did not include natural debris jams caused by coarse woody debris (CWD). The data collected for each dam included the approximate dimensions, construction material, structural condition (good, fair, or poor) and bank location (left, right, or across the creek).

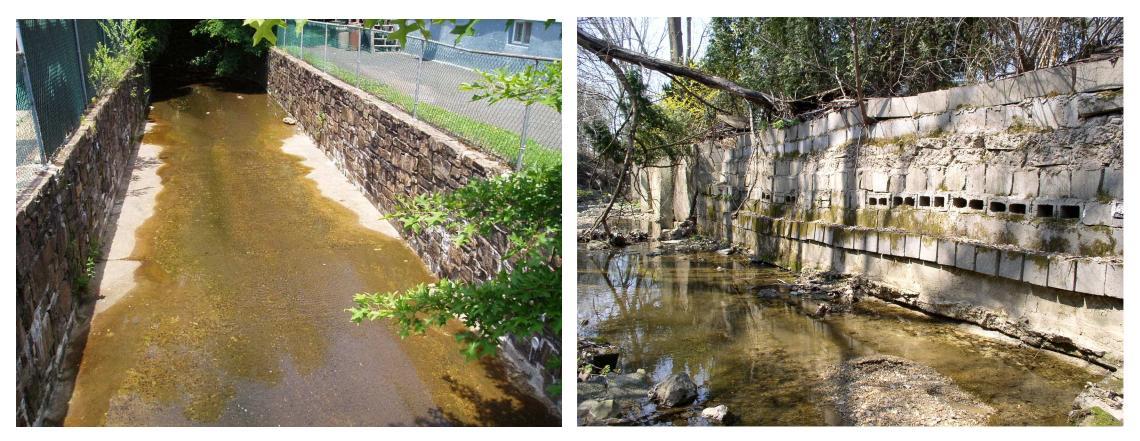
Figure 2-14: Examples of channels assessed in infrastructure trackdown.

A channel was defined as a straightening and reinforcement of stream bed and/or banks with manmade materials such as concrete (Figure 2-14). Channels were located on one or both banks, as well as on the bottom of the stream bed. Each channel was mapped by taking GPS coordinates at the start and end of the channel with photos taken at each point. The data collected for each channel included approximate dimensions, structural condition (good, fair, or poor), the portion of stream that was channelized (i.e. left bank, right bank or bottom), and construction material (stone or concrete).

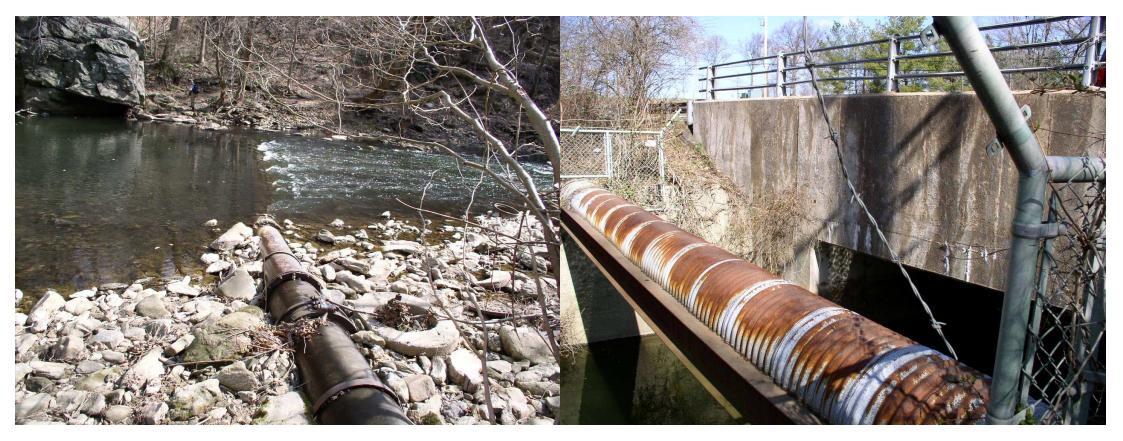
Figure 2-16: Example of a pipe assessed in infrastructure trackdown.

A pipe was defined as a conduit for carrying a utility across the stream (Figure 2-16). The data collected for each pipe included the approximate diameter, construction material (i.e. concrete, metal, terra cotta, etc.), the length and height above the water or ground surface of the exposed portion, structural condition (i.e. good, fair, or poor), presence and quality of dry weather flow, bank location (i.e. left, right or across the creek), and submergence depth.

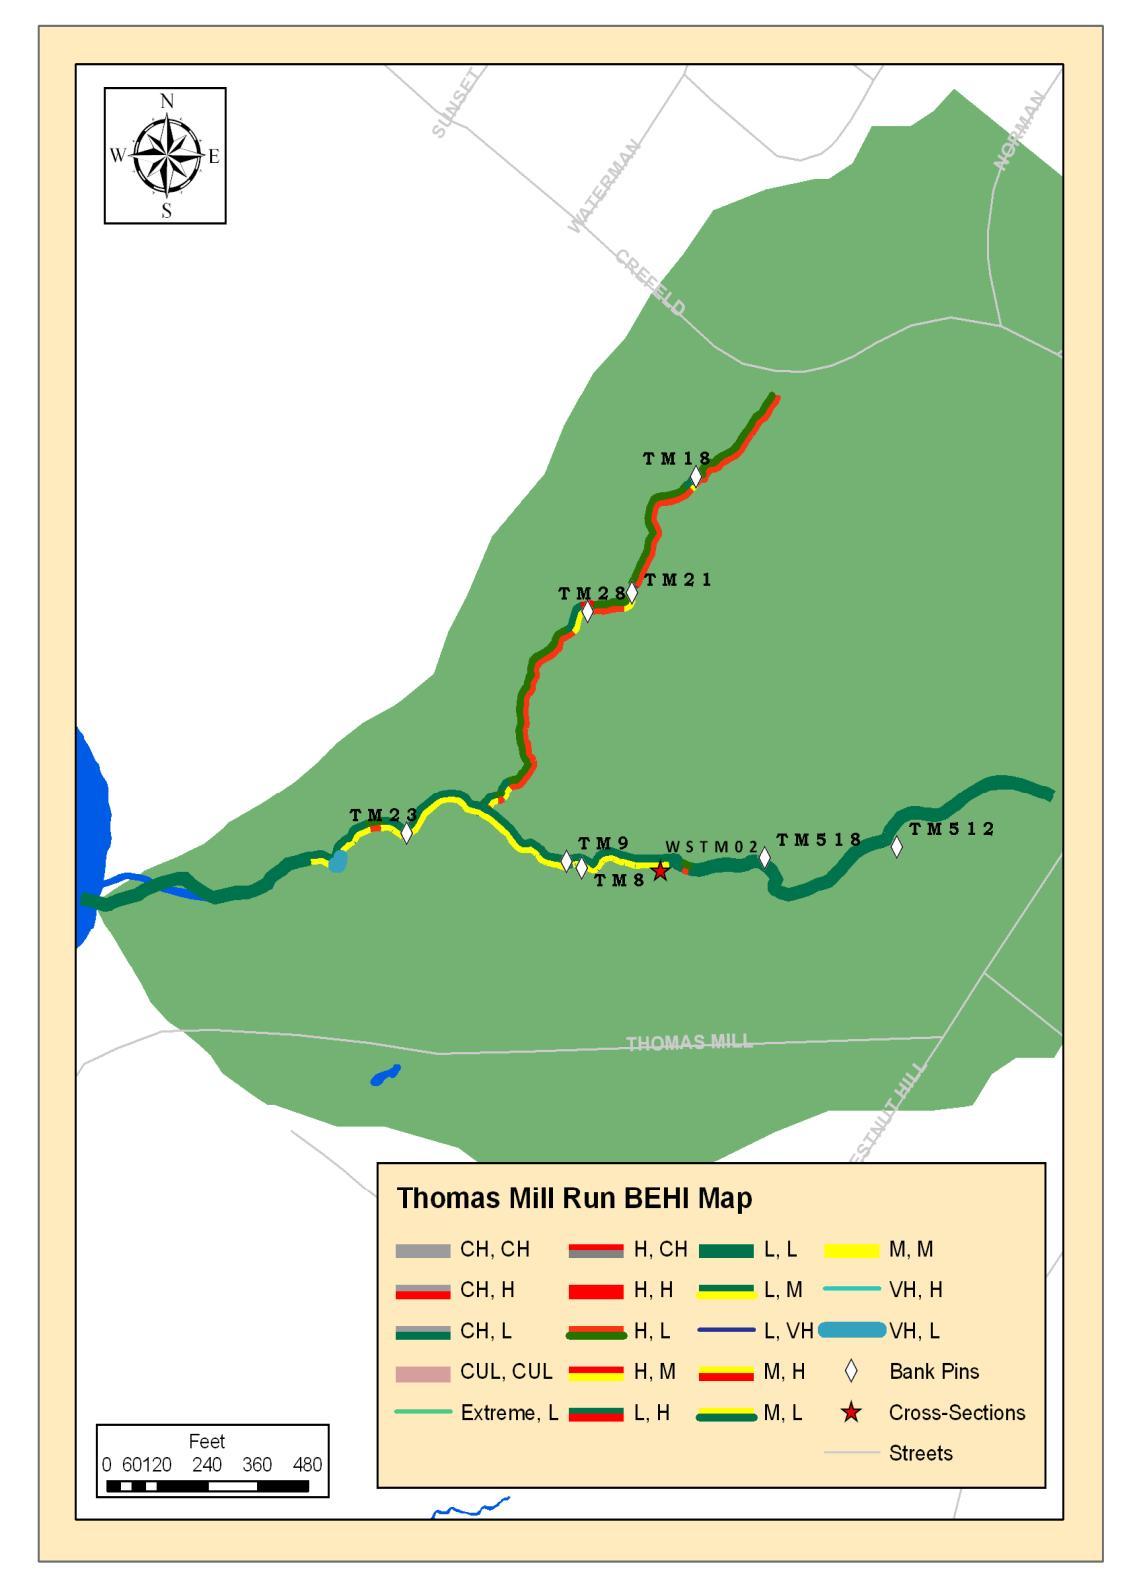
Figure 3-4: Thomas Mill Run Watershed BEHI Ratings and Bank Pin Locations

There were nine bank pin locations along Thomas Mill Run (Figure 3-4). The calculated erosion rates are included in Table 3-2. The spatial distribution of BEHI assessment results were represented graphically (Figure 3-4) for each of the segments assessed on Thomas Mill Run. Each bank within a respective segment was assessed and rated separately; however, channelized and culverted segments were not assessed as they confer a high degree of protection from bank erosion.

Bank erosion was observed to be most prevalent in the small tributary to Thomas Mill Run on which the entire DSL bank had high rates of erosion (Figure 3-4) - the main channel however, was observed to have limited erosion. The scores for both the left and the right banks were rated as "marginal" although both banks compared favorably to the Small Tributary averages which were also rated as "marginal." The erosion observed on the unnamed tributary to Thomas Mill Run was significant in that Thomas Mill Run was ranked among the most-erosion prone tributaries in the Lower Wissahickon. The erosion rate (normalized to stream length) was the second highest in the Lower Wissahickon at (79 lb/ft) after Gorgas Run where an erosion rate of (81 lb/ft) was estimated.

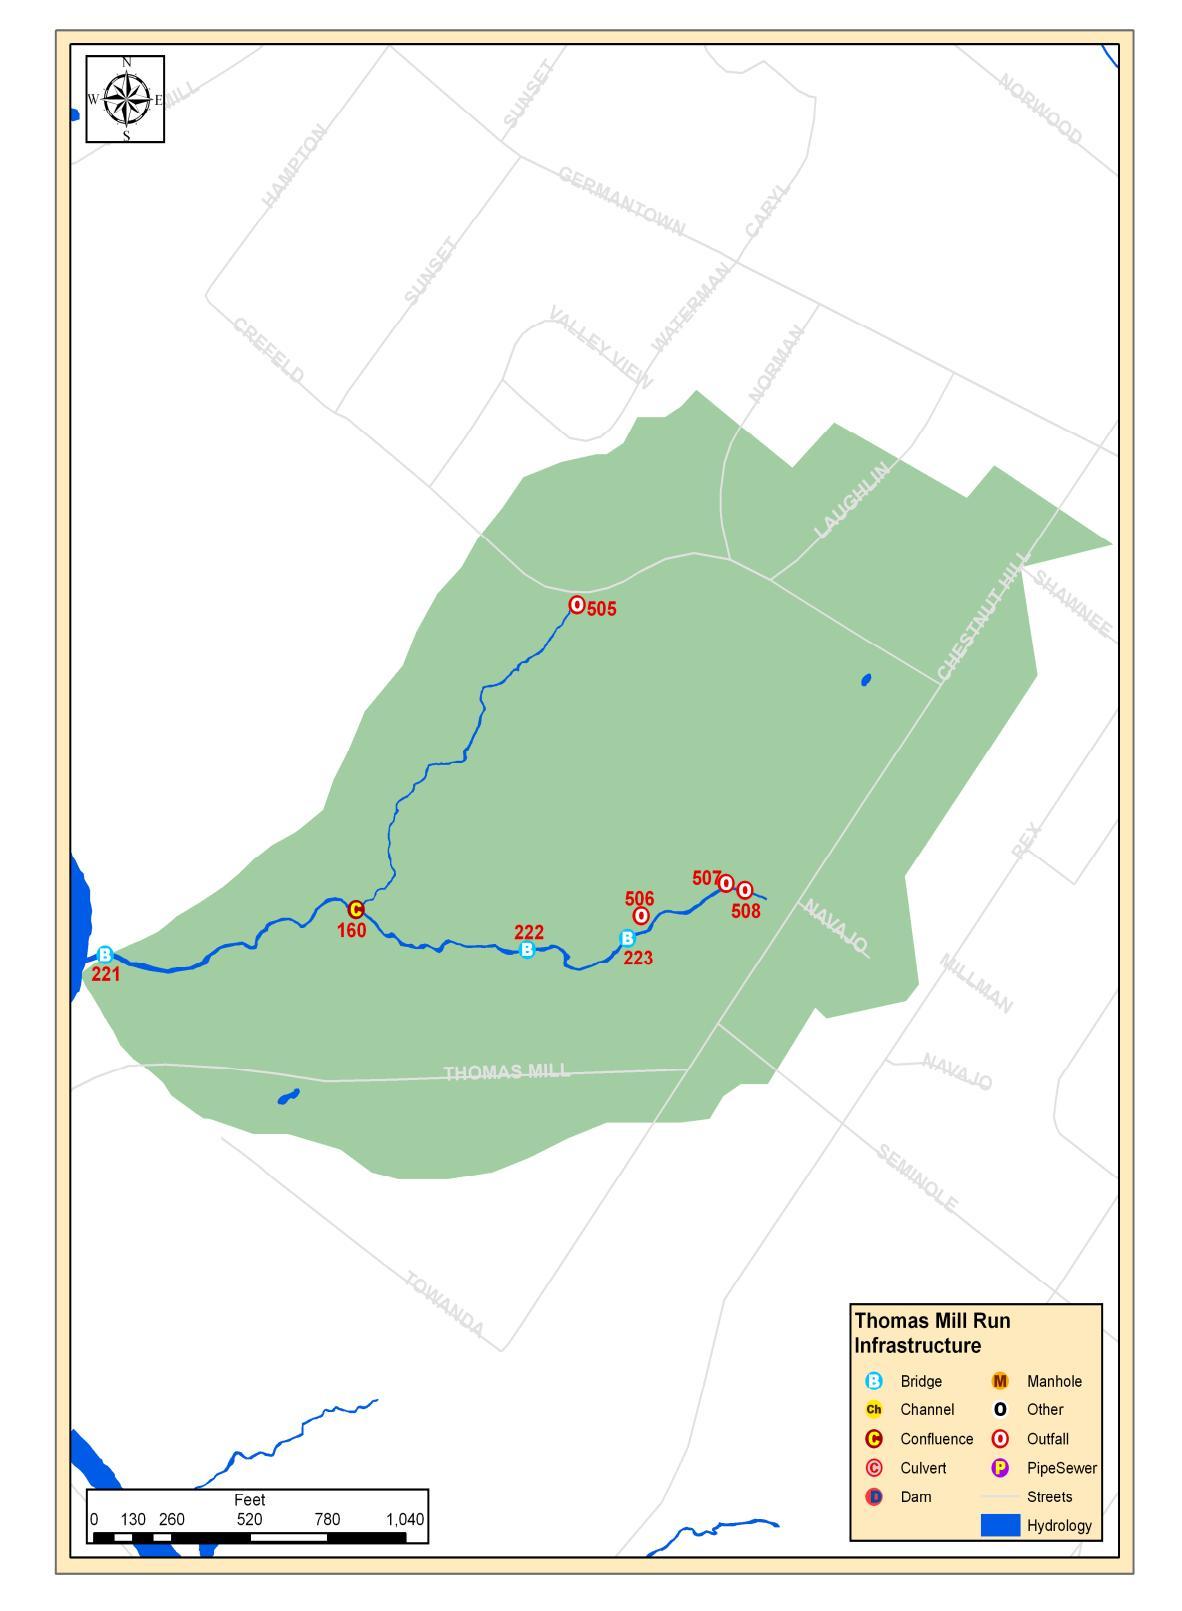
Figure 3-5: Thomas Mill Run Infrastructure Locations

Thomas Mill Run is a small tributary to the Wissahickon Creek that flows almost entirely within Fairmount Park. This stream has only a few infrastructure elements which is a direct result of the tributary's location within the Park. Despite the benefit of its location, Thomas Mill Run exhibits some of the impairments associated with urban streams given its proximity to development in the form of residential neighborhoods that surround the stream channel. The most predominant infrastructure elements in the watershed were stormwater outfalls. The number of headwater outfalls (Table 3-4) on this stream indicates that it is heavily influenced by stormwater discharges in the upstream-most segments of WSTM02 (Figure 3-5).

WSout505 had an area of five square feet and conveyed no dry weather flow. This outfall was the headwaters for a tributary (unnamed tributary A) to the main stem of Thomas Mill Run. The tributary channel was observed to be intermittently dry, as there was only flow in the channel during wet weather events. These unfavorable flow conditions can cause channel instability and degrade instream habitat from frequent erosion and sedimentation. The channel did however convey the stormwater flows away from Crefeld Avenue effectively.

Similarly, the main stem of Thomas Mill Run is impacted by stormwater runoff discharged from outfalls (WSout506, WSout507 and WSout508). There was a small amount of steady dry weather flow observed at the headwaters of the main stem. The headwaters emanated from WSout508, a four foot diameter outfall, which conveyed drainage from Chestnut Hill Avenue. The size of this outfall indicates that during wet weather events the discharge from this outfall has the potential to be substantially larger. The other two outfalls, WSout507 and WSout506, had no dry weather flow but were in degraded condition. WSout506 was partially blocked by a build-up of sediment and debris. The three bridges on Thomas Mill Run (WSbri221, WSbri222 and WSbri223) were small although they constricted flow within the channel. The bridges were built along the stream to connect the Fairmount Park trails parallel to the channel. WSout507 was the only piece of infrastructure identified as being in poor condition. The bank that once supported the pipe eroded which exposed the pipe leading to the outfall; subsequently, the pipe collapsed due to the lack of proper support.

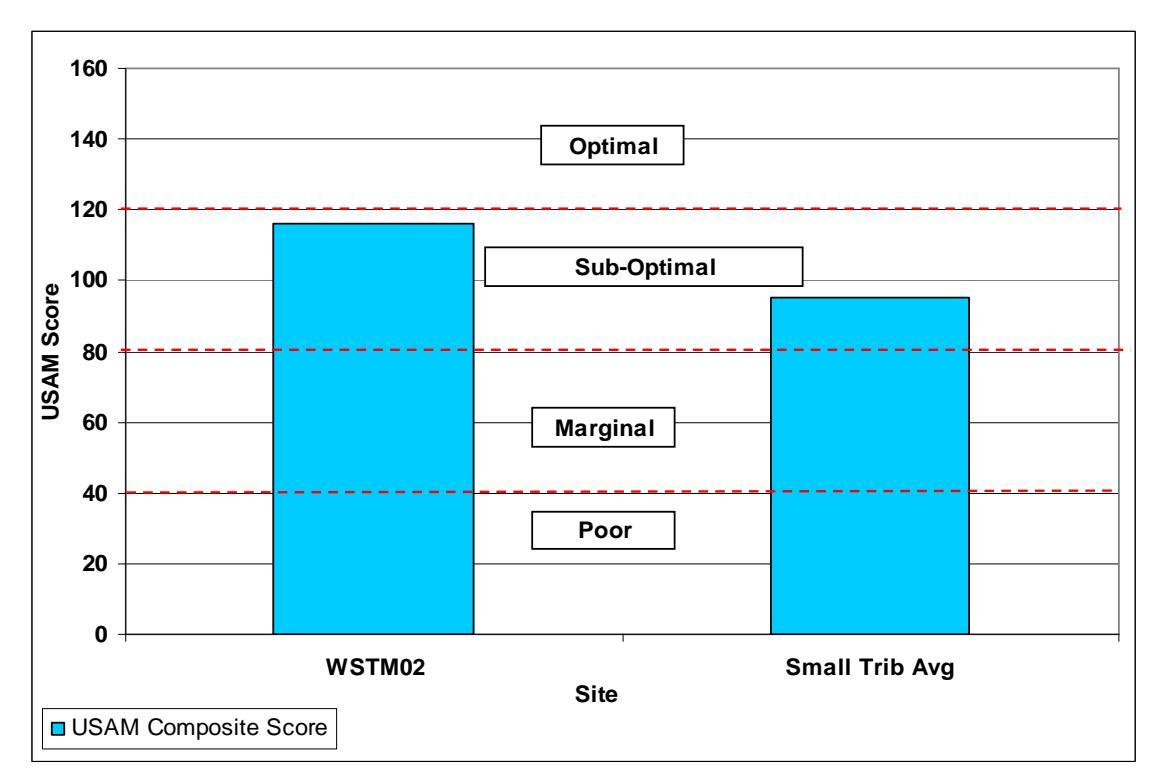
Figure 3-8: Thomas Mill Run USAM Results

Most of reach WSTM02 is located entirely within Fairmount Park. About 485 feet of the main stem channel, upstream of outfall WSout506 and up to the headwaters, was outside of Fairmount Park. The watershed was completely forested; however, the surrounding land use was residential. As such, Thomas Mill Run receives large volumes of runoff from its very small drainage area (0.07 mi<sup>2</sup>), which is notable given the relatively small bankfull channel in WSTM02 (10.4 ft<sup>2</sup>). The WSTM02 reach received a USAM composite score of 116/160 (Figure 3-8).

The mean scores for both the *Overall Stream Condition* USAM component as well as the *Overall* USAM score were all classified as "suboptimal" (Table 3-6). Conditions within the Thomas Mill Run watershed's buffers and floodplains were considerably better than conditions observed within the stream channels as the *Overall Buffer and Floodplain Condition* was rated as "optimal". The watershed scores for the both USAM components as well as the composite USAM score compared well against the respective Small

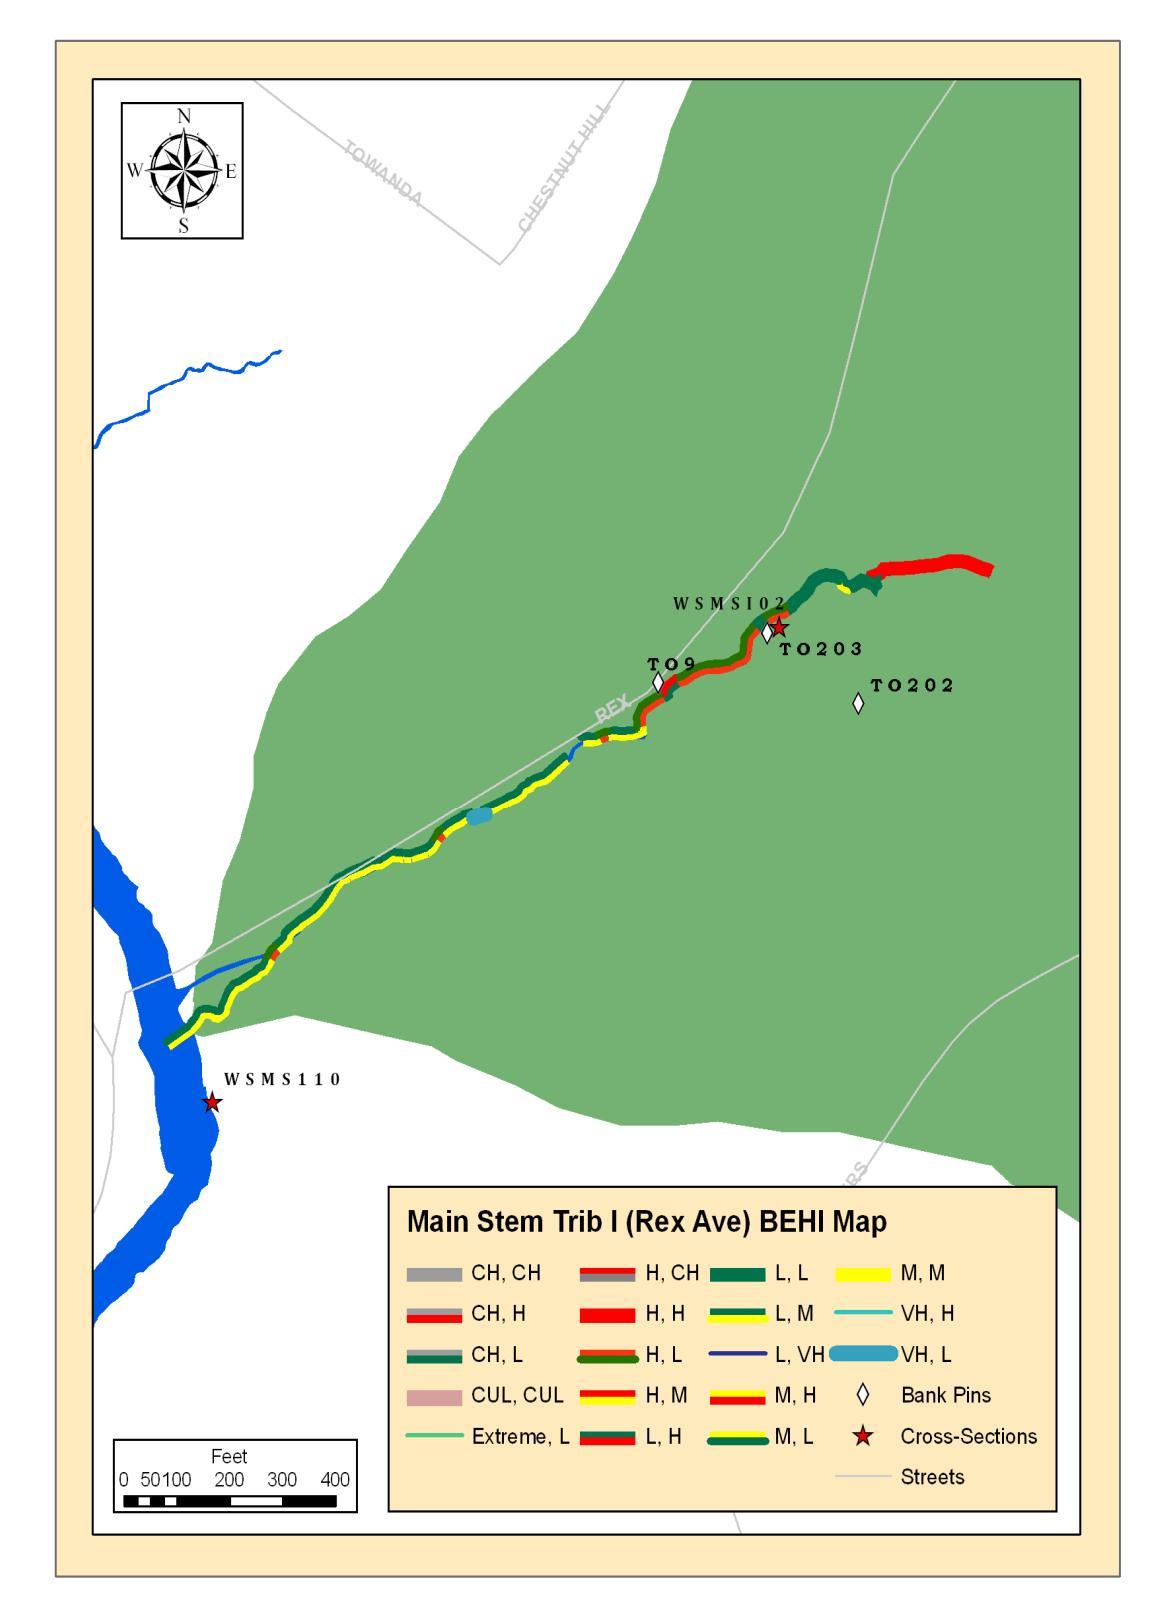
Figure 3-12: Tributary I - Rex Avenue Watershed BEHI Ratings and Bank Pin Locations

There were three bank pin locations along WSMSI – Tributary 1 (Figure 3-12). The calculated erosion rates are included in Table 3-10. The spatial distribution of BEHI assessment results were represented graphically (Figure 3-12) for each of the segments assessed on WSMSI – Tributary I. Each bank within a respective segment was assessed and rated separately; however, channelized and culverted segments were not assessed as they confer a high degree of protection from bank erosion.

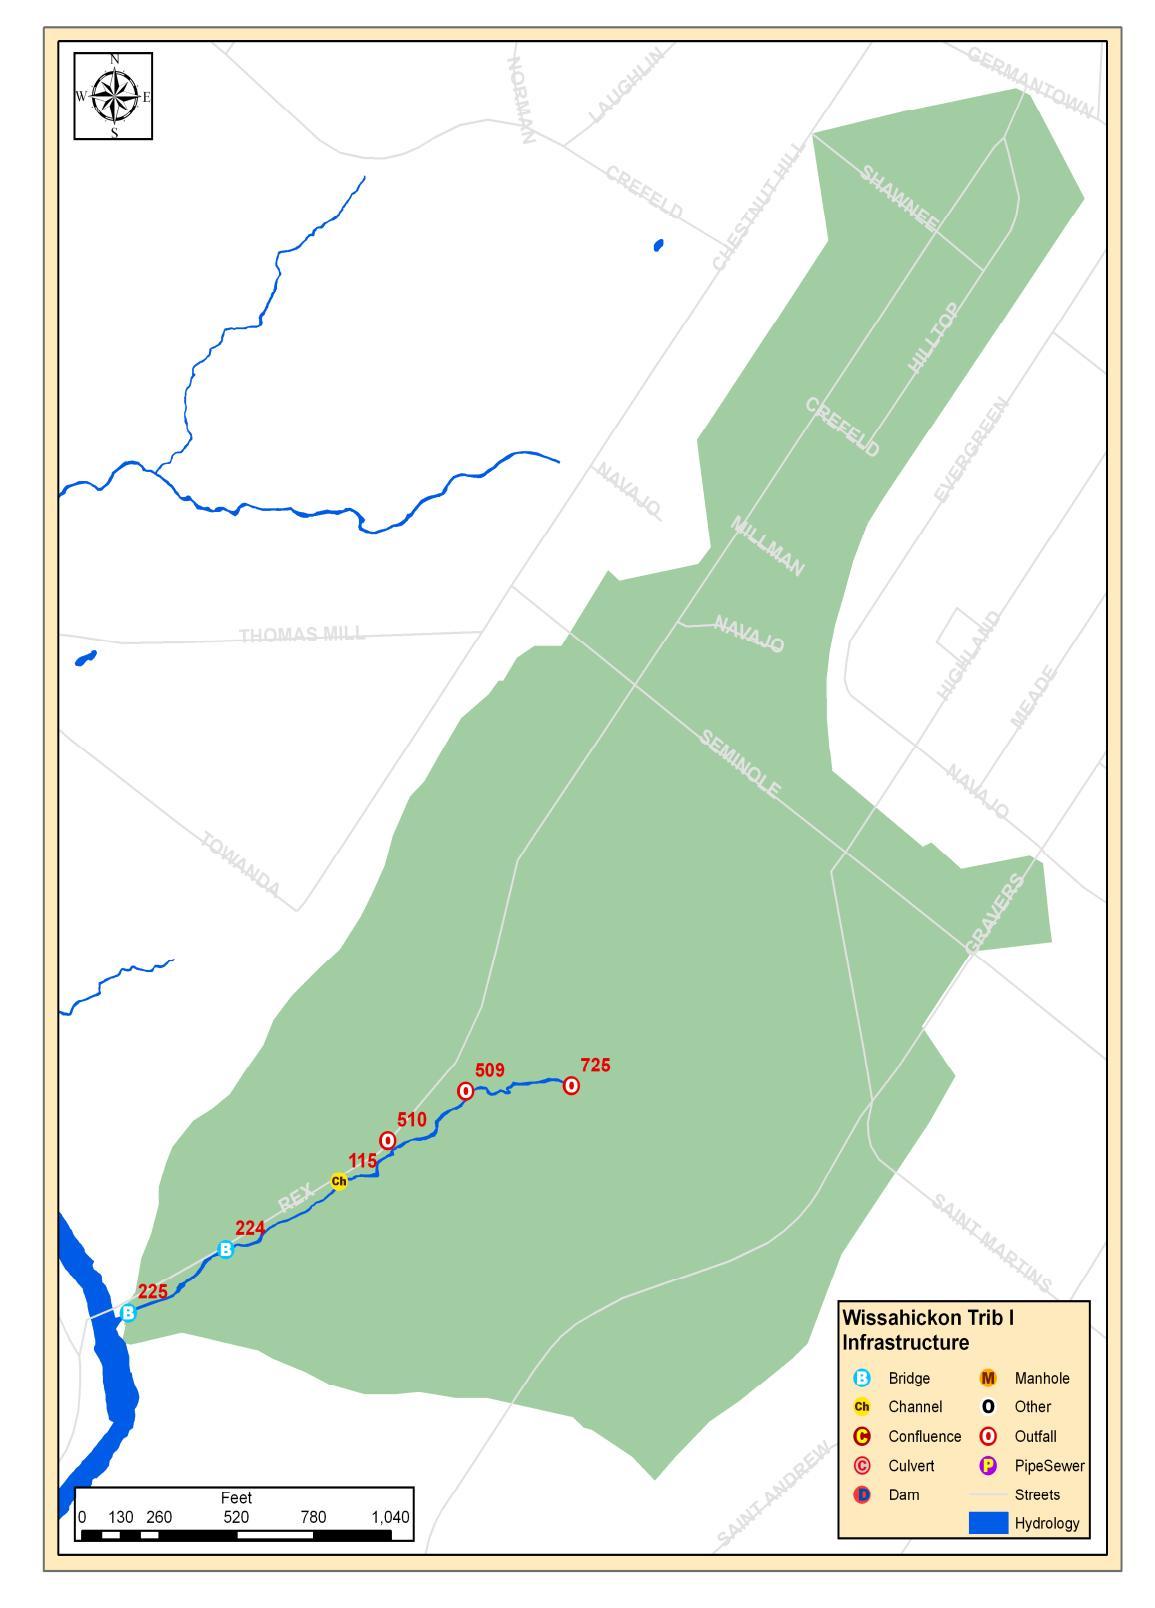
Figure 3-13: Tributary I Infrastructure

Wissahickon Tributary I is located within Fairmount Park adjacent to Rex Avenue and north of Gravers Lane. The most prominent piece of infrastructure on this stream is WSout509 (W-085-02), which is the largest outfall (4.5 foot diameter) on the tributary. It conveys stormwater drainage from Germantown Avenue and the nearby streets through a 54-inch diameter pipe directly to Tributary I. This outfall was observed to have a dry weather baseflow, which was a major contributing factor to the impairment of this tributary.

The high flows from WSout509 and to lesser extent outfalls WSout725 and WSout510 have impacted many aspects of the stream's physical and biological health. The eroding banks and "flashy" flow regime have spawned emergency repair and bank restoration projects to improve the condition of the stream. WSchal15 was most likely a temporary structure constructed to provide immediate protection to the eroding bank in the vicinity of the channel; to prevent Rex Avenue from collapsing into the stream, and possibly to keep the stream from exposing the water main sewer and sanitary interceptor that run parallel to Rex Avenue. Just downstream of this channelized portion, the 15-inch Wissahickon High Level Interceptor crosses underneath the stream. There were no infrastructure elements found to be in poor condition. WSchal15 was in fairly poor condition; however, it appeared to be a temporary structure.

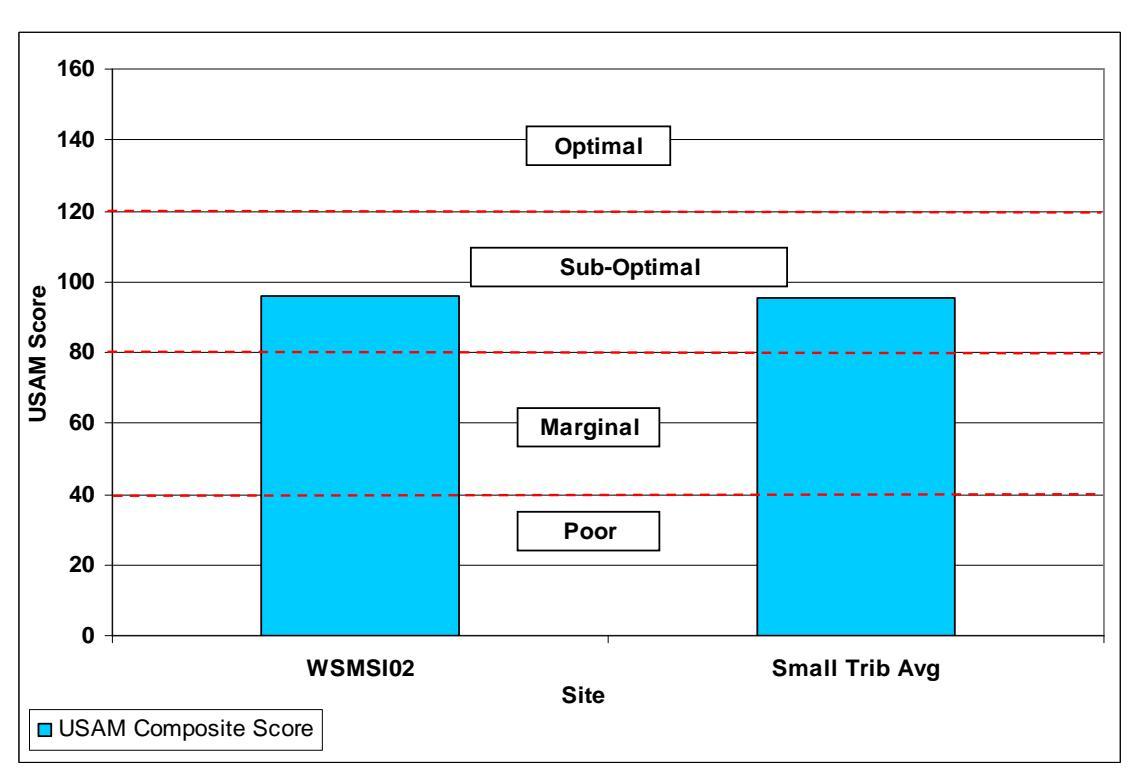
Figure 3-15: Tributary I - Rex Avenue USAM Results

The headwaters of reach WSMSI02 began as flow from a privately owned outfall, WSout725, which was located within Fairmount Park. The channel was relatively small with a bankfull cross-sectional area of only 11.4 ft<sup>2</sup>. The substrate distribution was dominated by gravel (61%) although cobble and a limited amount of boulders were also observed. The channel was characterized by a moderate width to depth ratio (13.8) and moderate degree of entrenchment (ER=1.4). As such, reach WSMSI02 was classified as a B4 type channel. The USAM composite score for the reach was 96/180 (Figure 3-15).

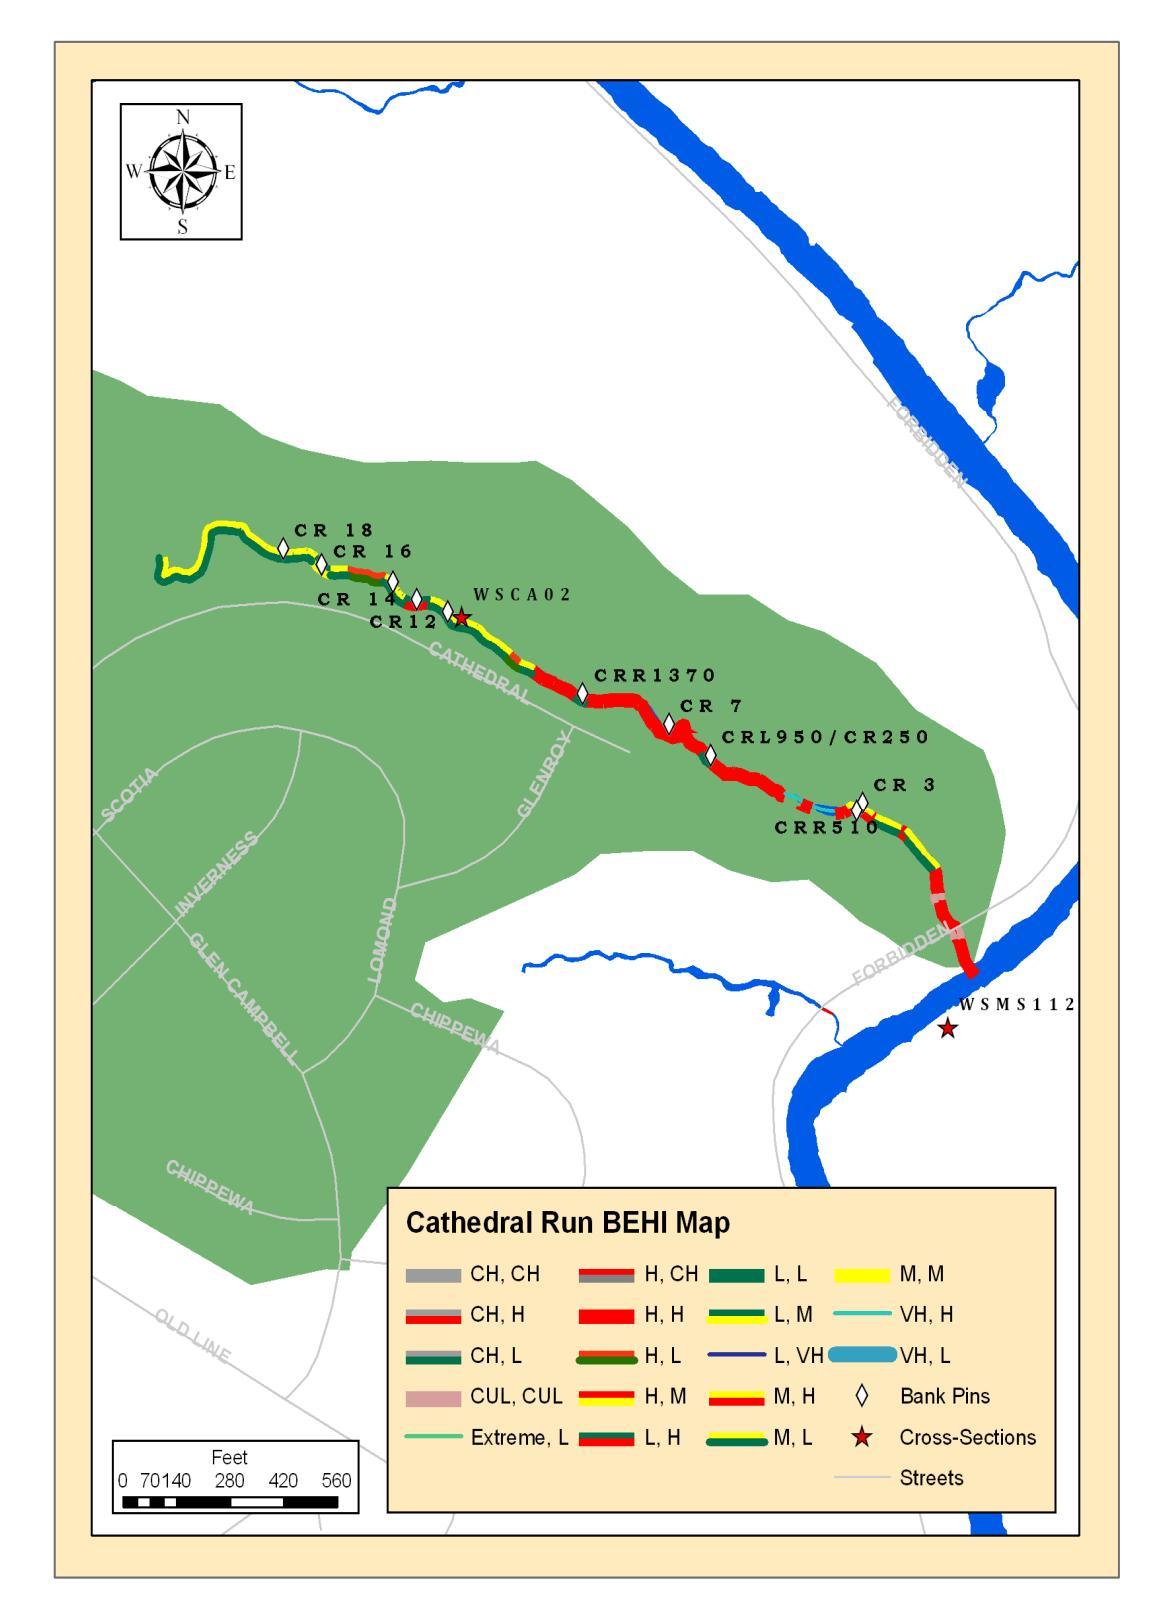
Figure 3-19: Cathedral Run Watershed BEHI Ratings and Bank Pin Locations

There were 10 bank pin locations along Cathedral Run (Figure 3-19). The calculated erosion rates at each bank pin location are included in Table 3-18. The spatial distribution of BEHI assessment results were represented graphically (Figure 3-19) for each of the segments assessed on Cathedral Run. Each bank within a respective segment was assessed and rated separately; however, channelized and culverted segments were not assessed as they confer a high degree of protection from bank erosion.

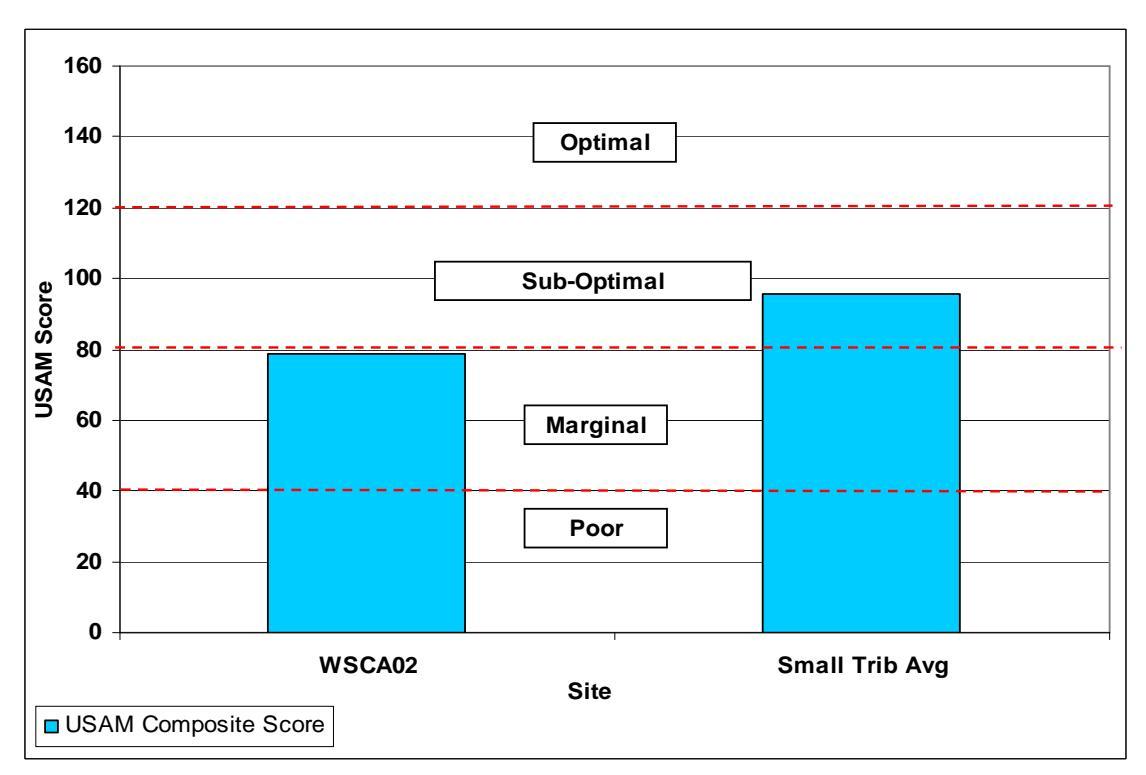
Figure 3-22: Cathedral Run USAM Results

The headwaters of reach WSCA02, located about 75 feet north of Cathedral Road, began as a zero order stream at the base of a steep swale that receives runoff from Courtesy Stables as well as WSout726. The WSCA02 channel was rather small with a bankfull cross sectional area of 6.9 ft<sup>2</sup>, although the drainage area for the reach (0.19 mi<sup>2</sup>) was relatively small as well. WSCA02 was dominated by gravel (55%) with cobble and boulders observed in much smaller proportions. A relatively high width to depth ratio was observed for WSCA02 as well as a moderately entrenched channel (ER=1.7). The reach was classified as a B4 type channel. The USAM composite score for the reach was 79/160 (Figure 3-22).

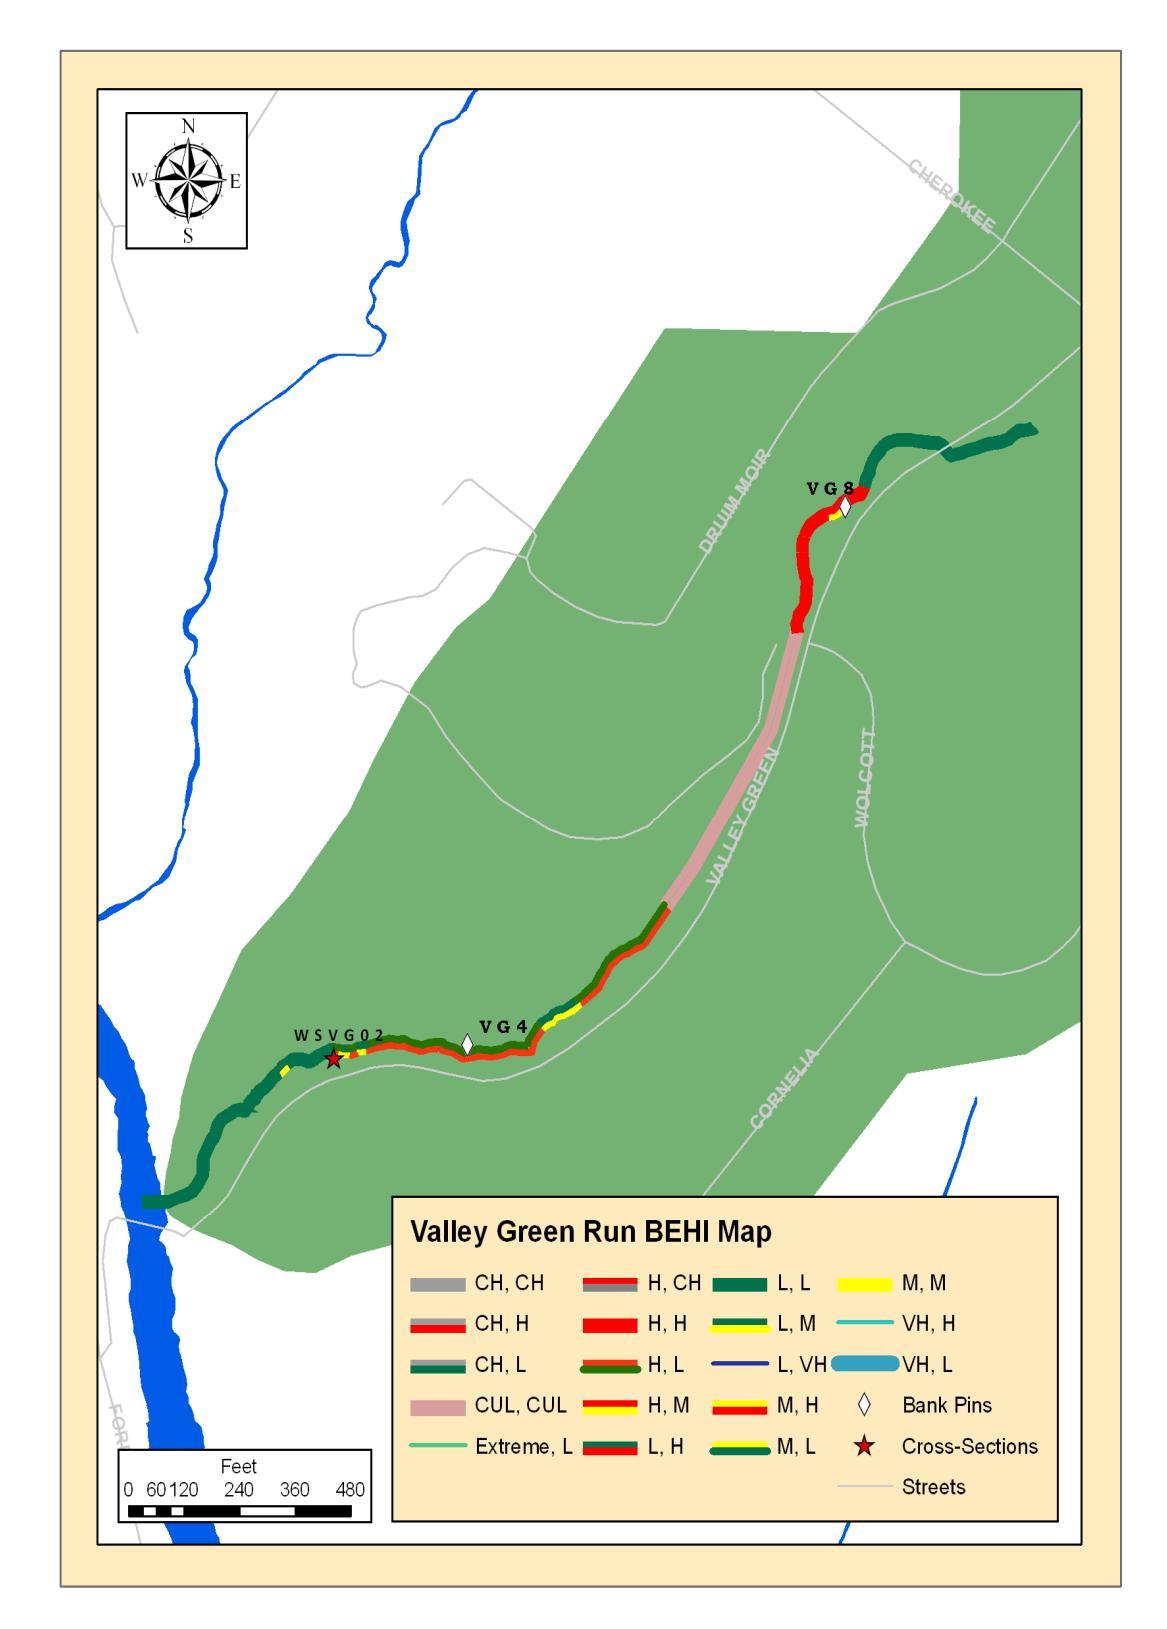
Figure 3-26: Valley Green Run Watershed BEHI Ratings and Bank Pin Locations

There were two bank pin locations along Valley Green Run (Figure 3-26). The calculated erosion rates are included in Table 3-26. The spatial distribution of BEHI assessment results were represented graphically (Figure 3-26) for each of the segments assessed on Valley Green Run. Each bank within a respective segment was assessed and rated separately; however, channelized and culverted segments were not assessed as they confer a high degree of protection from bank erosion.

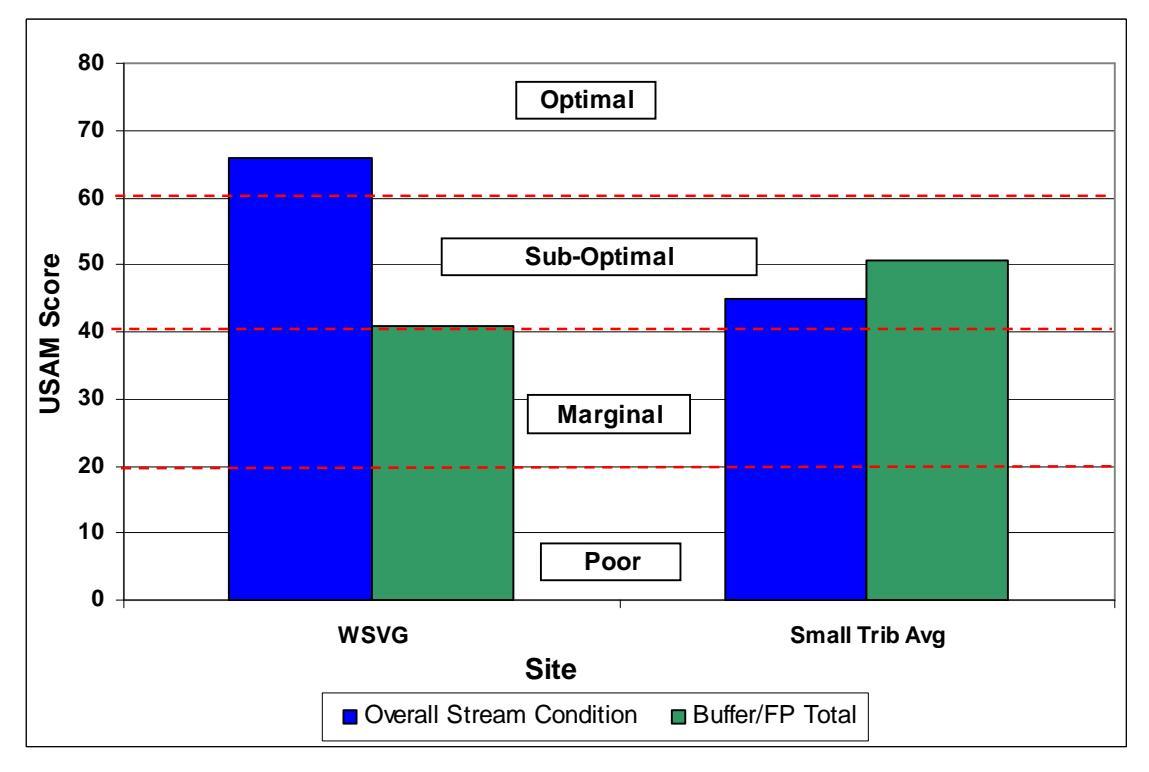
Figure 3-28: Results for Valley Green Run USAM Components

The majority of the first-order main stem channel of the Valley Green Run watershed is located within Fairmount Park. The upstream-most third of the channel was located outside of Fairmount Park, although the land cover abutting this segment of channel was forested. The Center for Watershed Protection's (CWP) Unified Stream Assessment Methodology (USAM) was used to score and rate the instream, riparian buffer and floodplain conditions of the stream corridor to allow for comparison to other reaches and watersheds within the Lower Wissahickon Basin.
