# WISSAHICKON CREEK STREAM ASSESSMENT STUDY LOWER WISSAHICKON WATERSHED

Philadelphia Water Department Office of Watersheds 2010

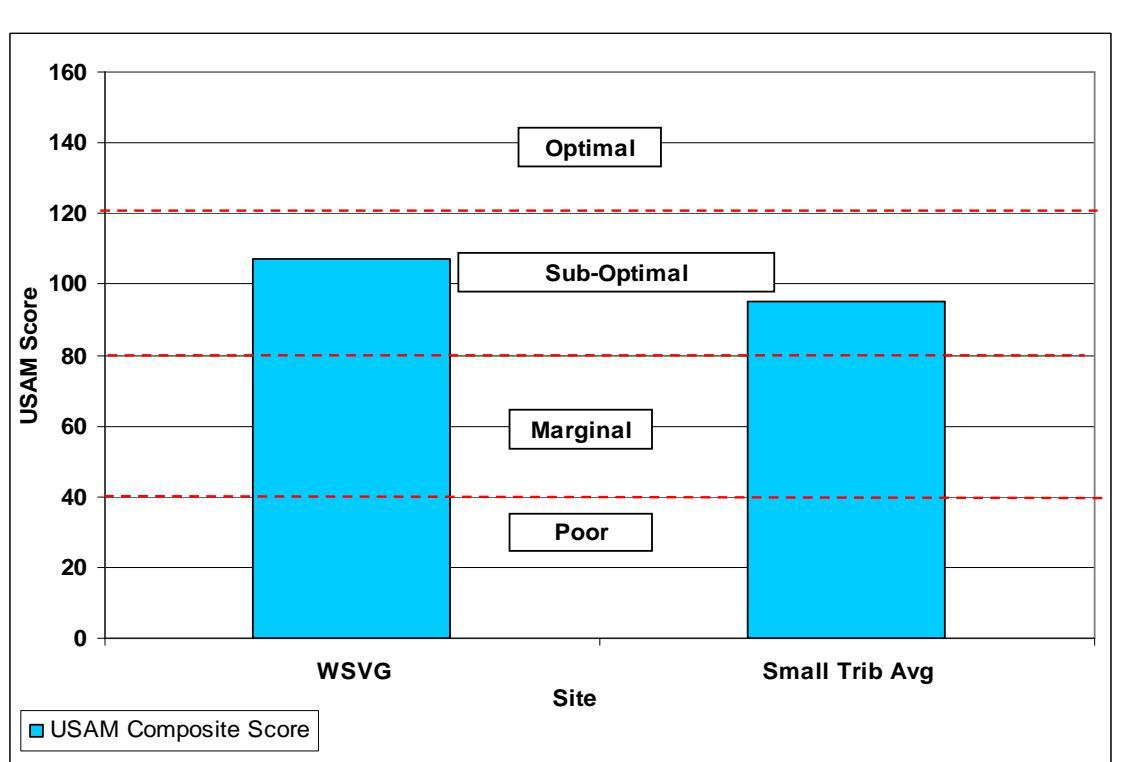
Figure 3-29: Valley Green Run USAM Results

The headwaters of reach WSVG02 began as flow from a privately owned outfall, WSout522, about 200 feet southwest of Cherokee Road. The total length of the main stem channel was 2,849 feet. The bankfull channel was rather small (6.9 ft<sup>2</sup>) with an estimated bankfull capacity of 34.3 cfs. The bankfull discharge to drainage area ratio for WSVG02 was 180.5 cfs/mi<sup>2</sup>, which was slightly below the median observation for the Lower Wissahickon Basin (185.6 cfs/ mi<sup>2</sup>). The observed stream bed substrate distribution had a nearly equal proportion of gravel (44%) and cobble (37%), with sand (16%) and boulder (1%) particles represented in much smaller proportions. The stream was characterized by a relatively high width to depth ratio (18.9) and a moderately entrenched channel (ER=1.4) such that the reach was classified as a B4/a channel type. The USAM composite score (Figure 3-29) for the reach was 107/160.

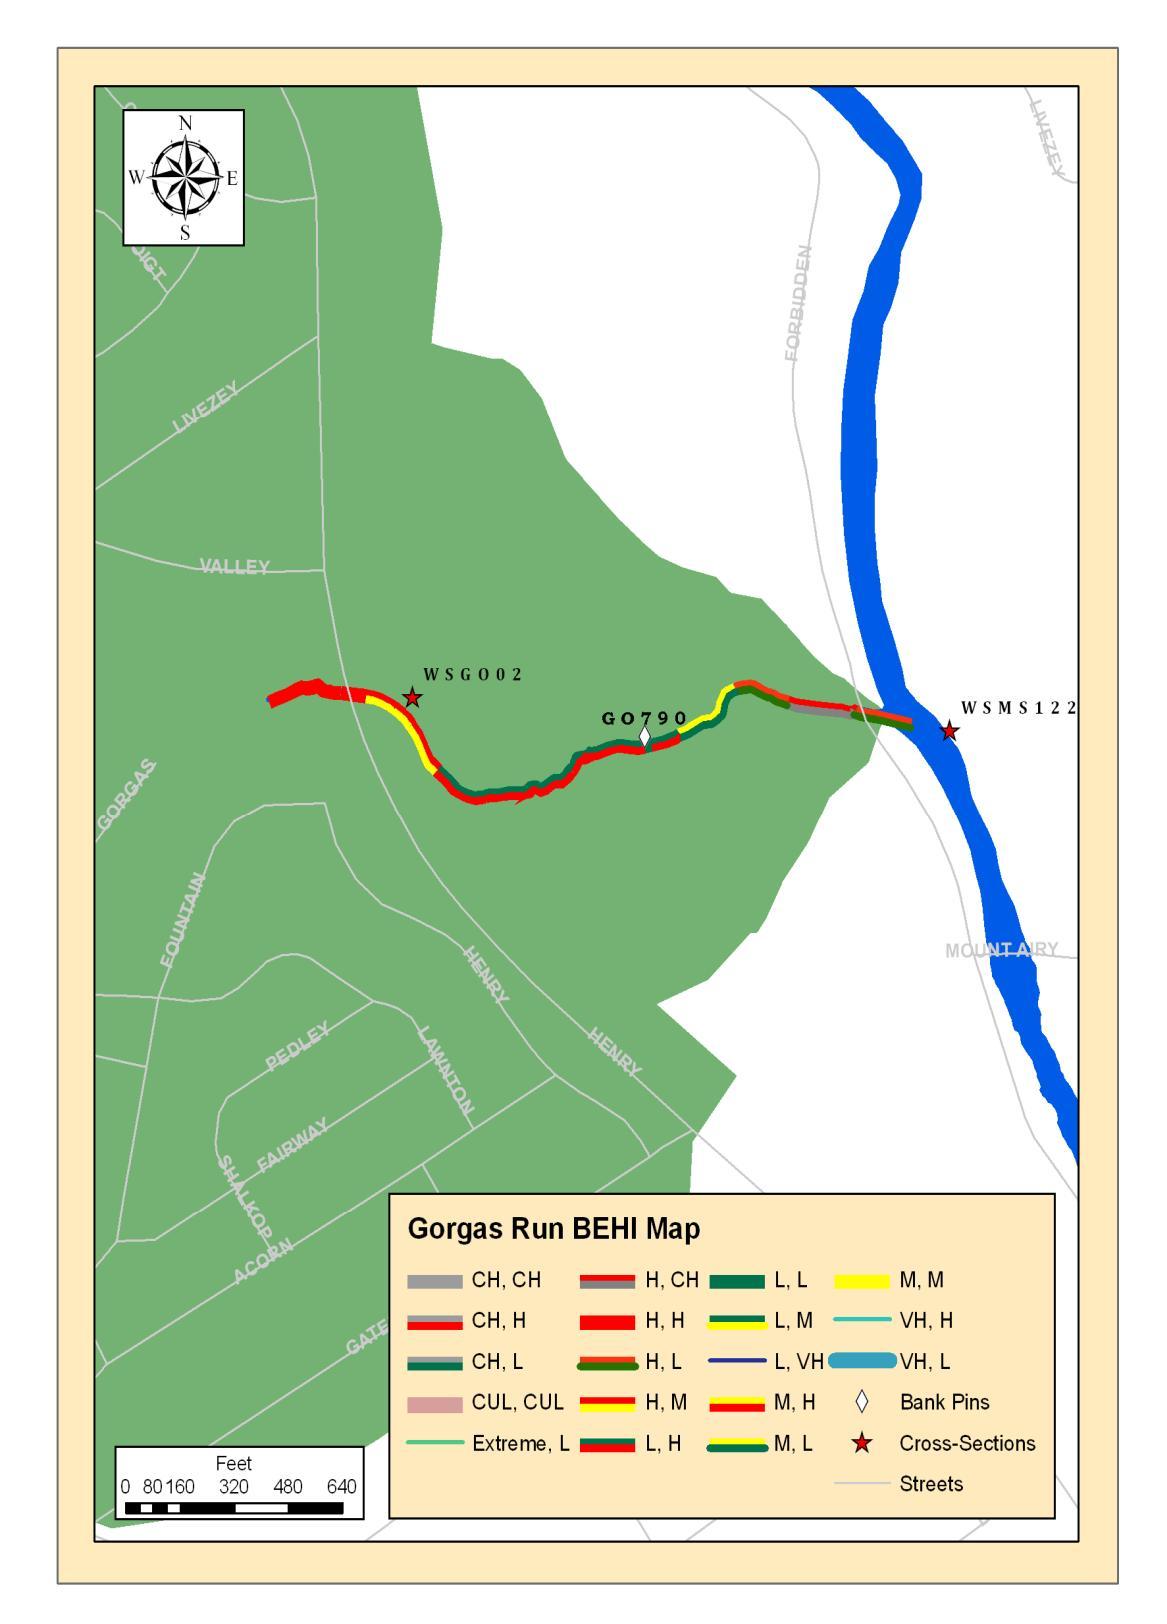
Figure 3-33: Gorgas Run Watershed BEHI Ratings and Bank Pin Locations

There was one bank pin location along Gorgas Run (Figure 3-33). The calculated erosion rates are included in Table 3-34. The spatial distribution of BEHI assessment results were represented graphically (Figure 3-33) for each of the segments assessed on Gorgas Run. Each bank within a respective segment was assessed and rated separately; however, channelized and culverted segments were not assessed as they confer a high degree of protection from bank erosion.

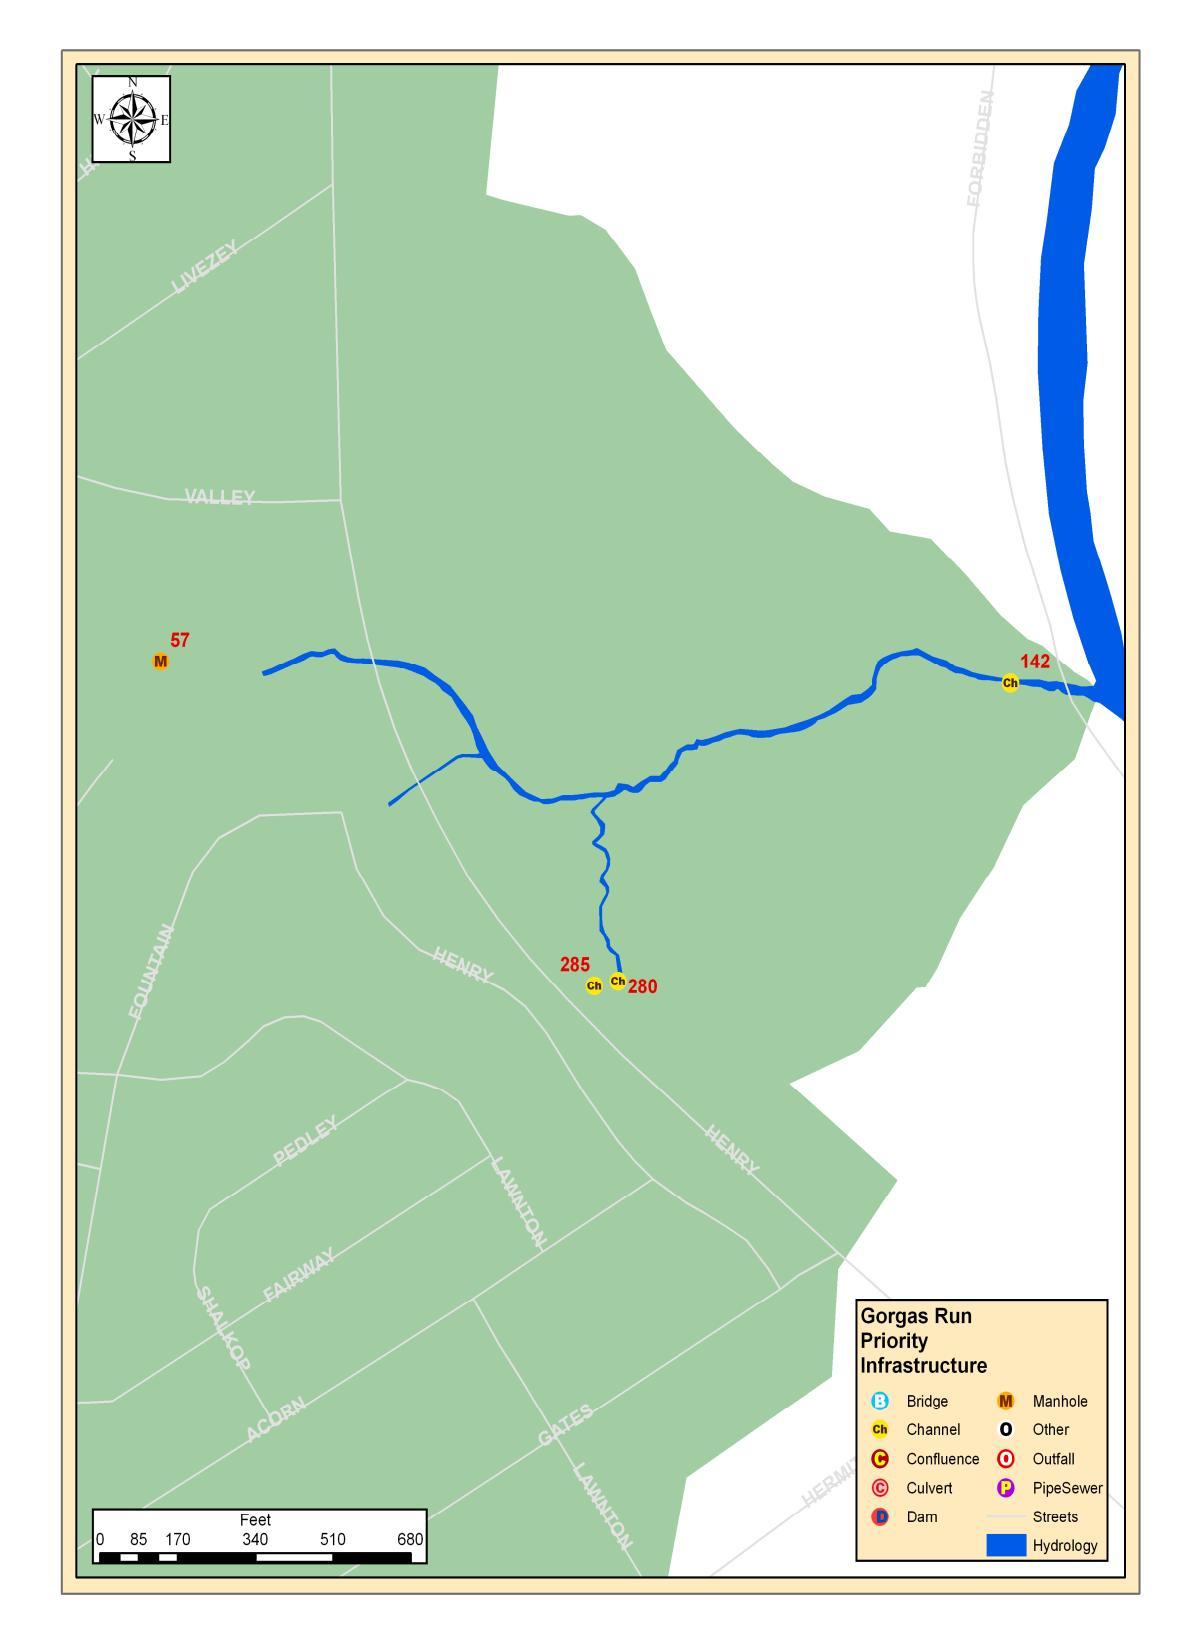
Figure 3-36: Gorgas Run Priority Infrastructure Locations

The stone channels downstream of WSout762, WScha280, WScha284, and WScha285, line the tributary downstream of the outfall for about 35 feet. The bottom (WScha280) and downstream left (WScha285) channels are in poor condition as the last five feet of the channel have broken off. WScha142 is an approximately 12-foot stone channel that lines the main stem of Gorgas Run for about 200 feet upstream of WSbri249 at Forbidden Drive. This channel is in poor condition as part of the wall and associated trail fencing had collapsed into the stream.

Priority infrastructure (Figure 3-36) on Gorgas Run included WScha280 (Figure 3-34), WScha285, WScha142 (Figure 3-34), and WSman57 which had no manhole cover and an exposed pipe orifice.

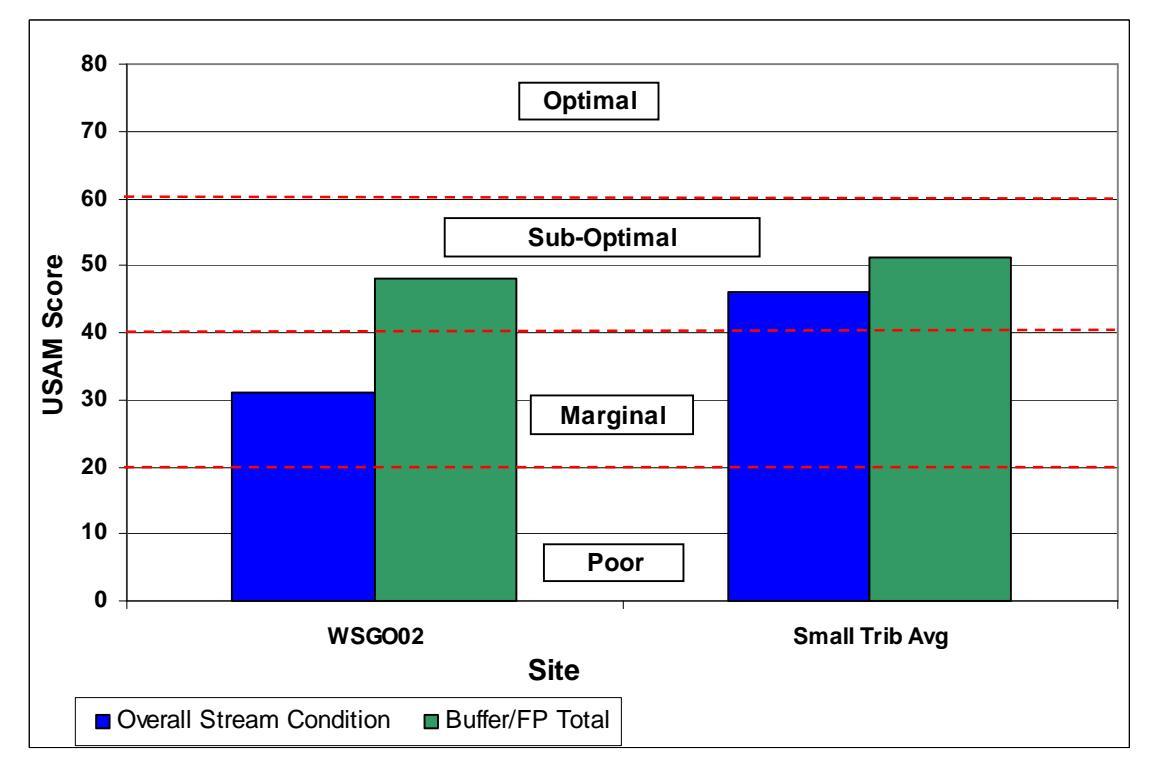
Figure 3-37: Results for Gorgas Run USAM Components

The Gorgas Run stream channel is a first-order, single thread channel with no tributaries. The majority of the channel is located entirely within Fairmount Park with the exception of an approximately 230-foot segment of the channel upstream of WSout566 (W-067-01). Gorgas Run is the last major tributary on the DSR side of the basin's corridor. The Center for Watershed Protection's (CWP) Unified Stream Assessment Methodology (USAM) was used to score and rate the instream, riparian buffer and floodplain conditions of the stream corridor to allow for comparison to other reaches and subwatersheds within the Lower Wissahickon Basin.

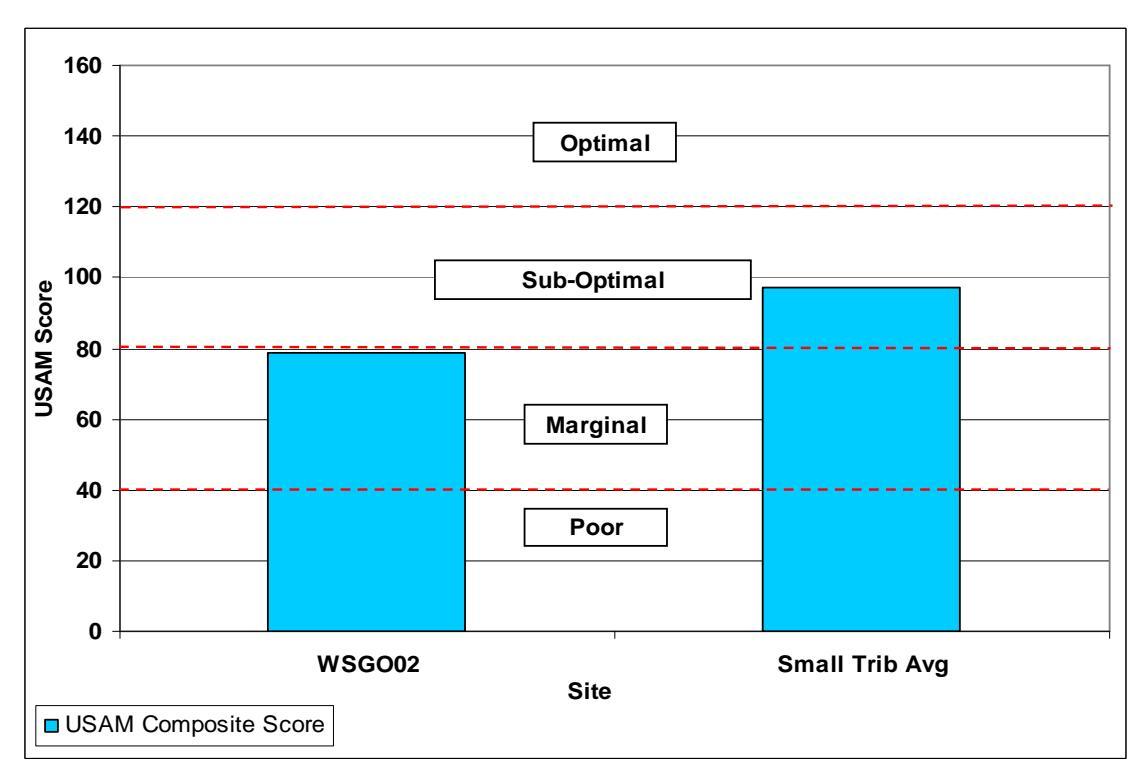
Figure 3-38: Gorgas Run USAM Results

The headwaters of reach WSGO02 begins approximately 230 feet upstream of WSout566 (W-067-01) and Henry Avenue. The channel is fed mainly by runoff from Gorgas Road as well as the trail adjacent to the channel. The main stem channel had a bankfull channel capacity relatively larger than the other small Lower Wissahickon tributaries; however the Gorgas Run drainage area (0.6 mi<sup>2</sup>) was also larger than that of the other small tributaries. The bed substrate within the reach was dominated by cobble (62%) with gravel and boulder comprising the remainder of the substrate distribution. Reach WSGO2 was characterized by a deeply entrenched (Entrenchment Ratio=1.1), moderate gradient (slope of 2.9%) channel and a relatively high width to depth ratio (20.9) which classified the reach as an F3b channel type. The USAM composite score for the reach was 79/160 (Figure 3-38).

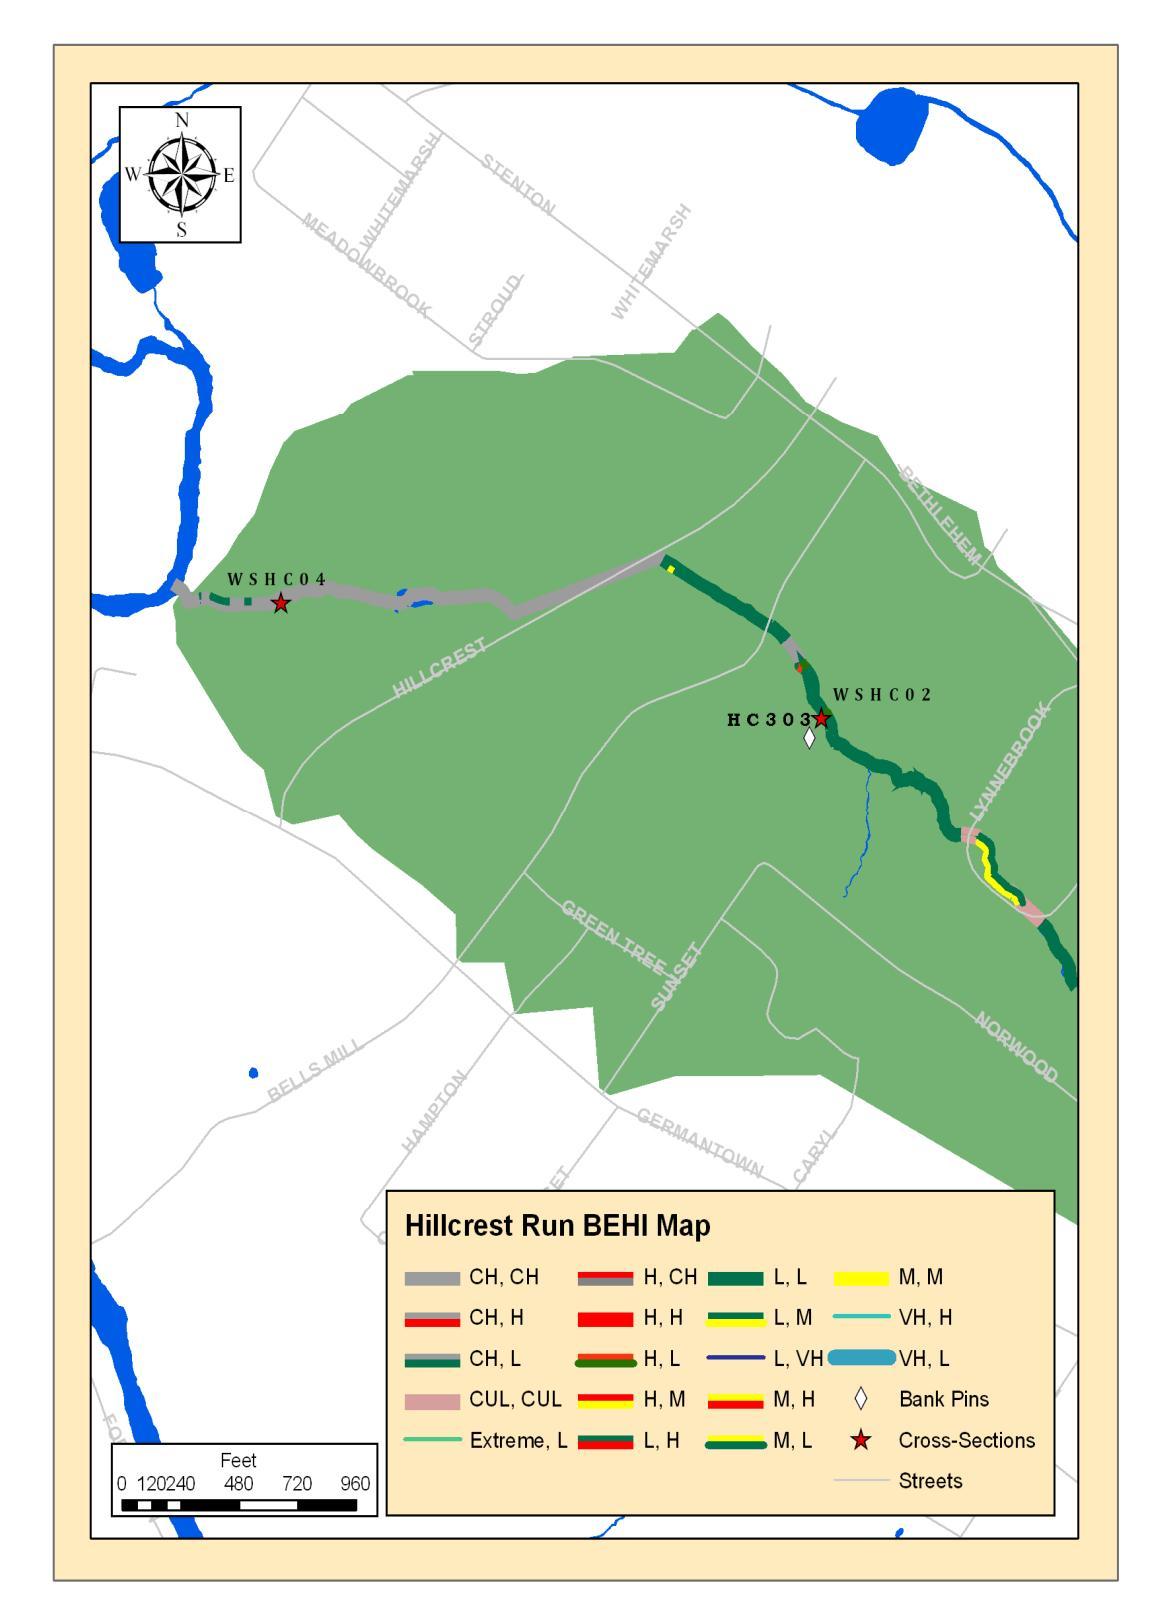
Figure 3-42: Hillcrest Run Watershed BEHI Ratings and Bank Pin Locations

There was one bank pin location along Hillcrest Run (Figure 3-42). The calculated erosion rates are included in Table 3-42. The spatial distribution of BEHI assessment results were represented graphically (Figure 3-42) for each of the segments assessed on Hillcrest Run. Each bank within a respective segment was assessed and rated separately; however, channelized and culverted segments were not assessed as they confer a high degree of protection from bank erosion.

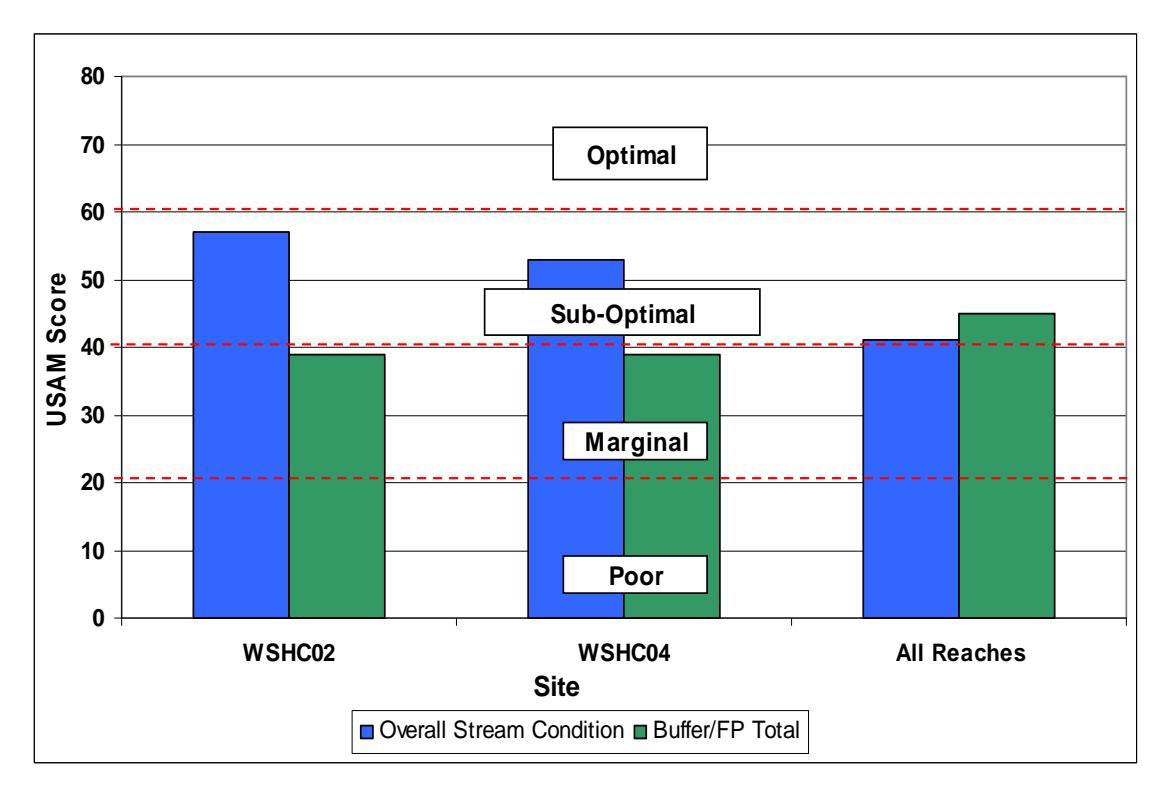
Figure 3-45: Results for Hillcrest Run USAM Components

The Hillcrest Run watershed was heavily developed as the dominant land use was singlefamily residential. There were no portions of the watershed that are within the boundaries of Fairmount Park, which distinguished the Hillcrest Run watershed from the other watersheds of the Lower Wissahickon Basin. The Center for Watershed Protection's (CWP) Unified Stream Assessment Methodology (USAM) was used to score and rate the instream, riparian buffer and floodplain conditions of the stream corridor to allow for comparison to other reaches and watersheds within the Lower Wissahickon Basin.

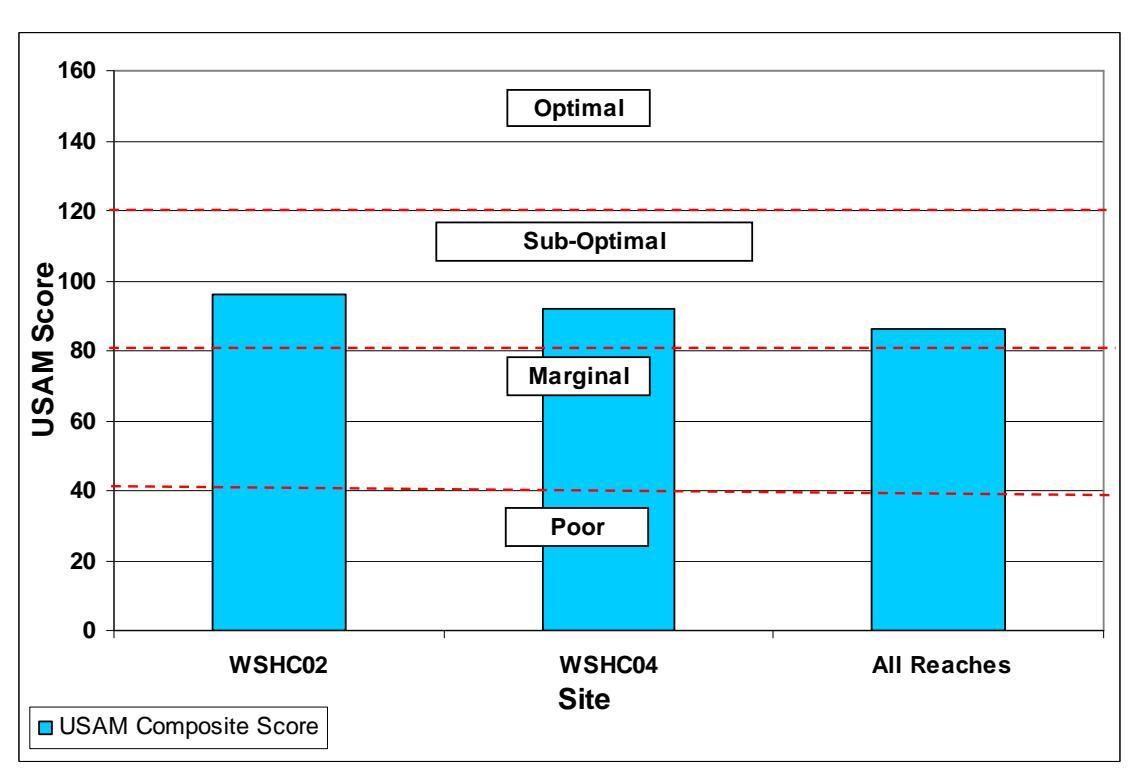
Figure 3-46: Hillcrest Run USAM Results

The headwaters of reach WSHC02 originated from an outfall, WSout469, located 485 feet from the intersection of Chestnut Hill Avenue and Norwood Avenue. There was a small tributary (530 feet) on reach WSHC02, of which the confluence with the main stem of Hillcrest Run was located 300 feet upstream of cross section WSHC02. In total, reach WSHC02 was 4,135 feet in length and ended at the culverted segment of the reach above Hillcrest Avenue. Reach WSHC02 was characterized by a low width to depth ratio (8.5), a moderately entrenched channel (ER=1.8) and a relatively steep slope (4.7%) which classified the channel as a B4a stream type based upon the Rosgen classification system. The composite USAM score (Figure 3-46) for reach WSHC02 was (96/160).

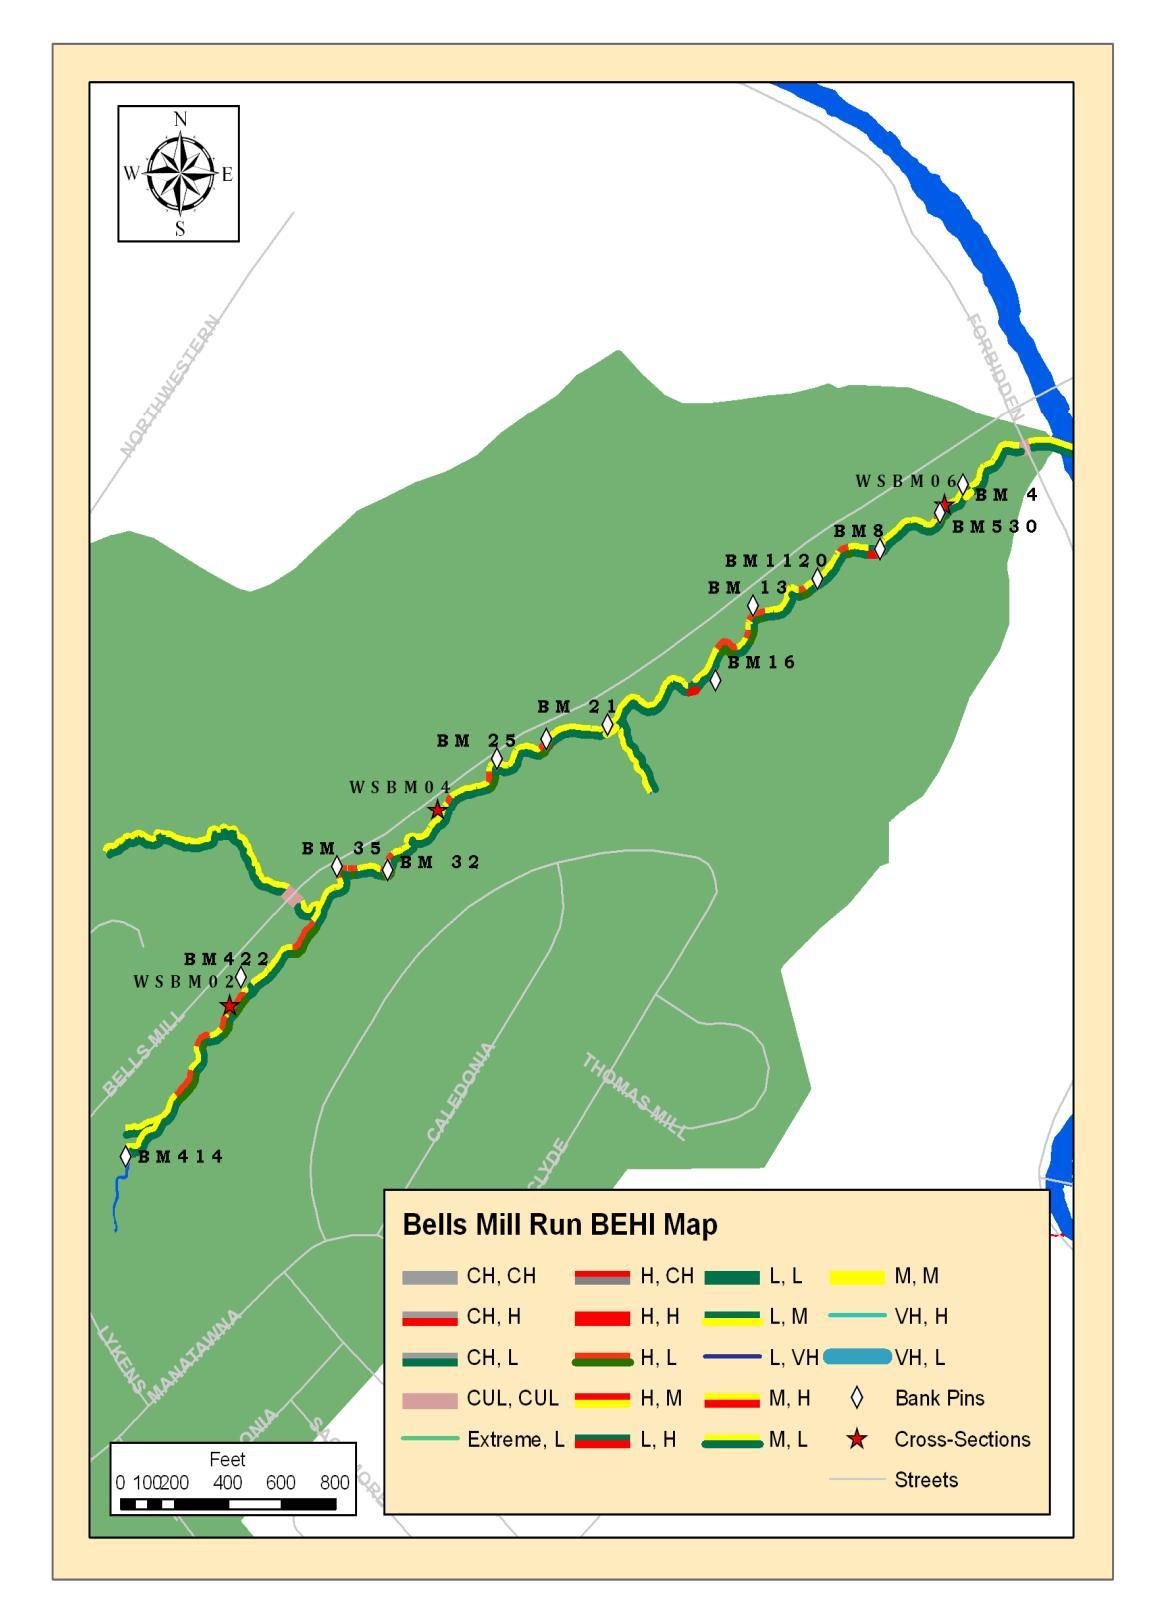
Figure 3-50: Bell's Mill Watershed BEHI Ratings and Bank Pin Locations

There were 13 bank pin locations along Bell's Mill Run (Figure 3-50). The calculated erosion rates are included in Table 3-50. The spatial distribution of BEHI assessment results were represented graphically (Figure 3-50) for each of the segments assessed on Bell's Mill Run. Each bank within a respective segment was assessed and rated separately; however, channelized and culverted segments were not assessed as they confer a high degree of protection from bank erosion.

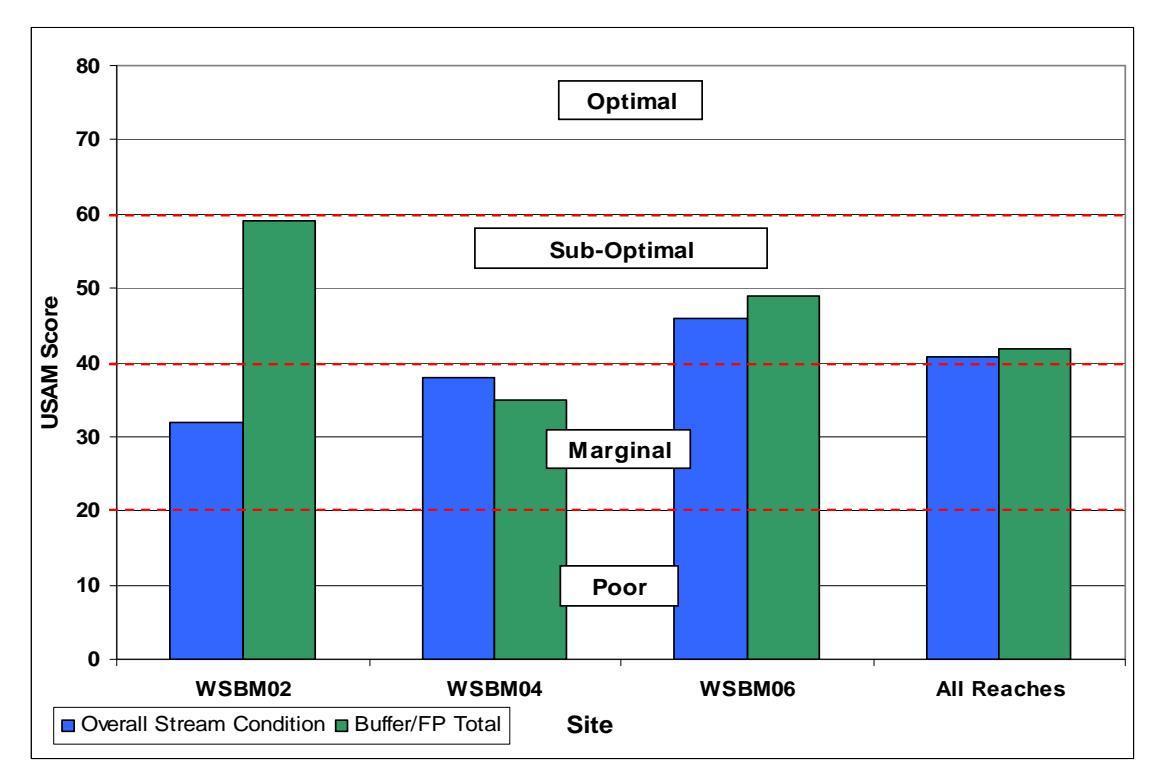
Figure 3-53: Results for Bell's Mill Run USAM Components

The mean scores for both the individual USAM components as well as the overall USAM score were classified as marginal to suboptimal (Table 3-54). Average buffer and floodplain conditions within the Bell's Mill Run stream corridors were slightly better than the average overall stream condition although there was high variability between scores for the respective USAM components among individual sites. The mean USAM composite score and *Overall Buffer and Floodplain Condition* score for the three Bell's Mill Run reaches were higher than the average scores respectively for all other reaches (excluding Bell's Mill Run reaches) in the Philadelphia portion of the Wissahickon Creek Watershed.

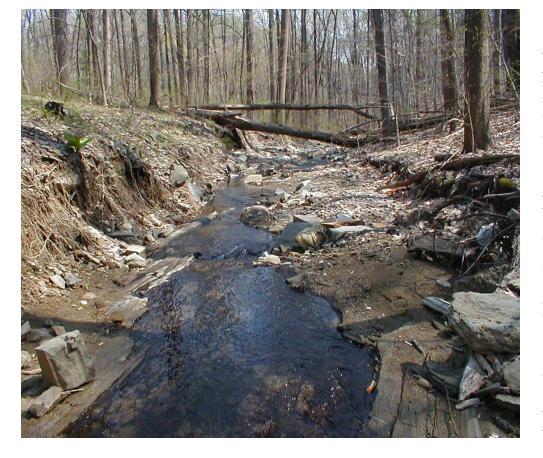
Scores for the *Floodplain Connection* parameter were rated "poor" for all Bell's Mill Run reaches. The mean score for Bell's Mill Run (3.3/10) was substantially lower than the 'All Reaches" average (6.3/10), which was rated "marginal". As mentioned previously, the entrenchment ratios in the Bell's Mill Run watershed were very low (1.2-1.3) and indicated channel incision. Active downcutting and scour were visible on the banks throughout the watershed. Extreme incision ultimately prevents flood waters from entering the

floodplain, which has adverse impacts on riparian vegetation and productivity. As the water table lowers, the soils of the streambank do not adequately support vegetation and become less cohesive, making them susceptible to more erosion and channel widening.

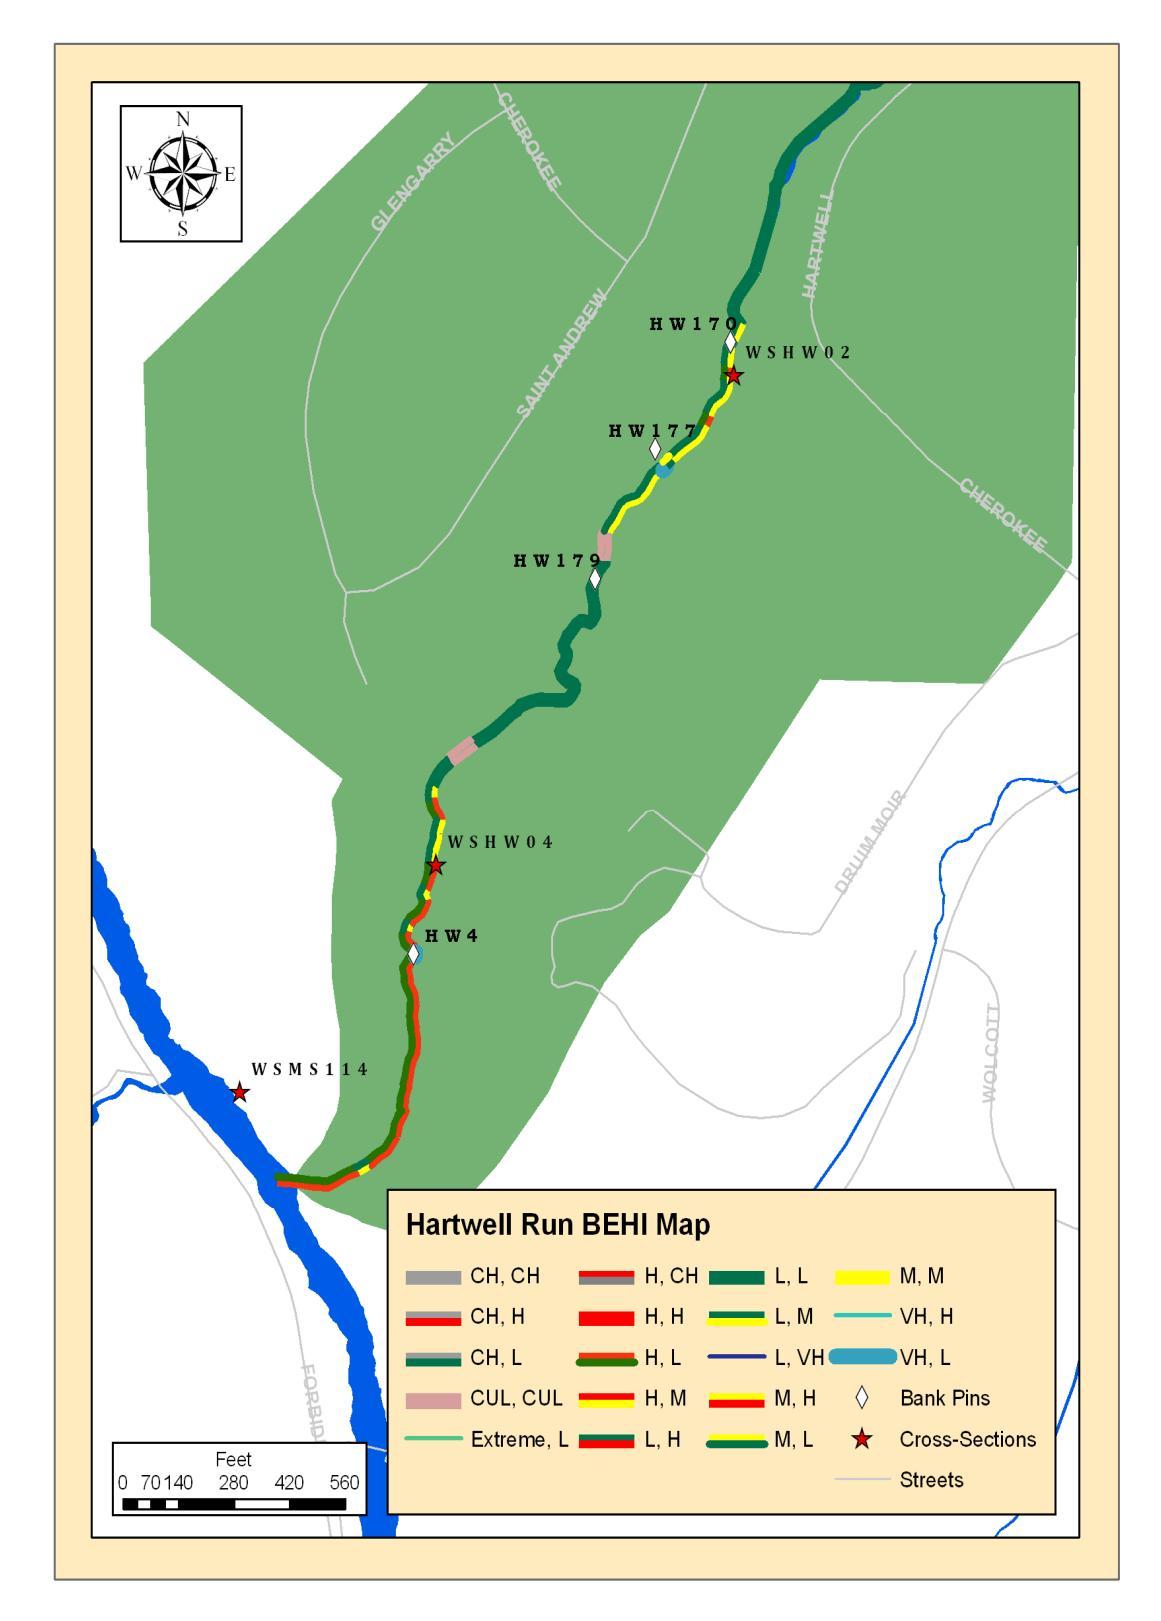
Figure 3-58: Hartwell Run Watershed BEHI Ratings and Bank Pin Locations

There were four bank pin locations along Hartwell Run (Figure 3-58). The calculated erosion rates are included in Table 3-58. The spatial distribution of BEHI assessment results were represented graphically (Figure 3-58) for each of the segments assessed on Hartwell Run. Each bank within a respective segment was assessed and rated separately; however, channelized and culverted segments were not assessed as they confer a high degree of protection from bank erosion.

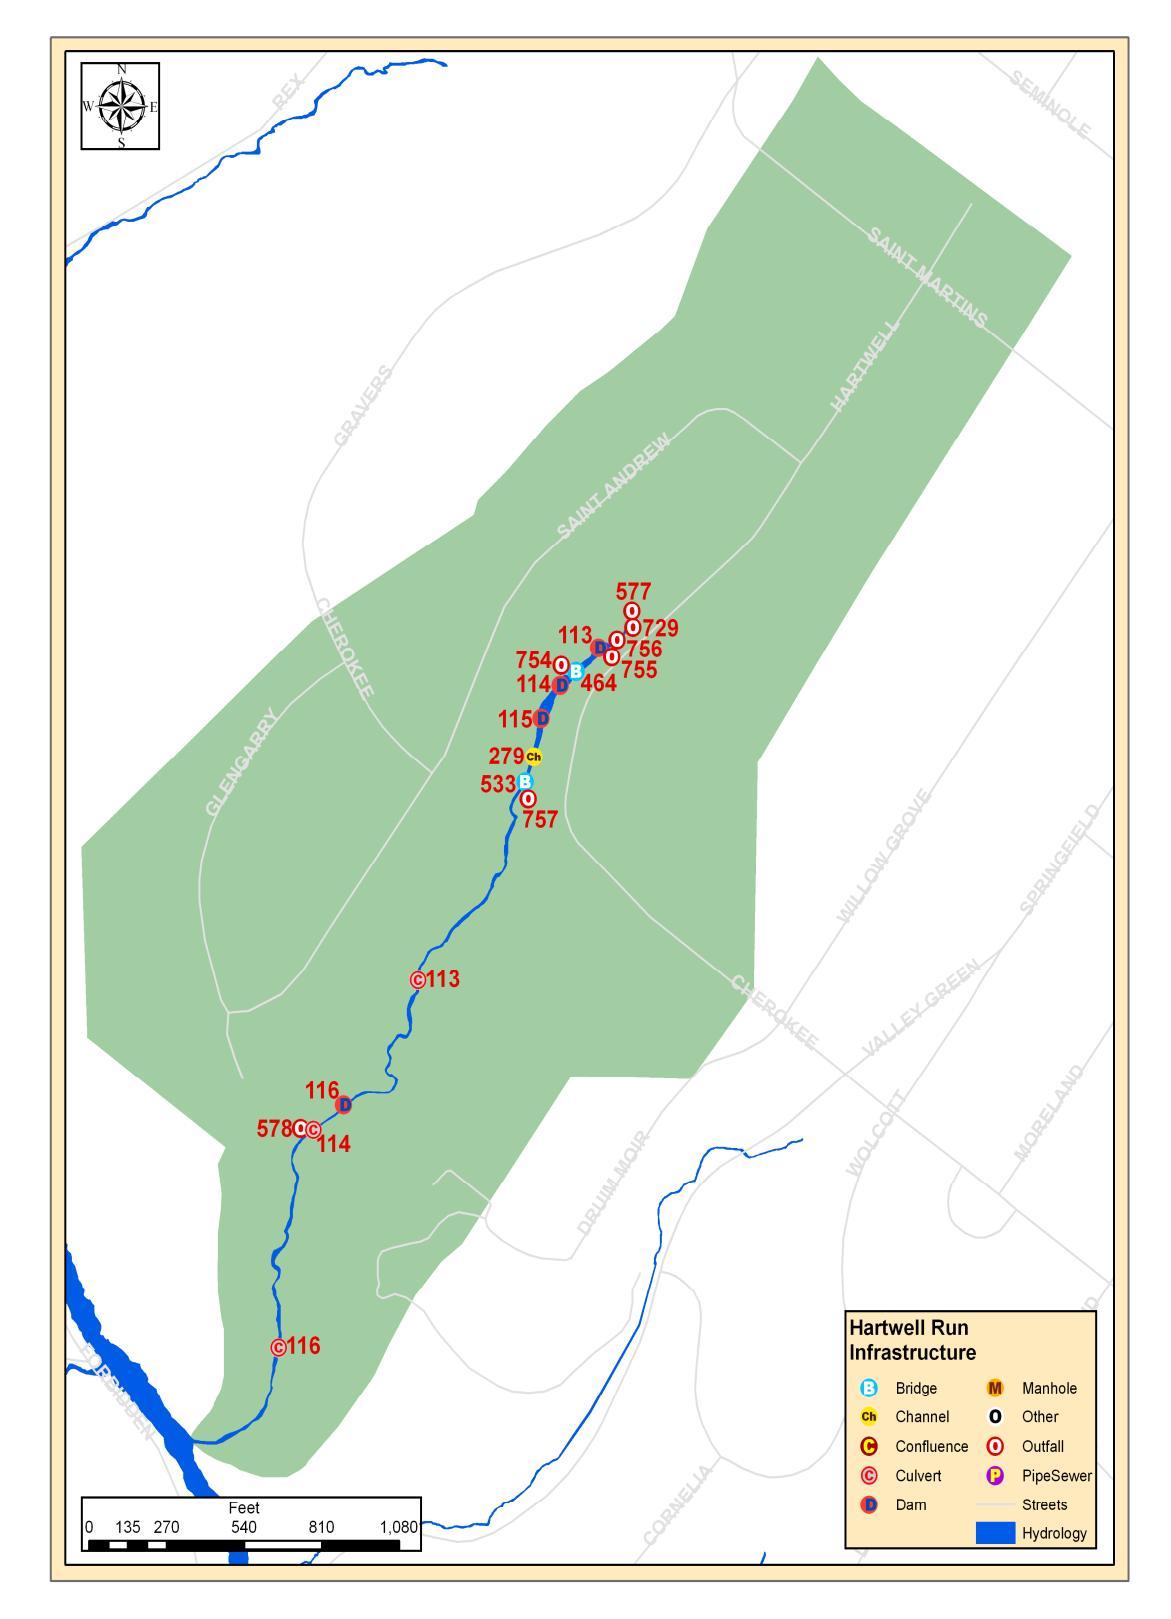
Figure 3-59: Hartwell Run Infrastructure Locations

Downstream in reach WSHW04, the channel was heavily influenced by stormwater. Increased flow from urban development has exceeded the capacity of the two culverts (Wscul13 and WScul114) in the reach. The culverts were built several decades ago and were not designed to transmit the current flow regime; therefore, these culverts can impede the downstream movement of water and sediment. At WScul116, which was constructed to protect the 45-inch Wissahickon High Level Interceptor, this occurred to such an extent that flow swept over the top of the culvert rather than through which caused substantial scour and mass slumping of the bank downstream of the culvert. PWD is currently modifying WScul116 so that it will no longer impede streamflow.

While a large portion of the flow came from the residential area upstream, WSout578 (W-076-07) in the upstream portion of WSHW04 conveyed stormwater from a 42-inch diameter pipe which drained St. Andrew Road and Glengarry Road. The majority of the infrastructure in the upstream residential area of WSHW02 was in good condition and only one infrastructure element, WScull14, was identified as being in poor condition.

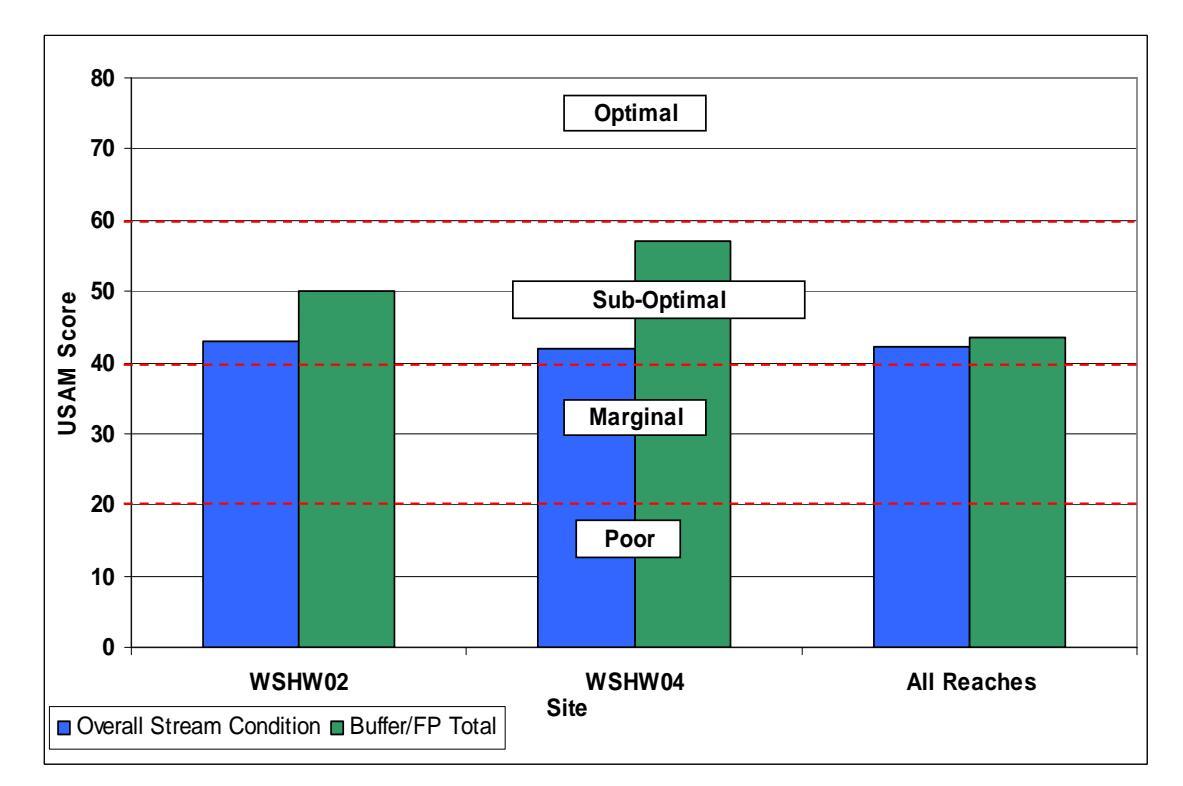
Figure 3-61: Results for Hartwell Run USAM Components

The mean scores for both of the individual USAM components as well as the overall USAM score were all classified as "suboptimal" (Table 3-62). Average conditions within the Hartwell Run watershed's buffers and floodplains were considerably better than conditions observed within the stream channels. The watershed averages for each

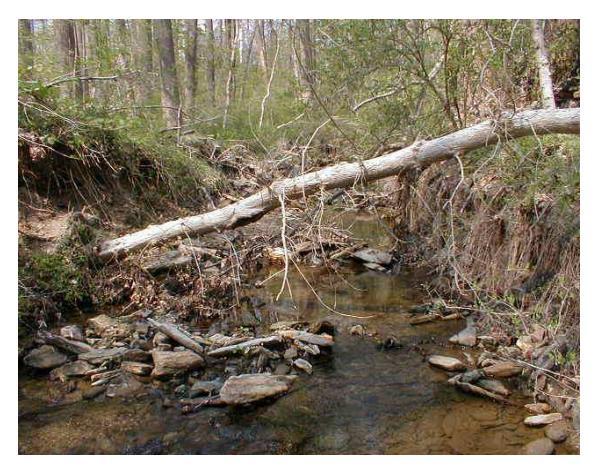
Ratings for this parameter ranged from "poor" to "marginal" however, these results concur with the state of floodplain connection throughout the Lower Wissahickon. Reach WSHW04 (1/20) had the worst score among all of the large Lower Wissahickon tributaries (WSKL02 and WSCR08 also scored 1/20). The mean watershed score of (5/20) was rated as "marginal" and was within the same range as the mean score for the Lower Wissahickon (6.3/10), which was also rated as "marginal." The low scores for

this parameter are symptomatic of the channel adjustments observed in many urban stream systems. Stream channels must reach equilibrium with "flashy" flows derived from impervious watersheds by adjusting laterally (channel widening) or vertically (incision or "downcutting").
