# WISSAHICKON CREEK STREAM ASSESSMENT STUDY LOWER WISSAHICKON WATERSHED

Philadelphia Water Department Office of Watersheds 2010

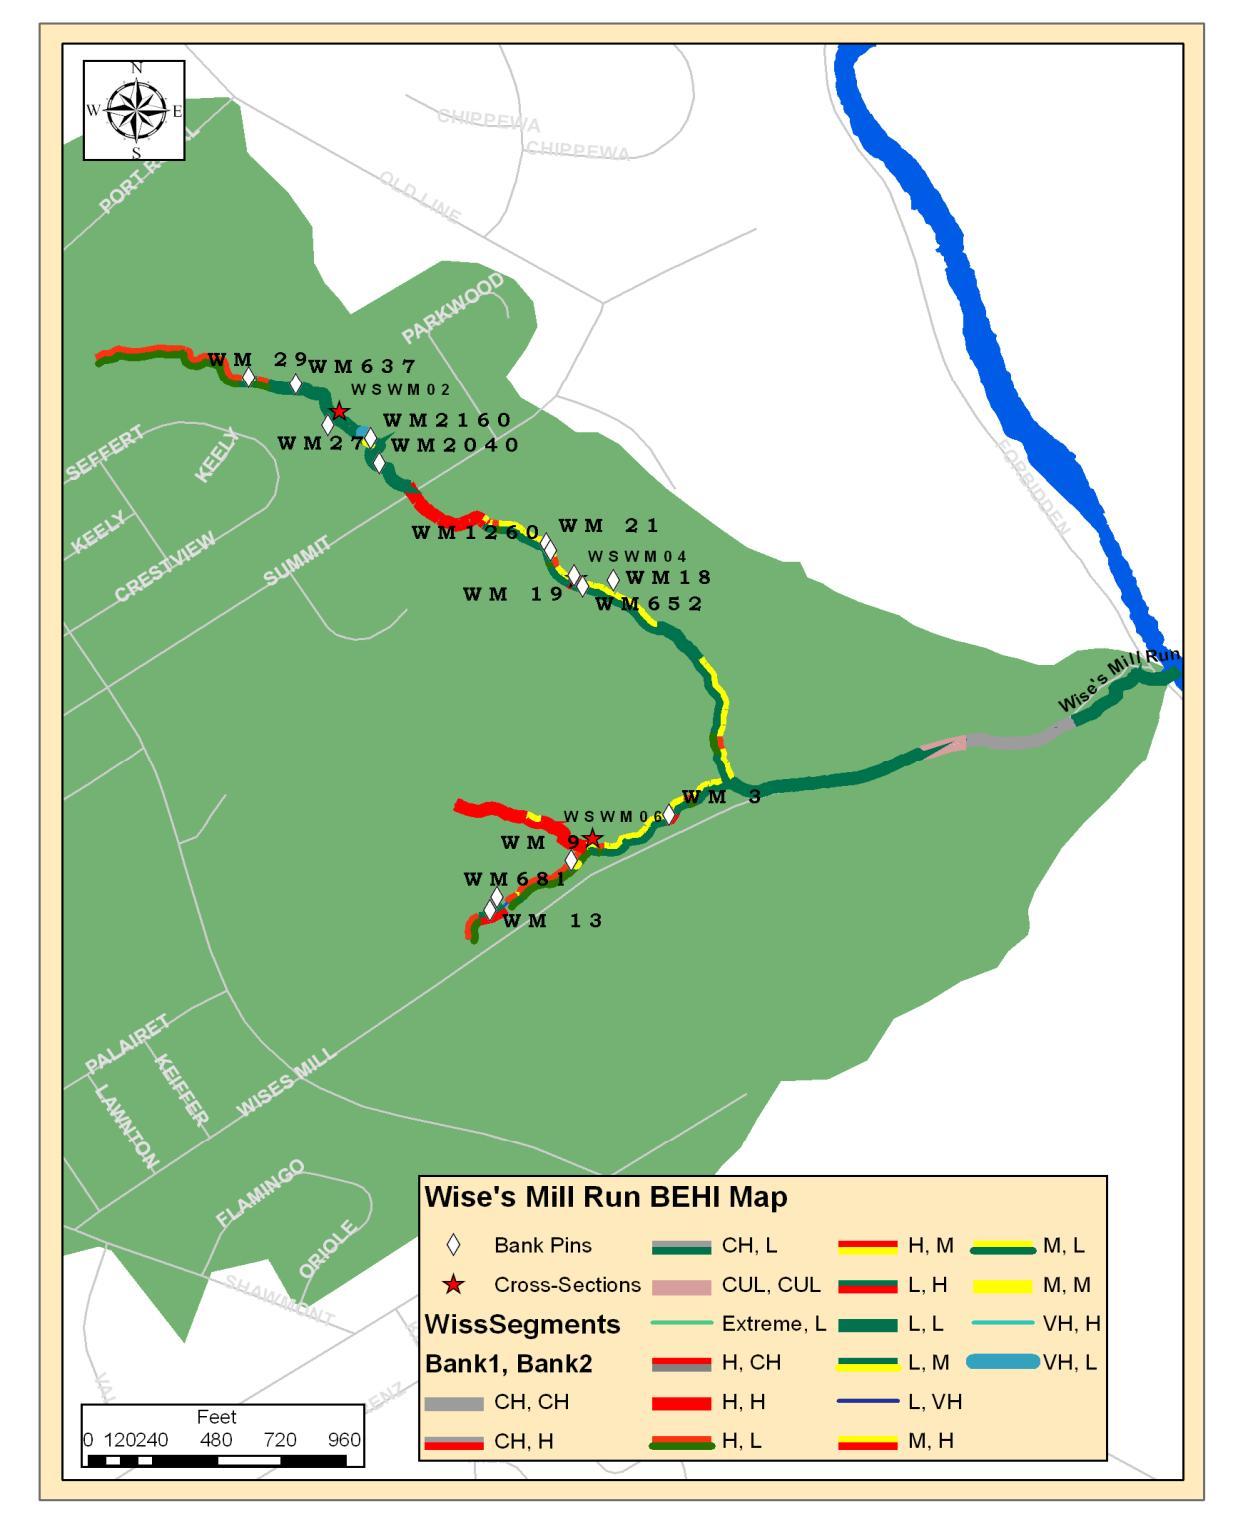
Figure 3-66: Wise's Mill Run Watershed BEHI Ratings and Bank Pin Locations

There were 13 bank pin locations along Wise's Mill Run (Figure 3-66). The calculated erosion rates are included in Table 3-66. The spatial distribution of BEHI assessment results were represented graphically (Figure 3-66) for each of the segments assessed on Wise's Mill Run. Each bank within a respective segment was assessed and rated separately; however, channelized and culverted segments were not assessed as they confer a high degree of protection from bank erosion.

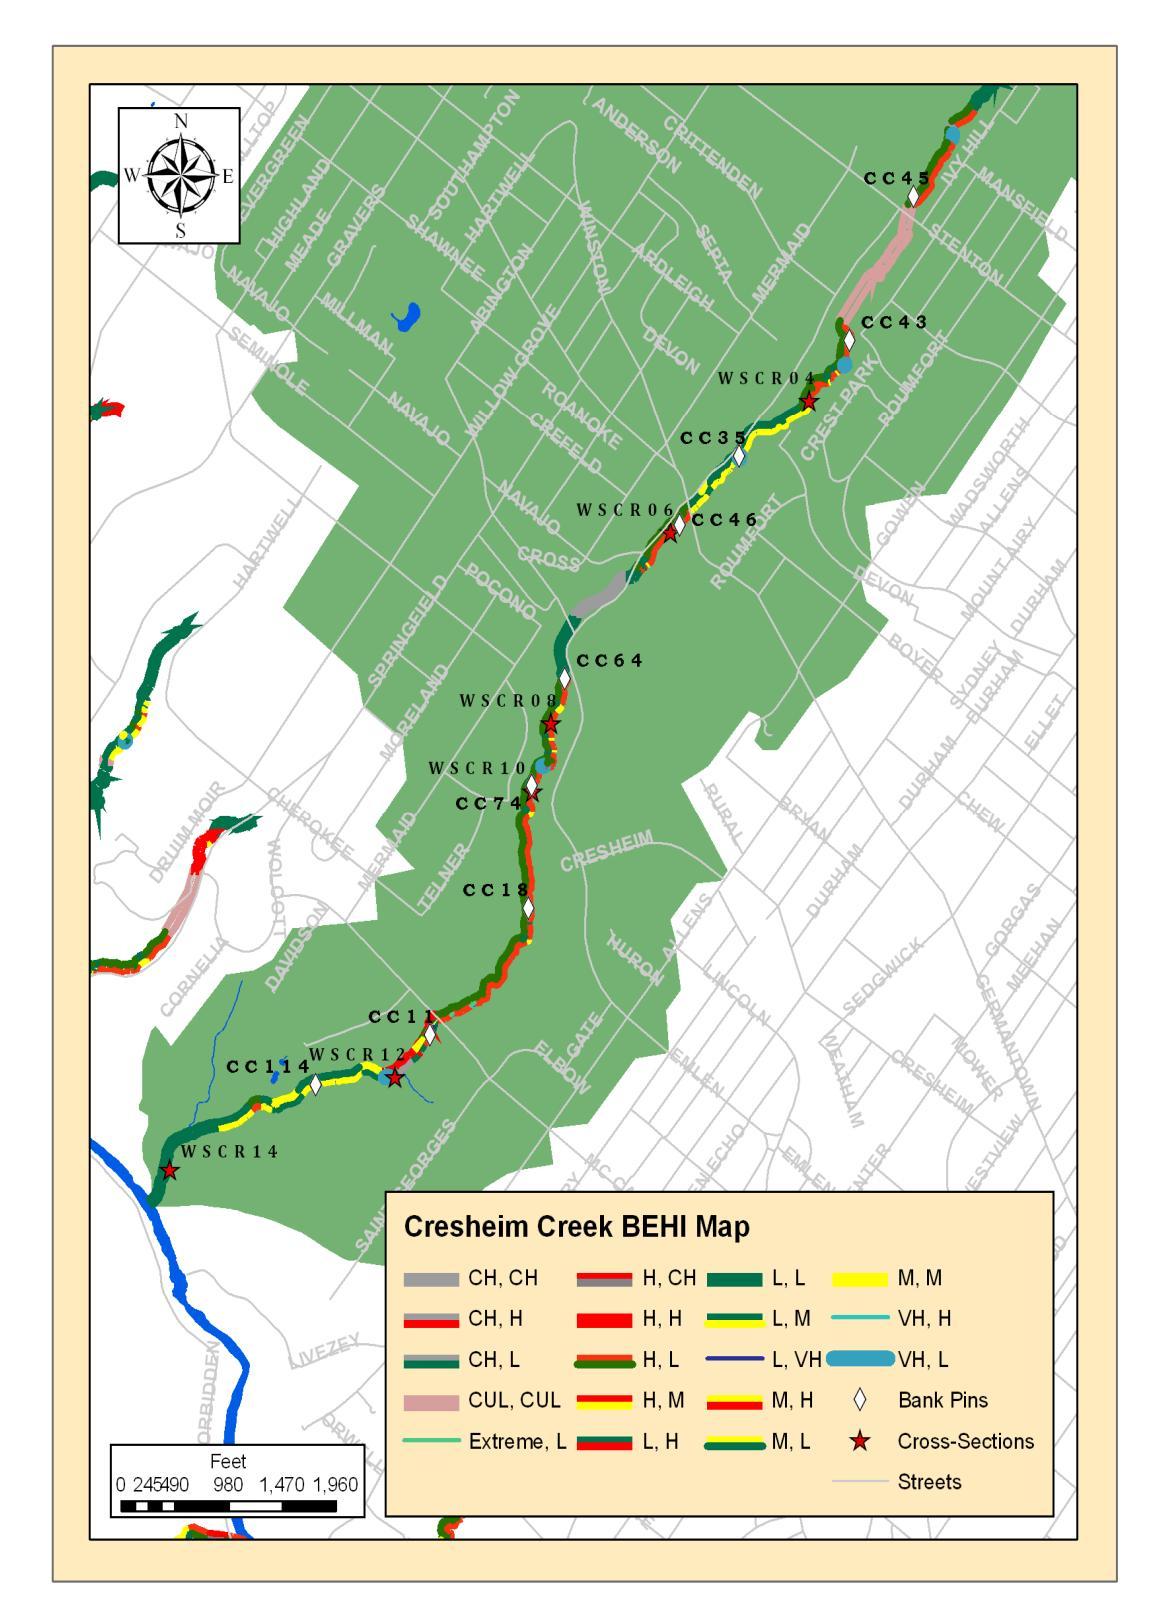
Figure 3-73: Cresheim Creek Watershed BEHI Ratings and Bank Pin Locations

There were nine bank pin locations along Cresheim Creek (Figure 3-73). The calculated erosion rates are included in Table 3-74. The spatial distribution of BEHI assessment results were represented graphically (Figure 3-73) for each of the segments assessed on Cresheim Creek. Each bank within a respective segment was assessed and rated separately; however, channelized and culverted segments were not assessed as they confer a high degree of protection from bank erosion.

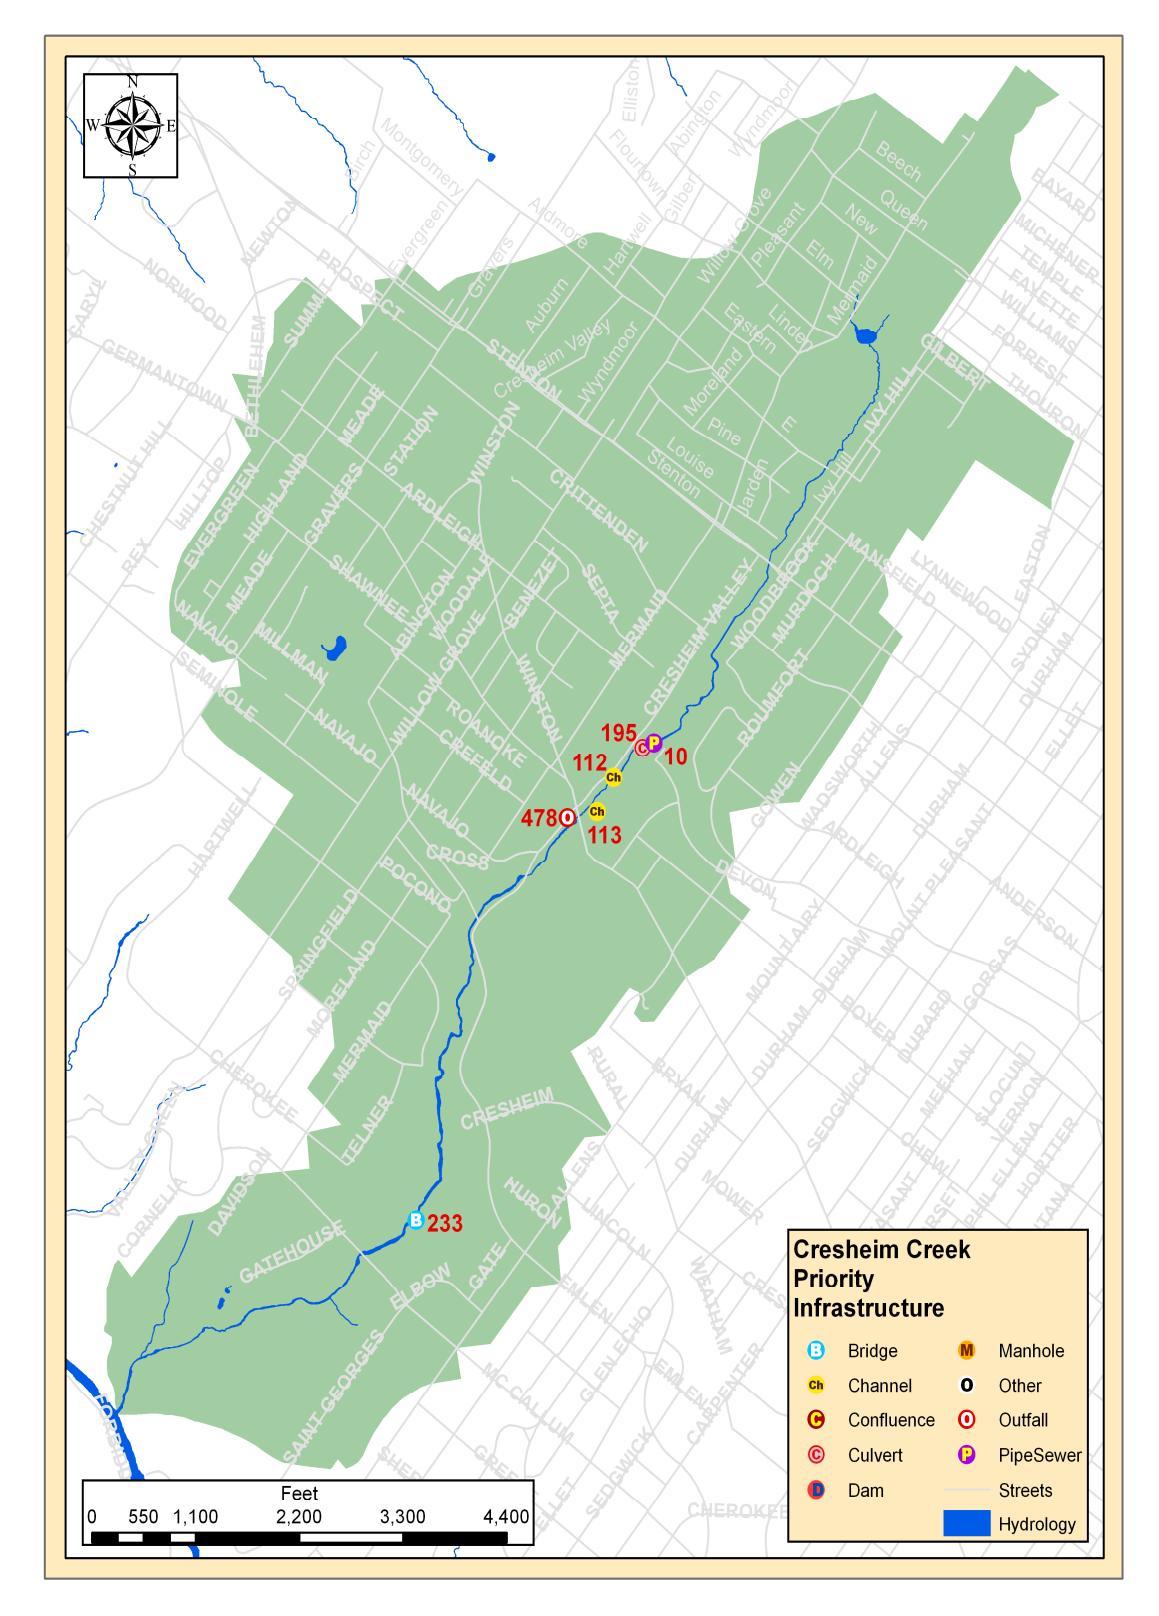
Figure 3-75: Cresheim Creek Priority Infrastructure

The Cresheim Creek watershed would likely have been completely besieged with infrastructure had the 3 downstream sections not been within the Park which only contained 9 of the 64 infrastructure points. The total percent of culverted channel length for the watershed was only 9%, which was small considering the large amount of culverts upstream. Most of the negative effects of the infrastructure in this watershed were attributed to the upstream portions of the stream. The majority of the infrastructure in this watershed was in good condition. There were some elements that exhibited signs of long-term use, although none were observed to be in extremely poor condition.

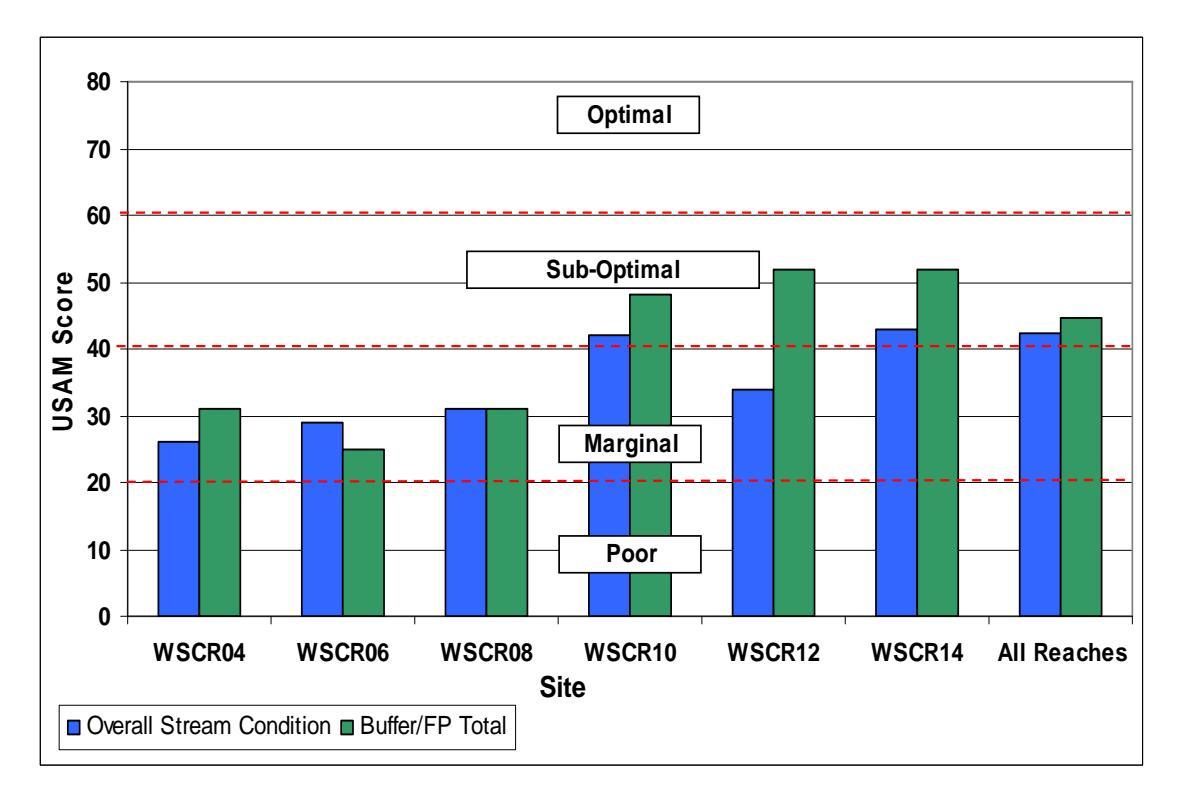
Figure 3-76: Results for Main Stem Cresheim Creek USAM Components

The mean scores for both the individual USAM components as well as the overall USAM score were all classified as "marginal" (Table 3-78). Average conditions within the Cresheim Creek watershed's buffers and floodplains were slightly better than conditions observed within the stream channels. The watershed averages for each component as well as the composite USAM score did not compare well against the respective All Reaches averages, especially for the *Overall Stream Condition* component. The scores for individual parameters ranged from poor to optimal, displaying similar levels of variability between reaches.

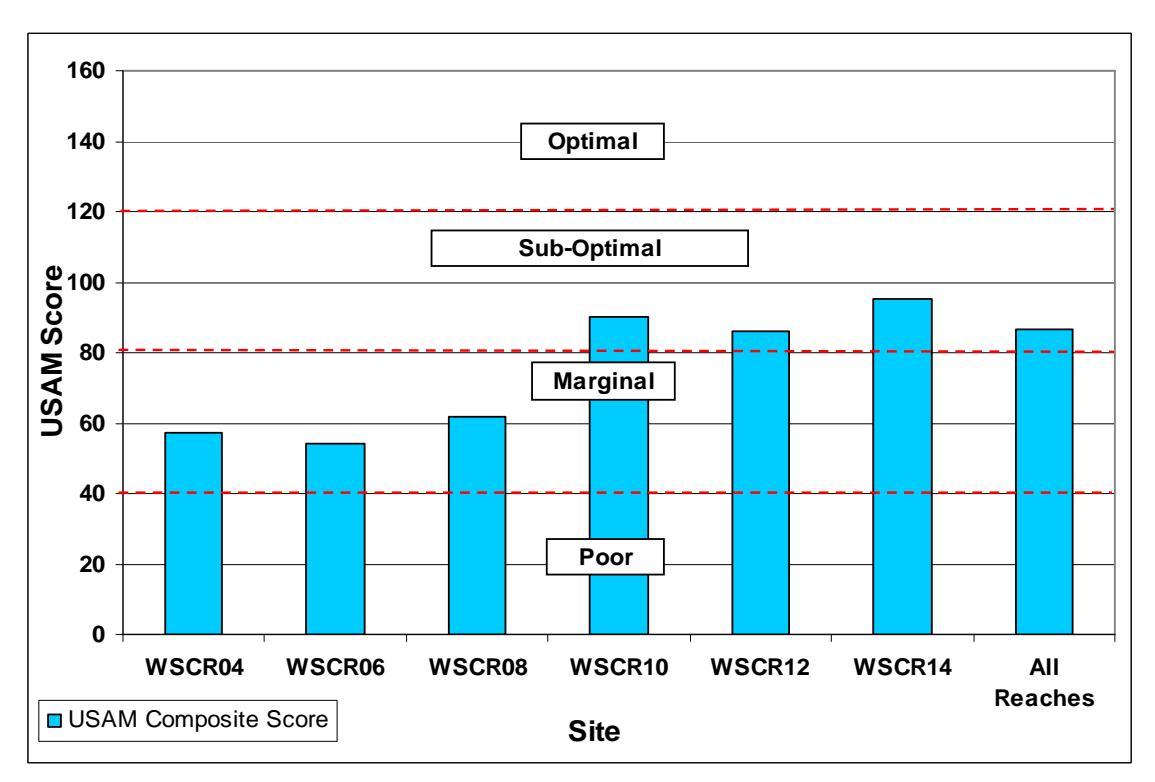
Figure 3-77: Cresheim Creek USAM Results

Reach WSCR04 formed the headwaters to Cresheim Creek and was the only reach with segments of stream channel in Montgomery County. The reach began as two small outfall-fed channels that drained to a shallow pond located 350 feet east of the intersection of Mermaid Lane and Flourtown Avenue. The larger of the two channels (DSR) received flow from WSout734 and WSout735. The DSL channel received flow from WScul532 which drained a large industrial park. Cross section WSCR04, used to characterize the reach, was located about 4,000 feet downstream within the Philadelphia portion of Cresheim Creek. The gravel-dominated (64%) reach was characterized by a very high width to depth ratio (41.7), a deeply entrenched channel (ER=1.2) and an extremely shallow gradient (0.9%). Overall, the reach was classified as an F4 stream type and had a composite USAM score (Figure 3-77) of (57/160).

composite USAM score of (95/160), which was the highest score observed for the Cresheim Creek watershed.

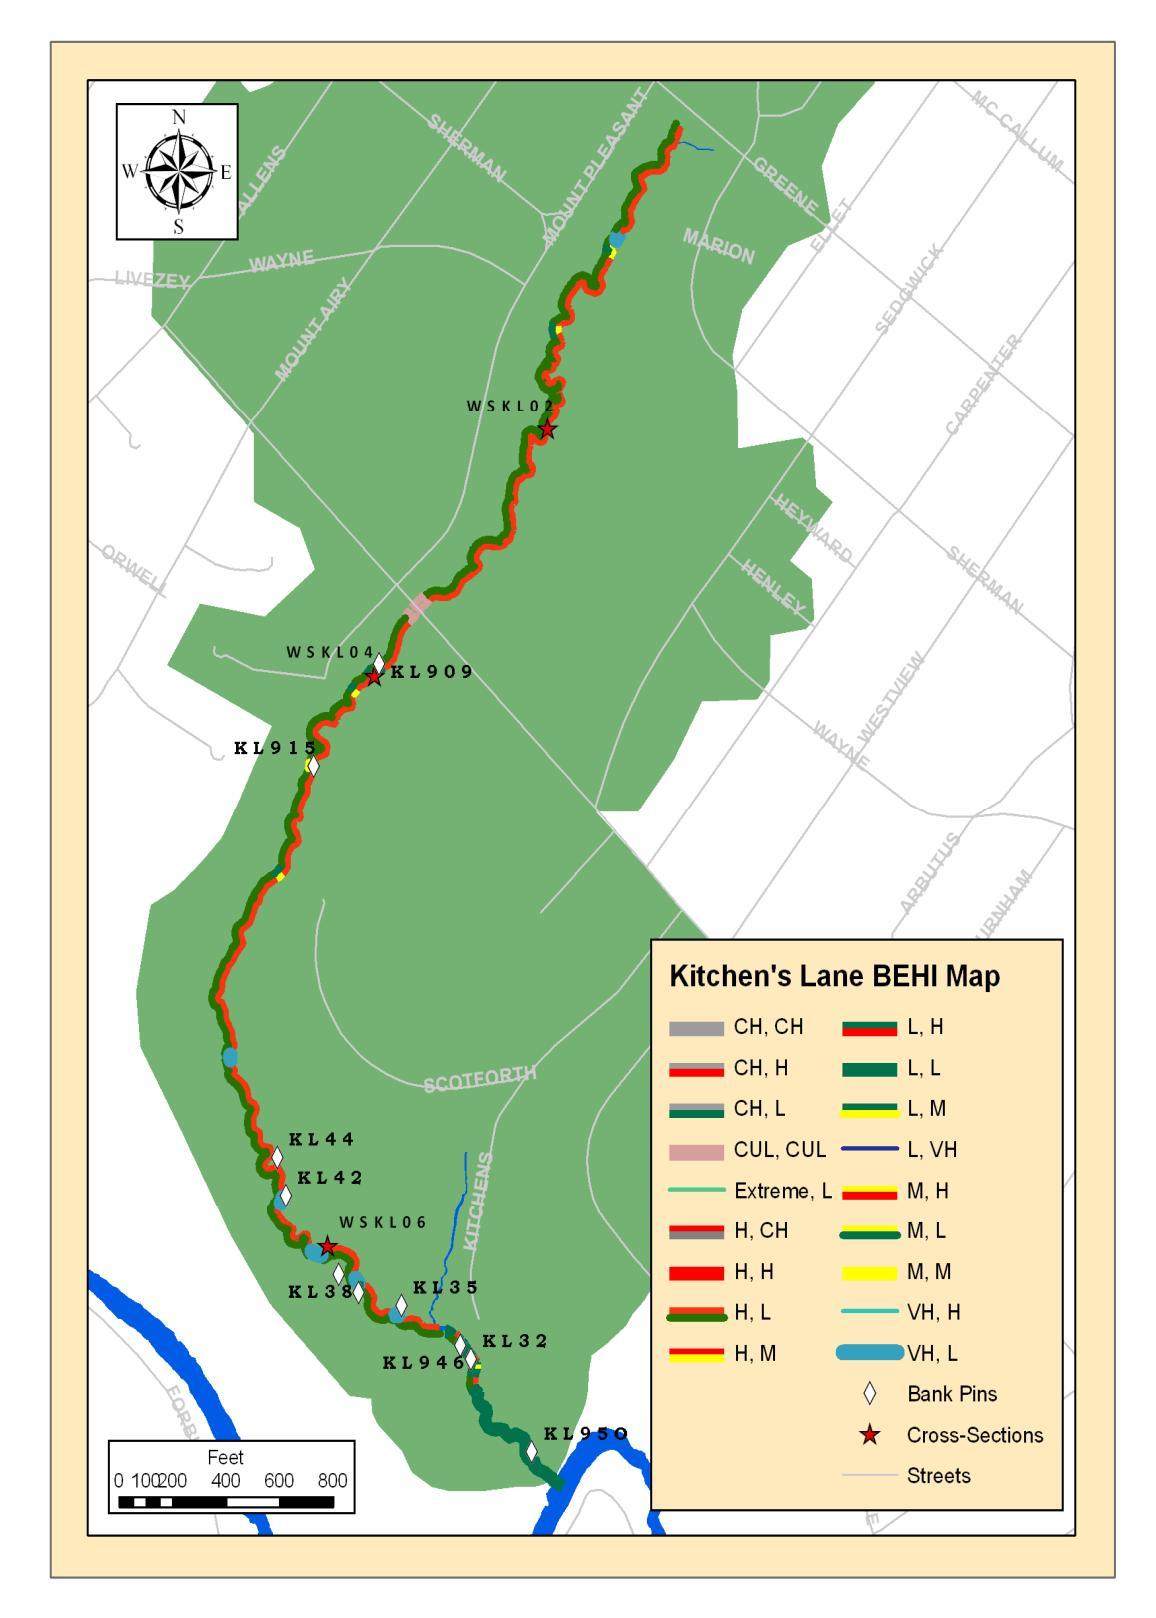
Figure 3-81: Kitchen's Lane BEHI Ratings and Bank Pin Locations

There were ten bank pin locations along Kitchen's Lane Run (Figure 3-81). The calculated erosion rates are included in Table 3-82. The spatial distribution of BEHI assessment results were represented graphically (Figure 3-81) for each of the segments assessed on Kitchen's Lane Run. Each bank within a respective segment was assessed and rated separately; however, channelized and culverted segments were not assessed as they confer a high degree of protection from bank erosion.

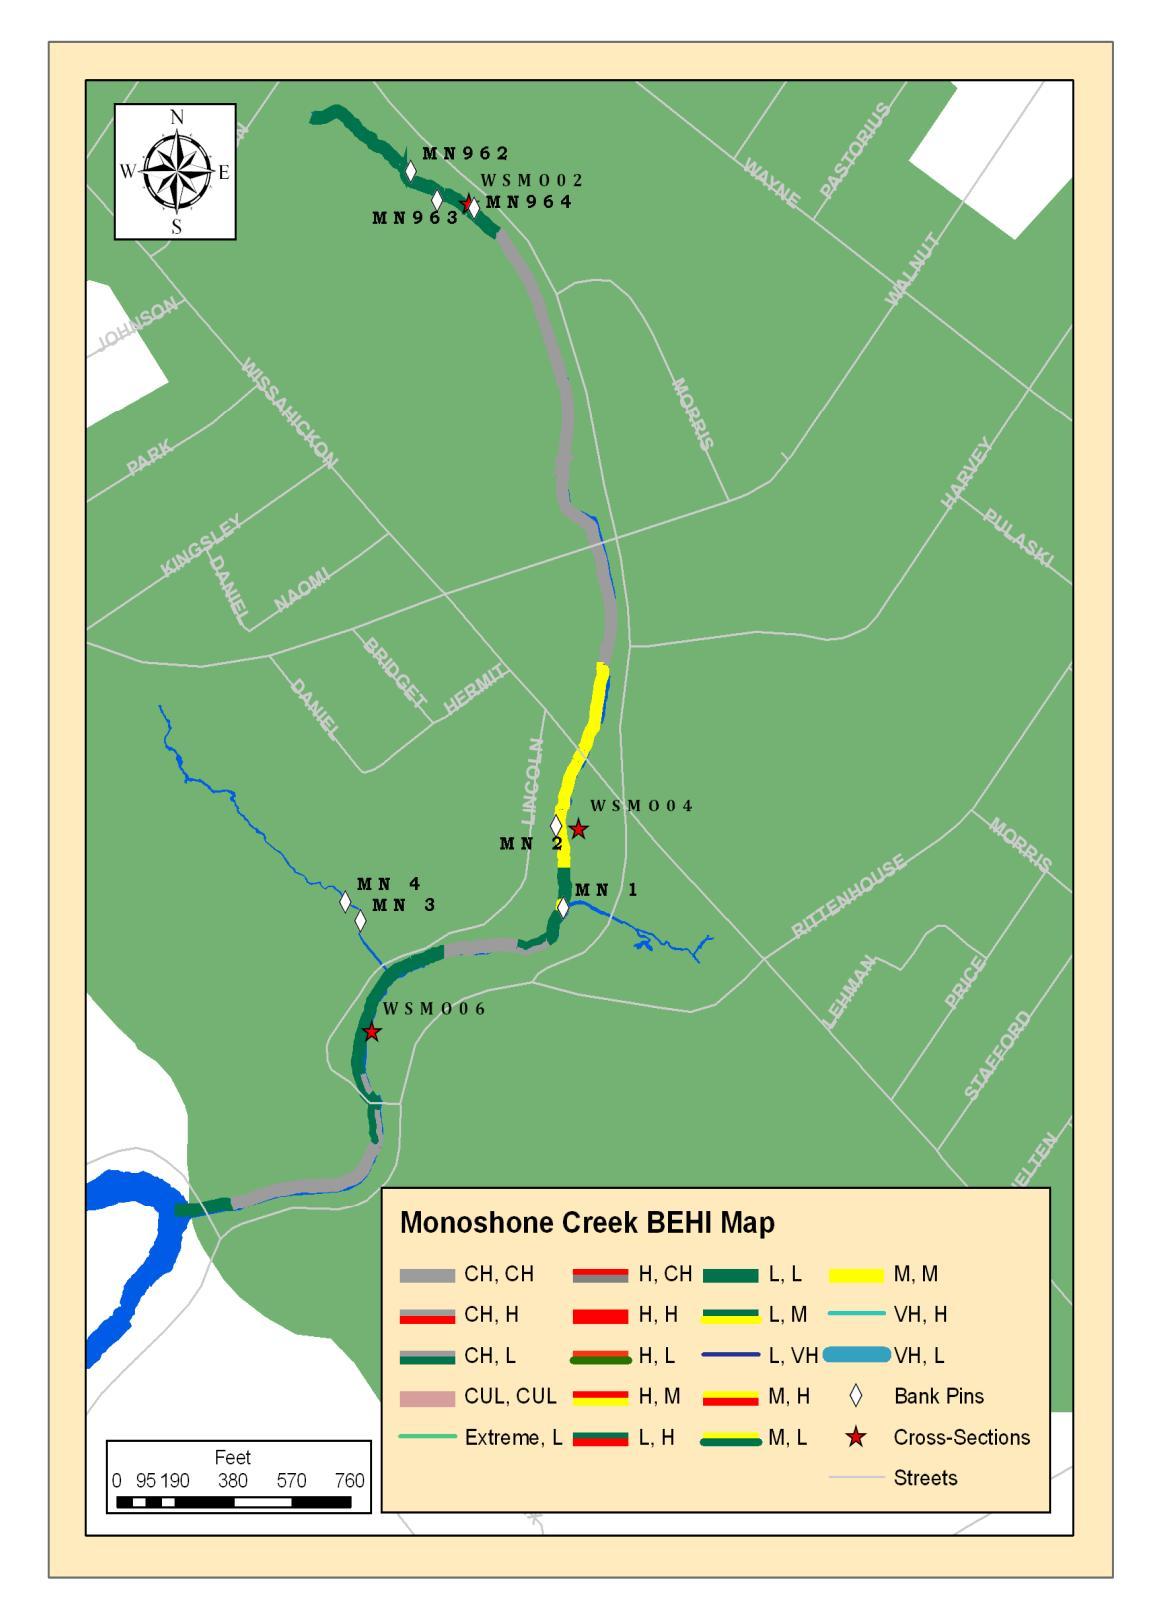
Figure 3-89: Monoshone Creek Watershed BEHI Ratings and Bank Pin Locations

There were seven bank pin locations along Monoshone Creek (Figure 3-89). The calculated erosion rates are included in Table 3-90. The spatial distribution of BEHI assessment results were represented graphically (Figure 3-89) for each of the segments assessed on Monoshone Creek. Each bank within a respective segment was assessed and rated separately; however, channelized and culverted segments were not assessed as they confer a high degree of protection from bank erosion.

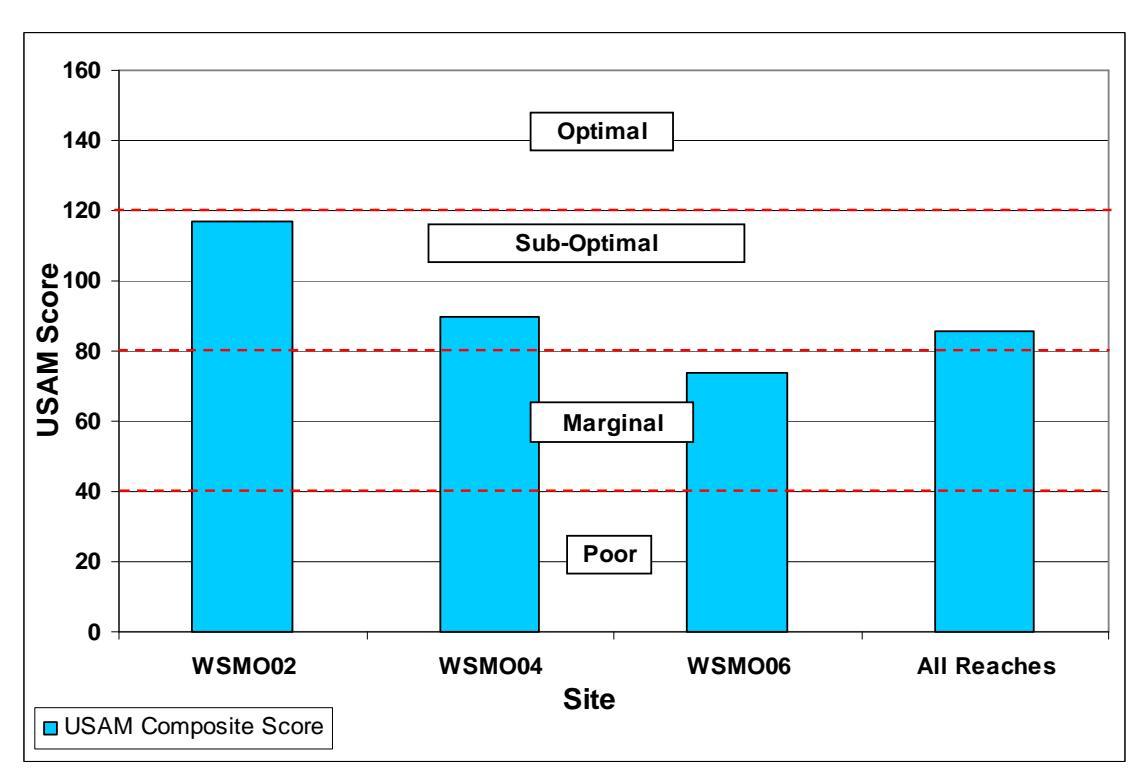
Figure 3-92: Monoshone Creek USAM Results

Reach WSMO02 contained the headwaters of Monoshone Creek which began as flow from WSout544 located 315 feet southwest of the intersection of Johnson Street and Lincoln Drive. The entire reach ran parallel to Lincoln Drive and was highly channelized (WScha203 on the DSR and WScha132 on the DSL) along the segment of the reach that was located within 40 feet of Lincoln Drive. The substrate particle size distribution was dominated by silt (67%) with sand (33%) comprising the remainder of the sediment in the reach. The channel morphology in reach WSMO02 was characterized by a moderate width to depth ratio (12), a deeply entrenched channel (ER=1.6) and a moderately shallow gradient (3.1%). The reach was classified as a type B6 stream channel and had a USAM composite score (Figure 3-92) of 117/160 which was the second highest score of all reaches assessed in the Lower Wissahickon Basin.

The mean scores for both the *Overall Stream Condition* component as well as the composite USAM score were classified as "optimal" (Table 3-94). Average conditions within the Monoshone Creek watershed's stream channels were slightly better than conditions observed within the buffers and floodplains. The watershed averages for the *Overall Stream Condition* component, as well as the composite USAM score, compared very well against the respective All Reaches averages, however the *Overall Buffer and Floodplain* component was relatively close to the All Reaches average. The scores for individual parameters ranged from poor to optimal, displaying similar levels of variability between reaches.

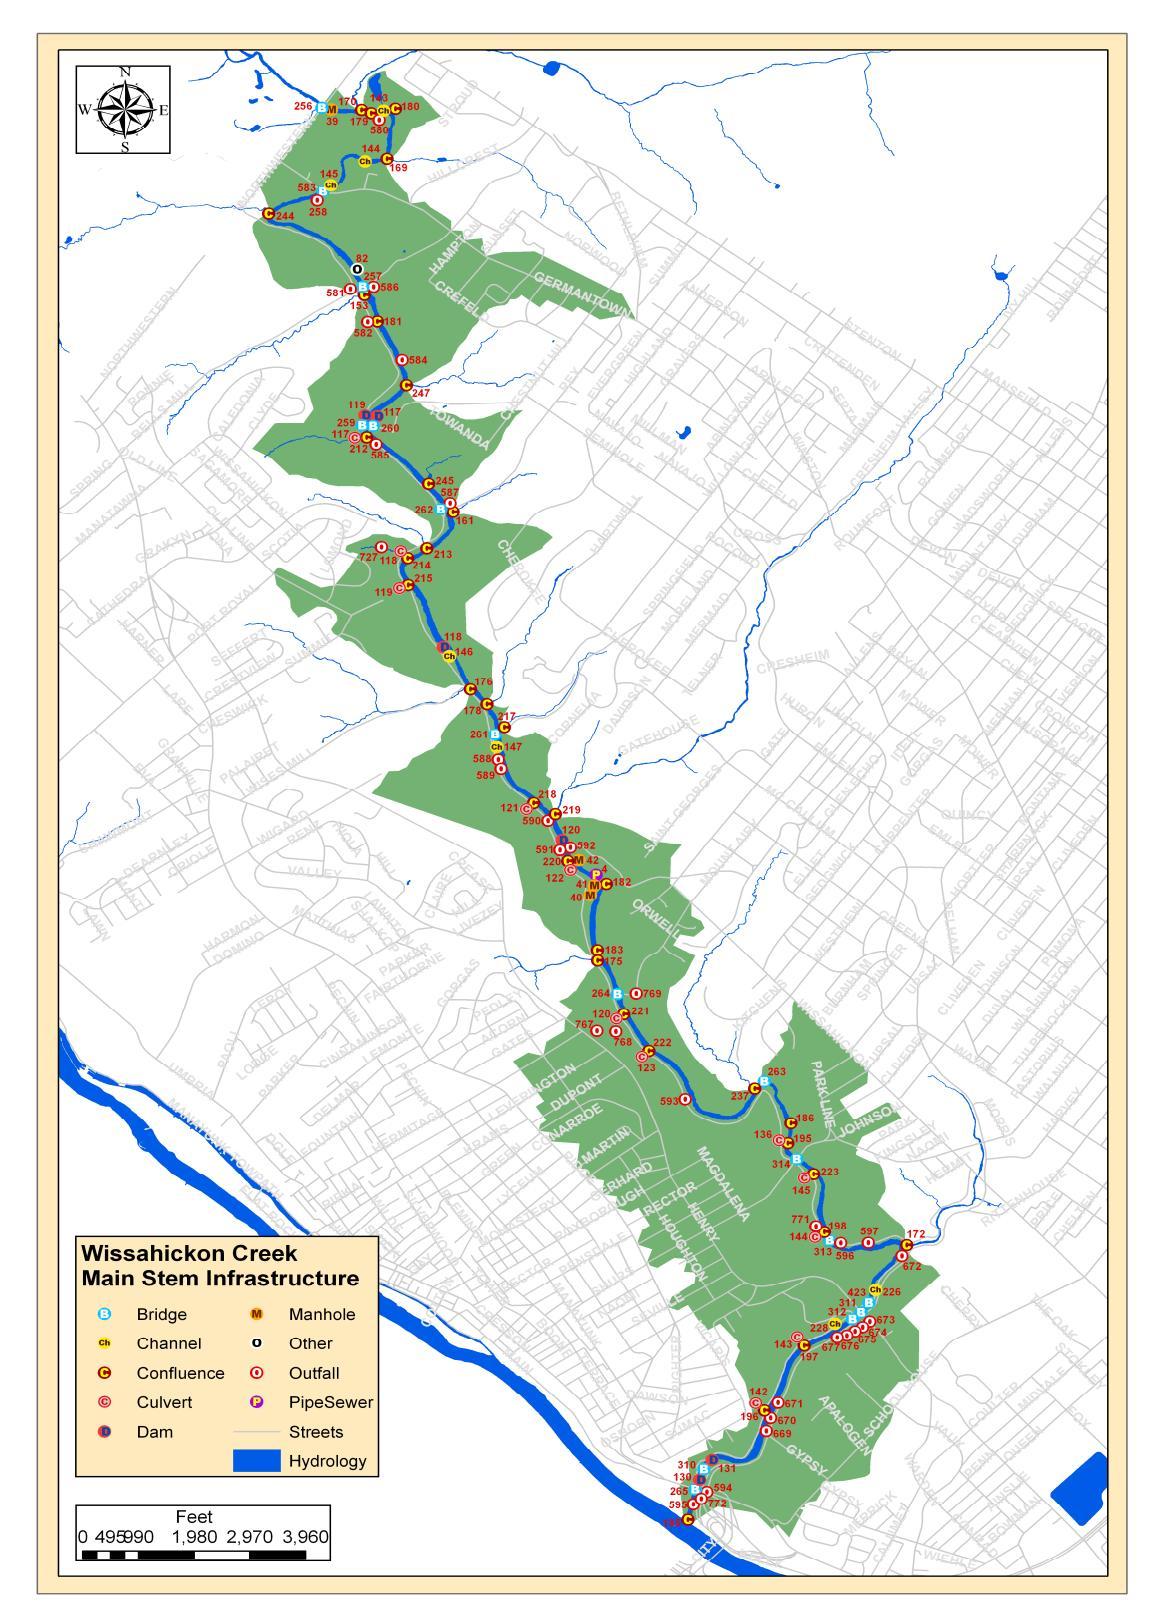
Figure 3-96: Lower Wissahickon Creek Main Stem Infrastructure Locations

There were four pieces of infrastructure identified as being in poor condition along the main stem of Wissahickon Creek. They were WScha143 and in WSMS102, and WScha146 in WSMS114, and WScul122 in reach WSMS120. Also WSpip04, a 20-inch water main, in section WSMS120, appeared to be in good condition, but was exposed by the creek.

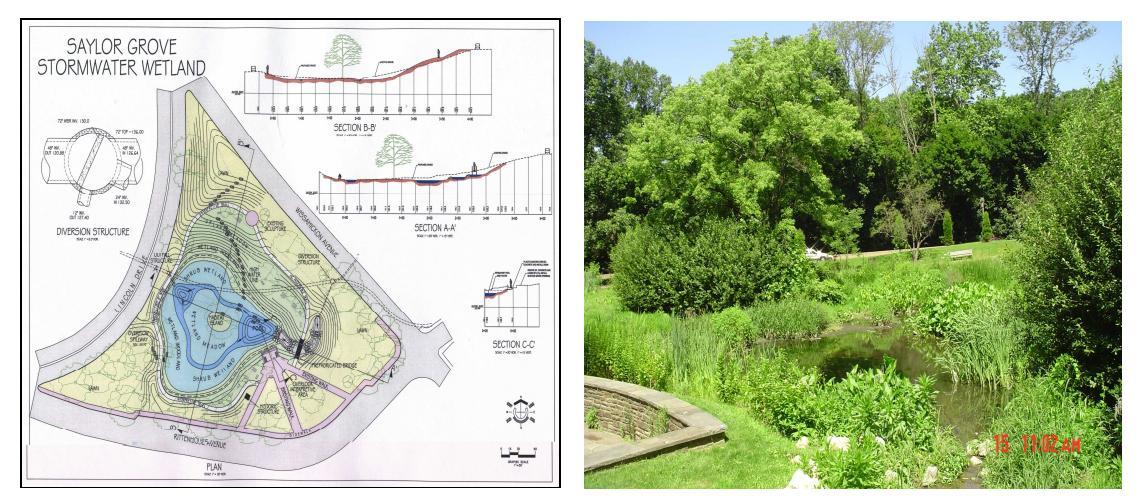
Figure 3-104: Plan view rendering of Saylor Grove Stormwater Wetland (left); fully vegetated view of Saylor Grove (right).

In 2009, the Saylor Grove treatment wetland was dredged for the first time as part of the post-construction maintenance program. The wetland dredging had two main objectives-to expand the capacity of the wetland to store and treat stormwater and to redefine the wetland's low flow channels. Results of the post-dredging sediment composition analysis revealed that the vast majority of sediment removed consisted of sand (0.075mm – 4.75mm) and silt (0.005mm – 0.075mm). These results had implied that the wetland is in fact removing a large part of the suspended sediment load delivered from the Monoshone Creek watershed. If not for the wetland, the fine sediment component of stormwater would enter Monoshone Creek where it would have adverse implications for water quality (e.g. turbidity and total suspended sediment (TSS)) as well as instream habitat (e.g. stream bed embeddedness).
