# **PENNYPACK CREEK STREAM ASSESSMENT REPORT**

## **LOWER PENNYPACK WATERSHED**

**Office of Watersheds 2013**

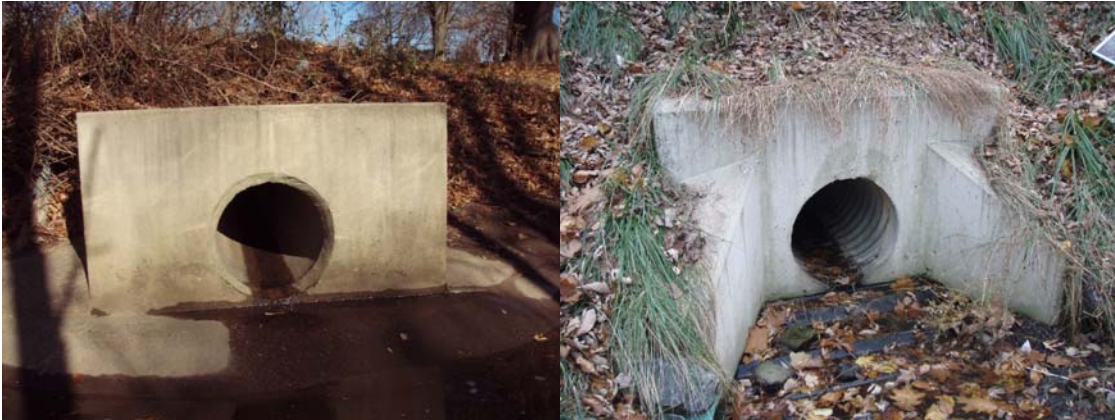
Figure 2-5: Example of an outfall point assessed in infrastructure trackdown

An outfall was defined as the end of a pipe which releases either stormwater, combined sewage, or an encapsulated creek into the waterway (Figure 2-5). Data was collected on outfalls larger than 12 inches. The data collected for each outfall included the pipe dimensions (diameter, height and width), the presence of an apron, the construction material (i.e. metal, concrete, terra cotta, etc.), structural condition (i.e. good, fair, or poor), presence of, and quality of dry weather flow, bank location (right or left), and submergence depth. The outfall area was determined based on the dimensions and is used for assessment and comparison in the infrastructure sections later in this report.

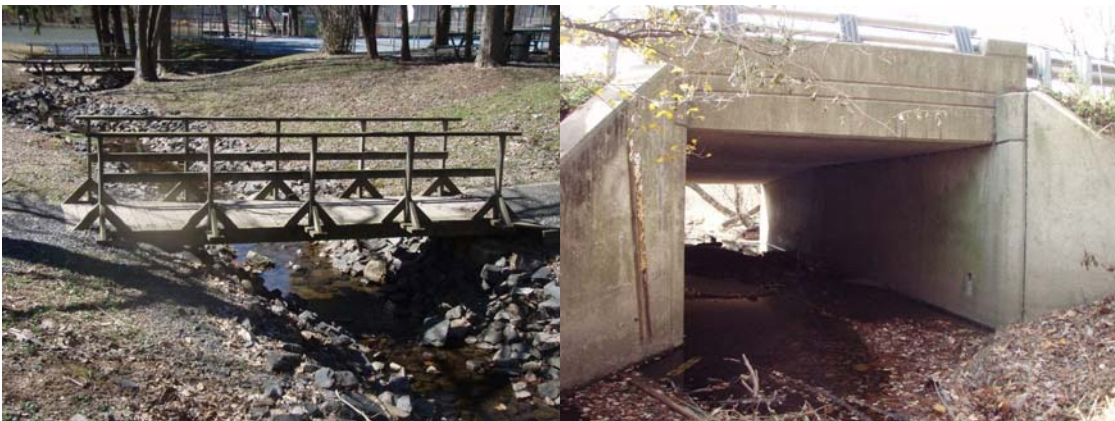
Figure 2-6: Examples of bridges assessed in infrastructure trackdown

A bridge was defined as a structure that spanned a stream over which a road or walkway passes (Figure 2-6). Bridges mapped in this report are shown as one point at the center of the bridge along the creek. The data collected for each bridge included the approximate height, width and length along the stream of the bridge opening, the construction material (i.e. metal, concrete, wood, stone, etc.), and structural condition (i.e. good, fair, or poor).

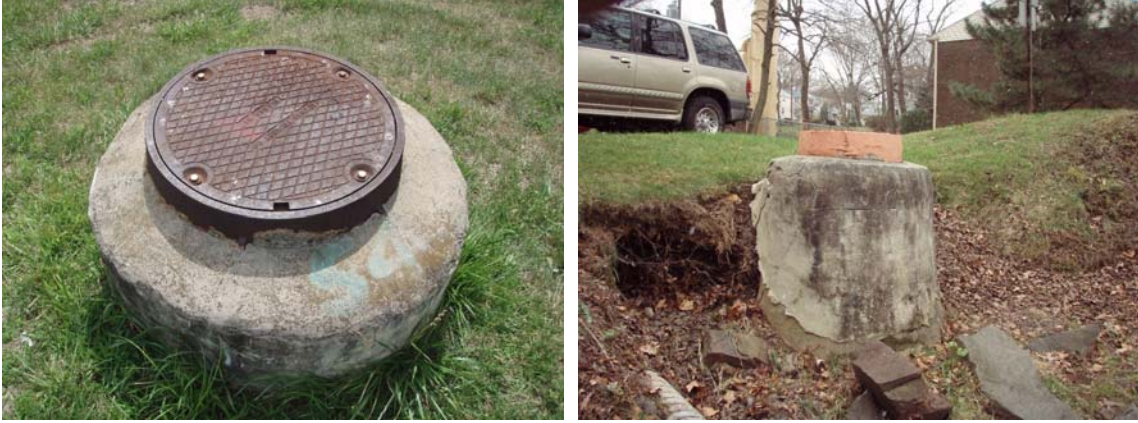
Figure 2-7: Examples of manholes assessed in infrastructure trackdown.

A manhole was defined as the covered opening that allows access to an existing utility (Figure 2-7). Data was collected for manholes either located within the creek or in close proximity to the stream banks. The data collected for each manhole included the approximate diameter of the manhole, the construction material (i.e. concrete or terra cotta), the height of the portion of manhole exposed above the ground or water surface, structural condition (good, fair, or poor), bank location (left or right) and the presence and description of any odor.

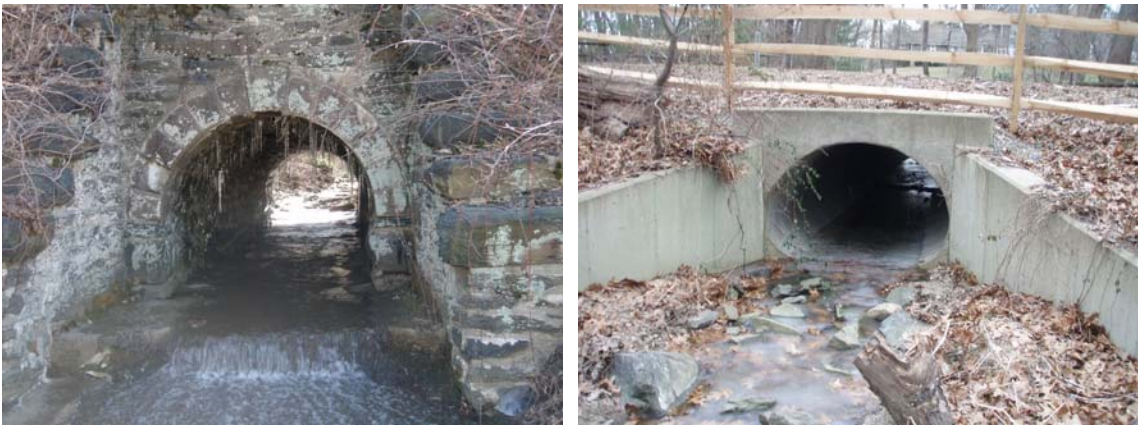
Figure 2-8: Examples of culverts assessed in infrastructure trackdown.

A culvert was defined as a conduit which carried the stream under a roadway, sidewalk, building, or miscellaneous structure (Figure 2-8). Culverts were mapped by taking GPS coordinates at the start and end of the culvert with photos taken at each point. The data collected for each culvert included the approximate dimensions, construction material (e.g. stone, concrete, brick, etc.), structural condition (i.e. good, fair, or poor), presence and quality of dry weather flow, and bank location (left or right). For comparison between reaches, the percentage of culverted stream length was calculated for each reach. This was determined by dividing the culverted stream length by the total stream length.

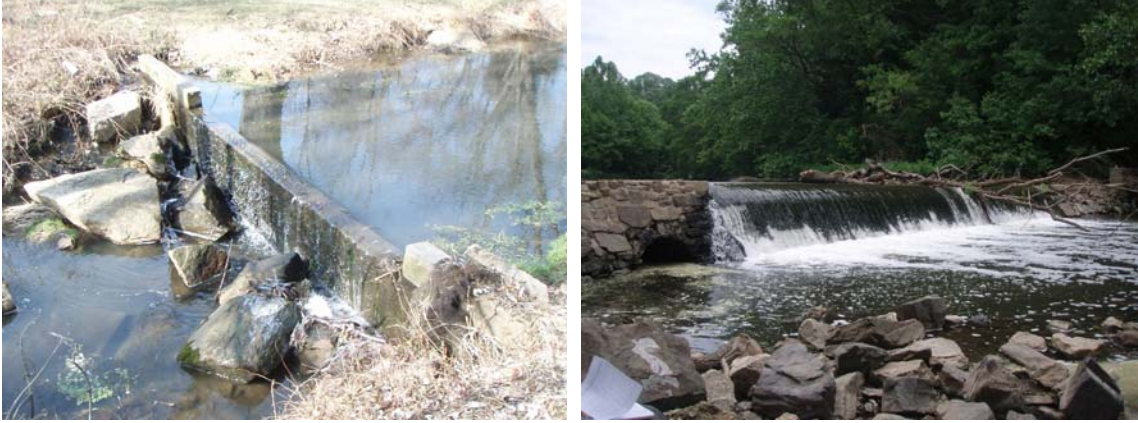
Figure 2-9: Examples of dams assessed in infrastructure trackdown.

A dam was defined as an obstruction that impounded stream flow (Figure 2-9). Data was only collected for manmade dams and did not include natural debris jams caused by coarse woody debris (CWD). The data collected for each dam included the approximate dimensions, construction material, structural condition (good, fair, or poor) and bank location (left, right, or across the creek).

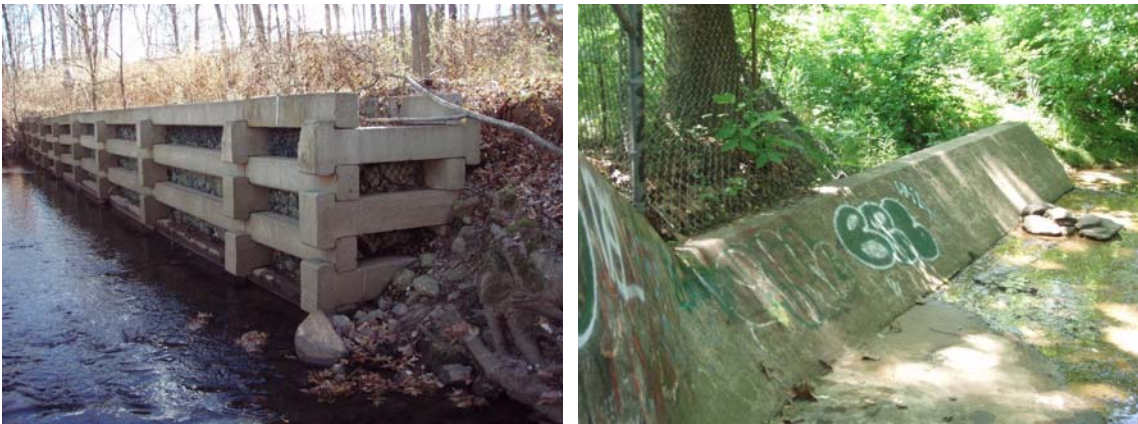
Figure 2-10: Examples of channels assessed in infrastructure trackdown.

A channel was defined as a straightening and reinforcement of stream bed and/or banks with manmade materials such as concrete (Figure 2-10). Channels were located on one or both banks, as well as on the bottom of the stream bed. Each channel was mapped by taking GPS coordinates at the start and end of the channel with photos taken at each point. The data collected for each channel included approximate dimensions, structural condition (good, fair, or poor), the portion of stream that was channelized (i.e. left bank, right bank or bottom), and construction material (stone or concrete). For comparison between reaches, the percentage of channelization was calculated by adding the total length of stream with one side (left bank, right bank, or the bottom) channelized, the total length channelized on two sides multiplied by two, and the total length channelized on all three sides multiplied by three, and dividing the sum by the total stream length multiplied by three.

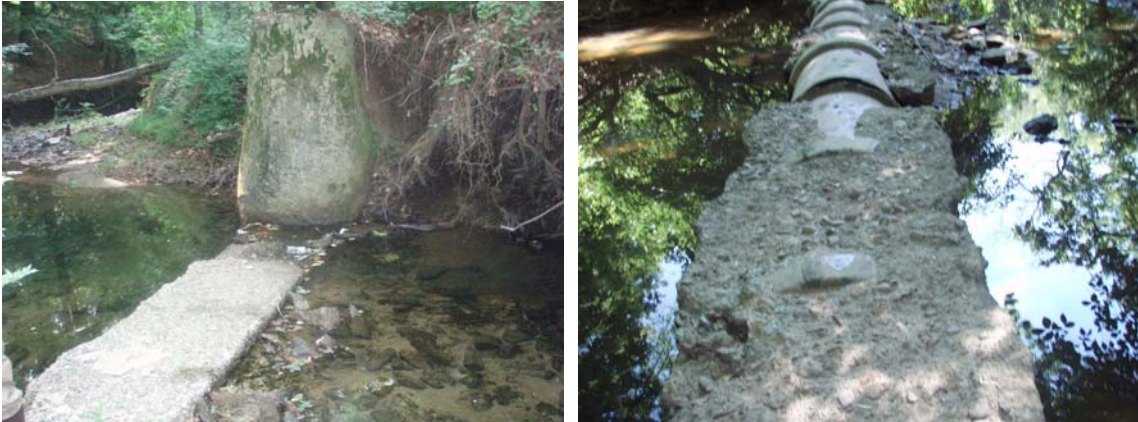
**Figure 2-11: Example of a pipe assessed in infrastructure trackdown.**

A pipe was defined as a conduit for carrying a utility across the stream (Figure 2-11). The data collected for each pipe included the approximate diameter, construction material (i.e. concrete, metal, terra cotta, etc.), the length and height above the water or ground surface of the exposed portion, structural condition (i.e. good, fair, or poor), presence and quality of dry weather flow, bank location (i.e. left, right or across the creek), and submergence depth.

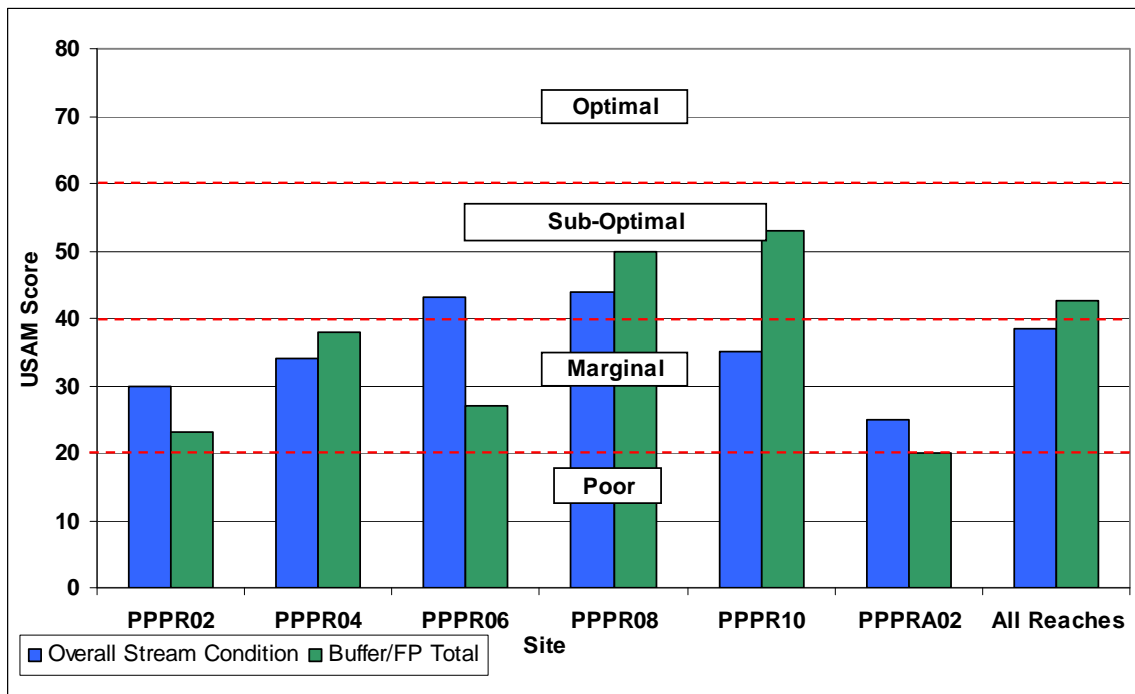
**Figure 3-13: Results for Paul's Run USAM Components**

Paul’s Run Watershed was a highly urbanized watershed characterized by residential land-use and a very narrow stream corridor. Wooded land-use composed only 10% of the watershed with the most extensive coverage located in the lower portion of the watershed near the confluence of Paul’s Run and Pennypack Creek. The Center for Watershed Protection’s (CWP) Unified Stream Assessment Methodology (USAM) was used to score and rate the in-stream, riparian buffer and floodplain conditions of the stream corridor to allow for comparison to other reaches and watersheds within the Lower Pennypack Creek basin. The all reaches parameter is the mean of the scores of all tributary reaches in the Lower Pennypack Creek study.

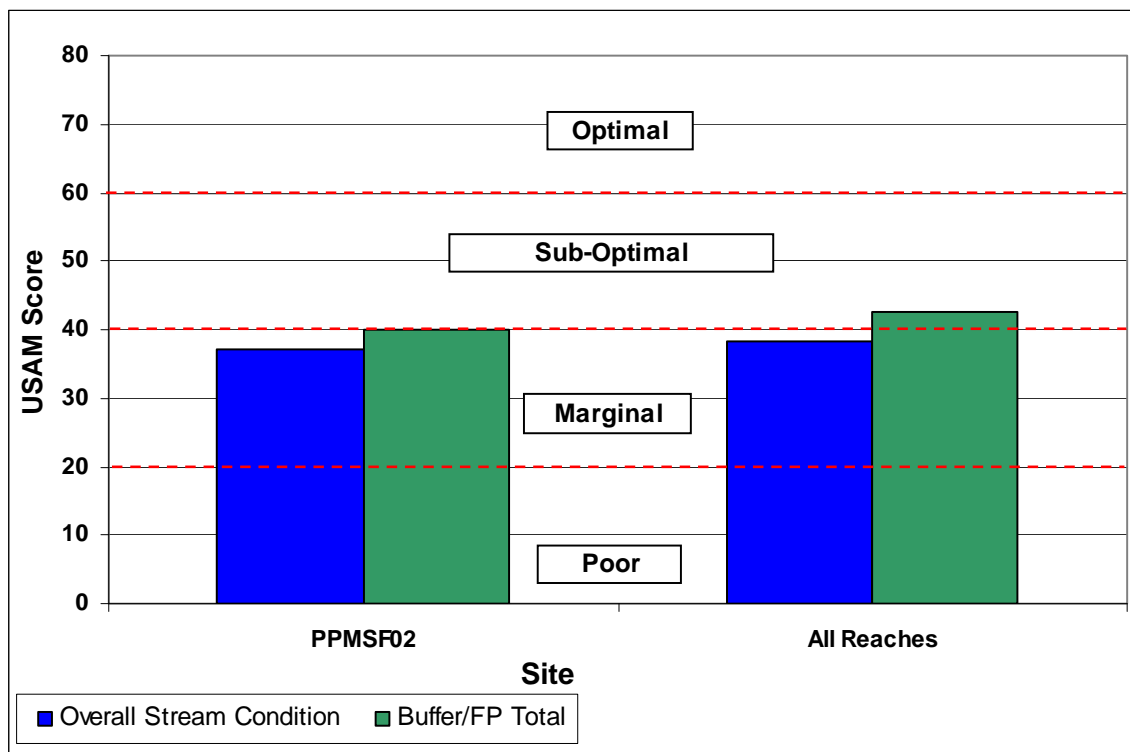
Figure 3-20: Results for Sedden's Creek (PPMSF02) USAM Components

The Center for Watershed Protection’s (CWP) Unified Stream Assessment Methodology (USAM) was used to score and rate the in-stream, riparian buffer and floodplain conditions of the stream corridor to allow for comparison to other reaches and watersheds within the Lower Pennypack Creek basin. The All Reaches parameter is the mean of the scores of all tributary reaches in the Lower Pennypack Creek study.

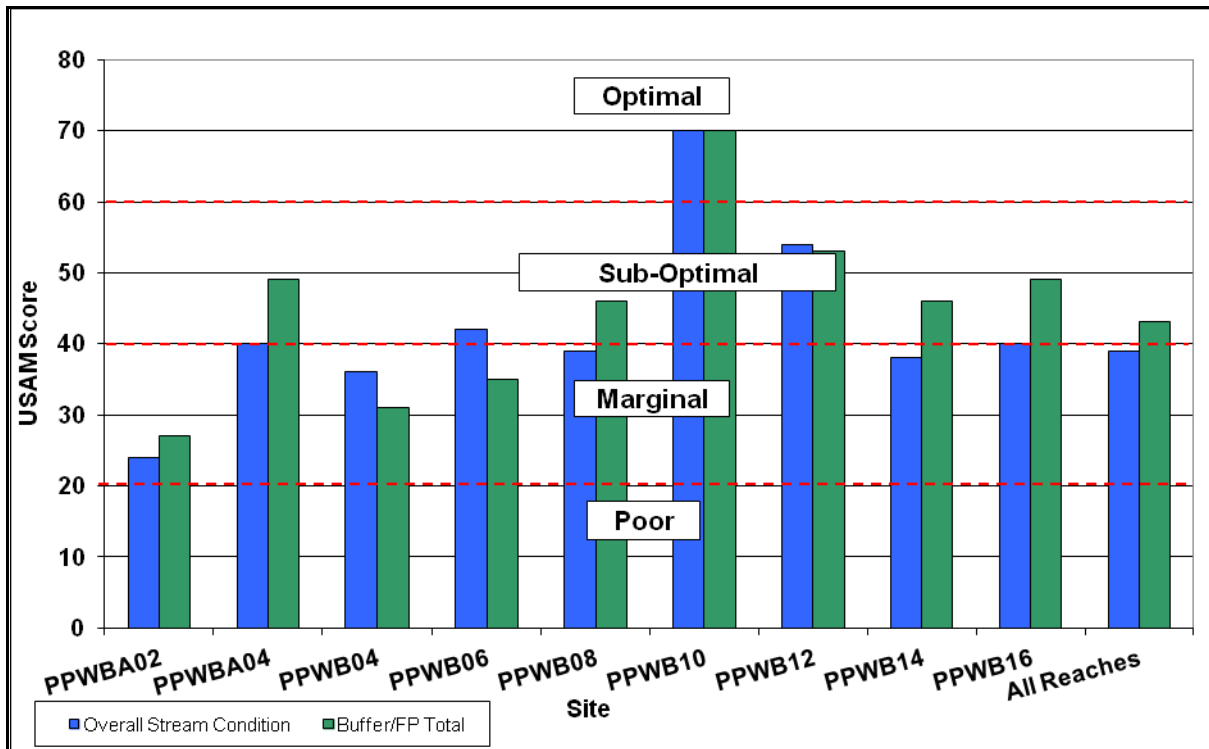
Figure 3-34: Results for Wooden Bridge Run USAM Components

The Center for Watershed Protection’s (CWP) Unified Stream Assessment Methodology (USAM) was used to score and rate the in-stream, riparian buffer and floodplain conditions of the stream corridor to allow for comparison to other reaches and watersheds within the Lower Pennypack Creek basin. The all reaches parameter is the mean of the scores of all tributary reaches in the Lower Pennypack Creek study.

very coarse gravel size class. The combination of favorable channel morphology and relatively coarse substrate attributed to high scores in both of the USAM components as well as the composite USAM score. The *Overall Stream Condition* (70/80), *Overall Buffer Floodplain Condition* (70/80) and composite USAM score (140/160) for PPWB10 were all rated as "optimal" and were the highest scores observed of all of the tributaries assessed (Figure 3-34 and Figure 3-35).

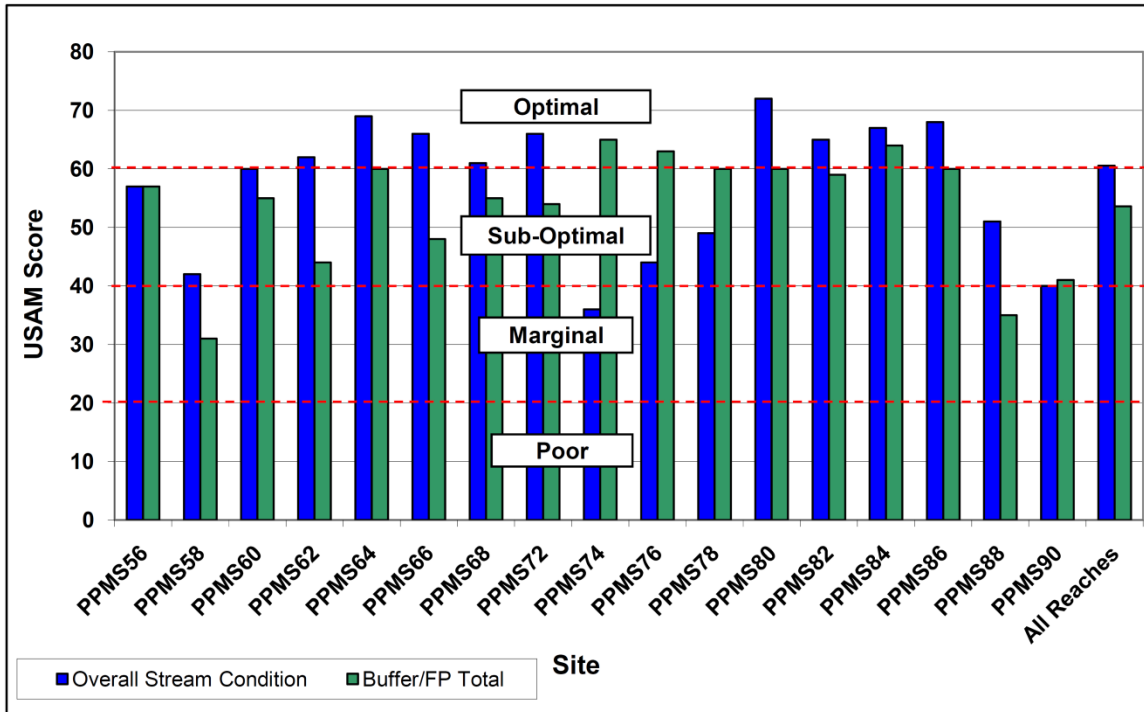
Figure 3-41: Results for Lower Pennypack Creek Main Stem USAM Components

The Center for Watershed Protection's (CWP) Unified Stream Assessment Methodology (USAM) was used to score and rate the in-stream, riparian buffer and floodplain conditions of the stream corridor to allow for comparison to other reaches and watersheds within the Lower Pennypack Creek basin. The all reaches parameter is the mean of the scores of all reaches in the Lower Pennypack Creek Main Stem.
